Appendices

FIGURE 3-5
Preferred Alternative
Crystal Airport
Environmental Assessment

FIGURE 1
 Proposed Action
 Crystal Airport
 Section 4(f) Evaluation

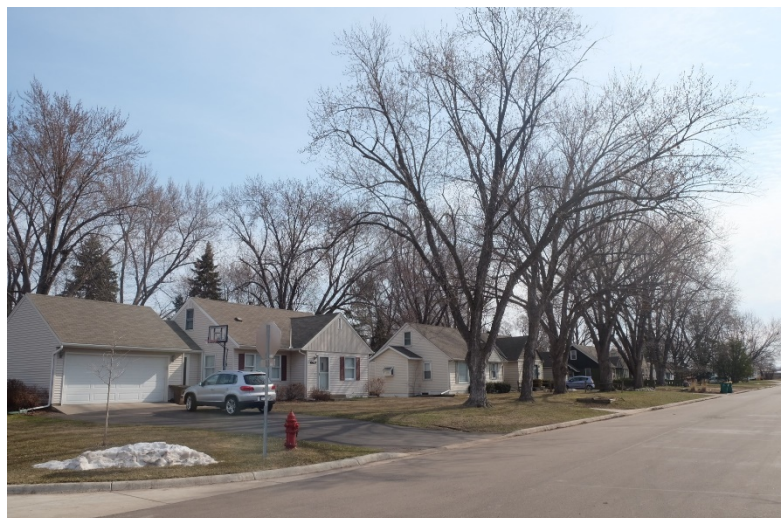
Silver maples along Dudley Avenue North (facing east from Hampshire Avenue intersection) in Runway 6L approach area.

Commonly planted in street and residential settings in the 1950s and 1960s, the silver maple *Acer saccharinum* (referred to as red maple in the field notes as silver maple is often grouped with red maple) is the most commonly occurring species in the survey. It is a highly adaptable species which thrives in most settings. It was widely planted due to its rapid growth. Most of the trees studied in the survey, however, were not next to open water or on a site with a very high water table (the residential development of the area includes drainage improvements). This means that they are not well situated to produce their maximum potential growth rates.

It was determined by the use of binoculars that during the 2017 growing season most of the twigs added between 12 and 24 inches of length. The average length of twig growth was 18 inches or slightly less. The evidence suggests that an average of 18 inches of twig elongation can be expected on the silver maples in the next five years. This will result in 18 inches of additional total height growth annually or slightly less.

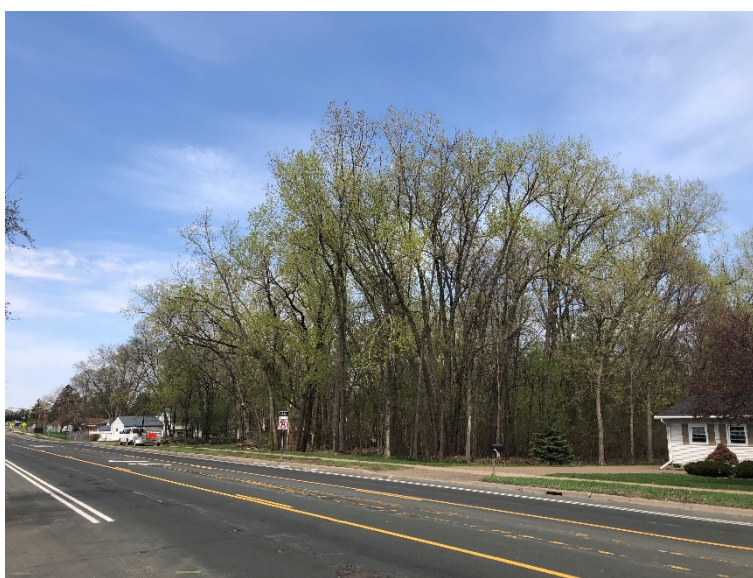
A stand of cottonwood trees in a public park north of 63rd Avenue North observed in the Runway 14L approach area

Cottonwood *Populus deltoides* is the tree which is most likely to cause ongoing approach issues wherever it is present. Several individual cottonwoods were identified during the survey, along with a large stand which is present in the Runway 14L approach area in a public park.

The growth rate on cottonwood is much faster and more variable than any of the other species identified. During very wet years twig elongation exceeding five feet is not uncommon. This rapid growth rate means that including cottonwood with the other species increases the average growth rate for all species markedly.

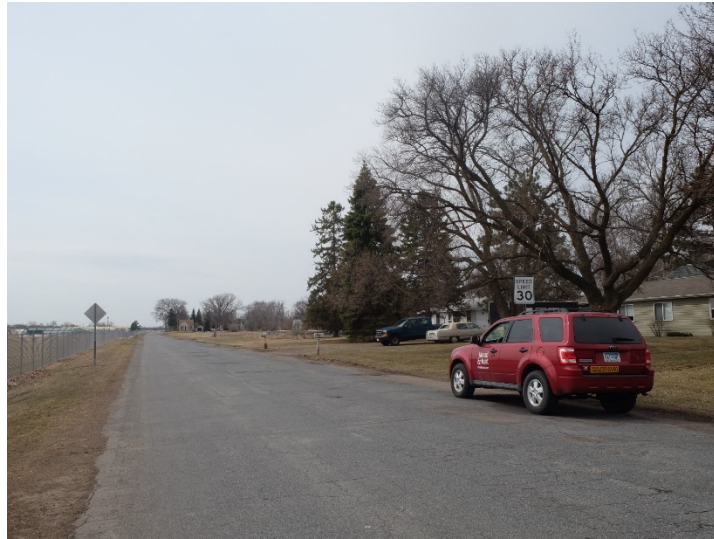
Species observed in the Runway 14L approach area west of Douglas Drive include boxelder, douglas fir, green ash, Siberian elm, and silver maple.

Seventy-five trees were observed in the Runway 14L approach area. The presence of 16 cottonwoods, primarily in the public park north of 63rd Avenue North, makes this area much more prone to rapid height increase than any of the others. Where the cottonwoods are present a growth rate of at least 30 inches is predicted. Aside from the cottonwoods a variety of other species were observed of which red maple and white poplar would be likely to gain height quickly. The average twig elongation of all the trees observed, excluding the cottonwoods is 15.0 inches. Removing the cottonwoods from consideration, the predicted rate of growth is 15 inches in this area.

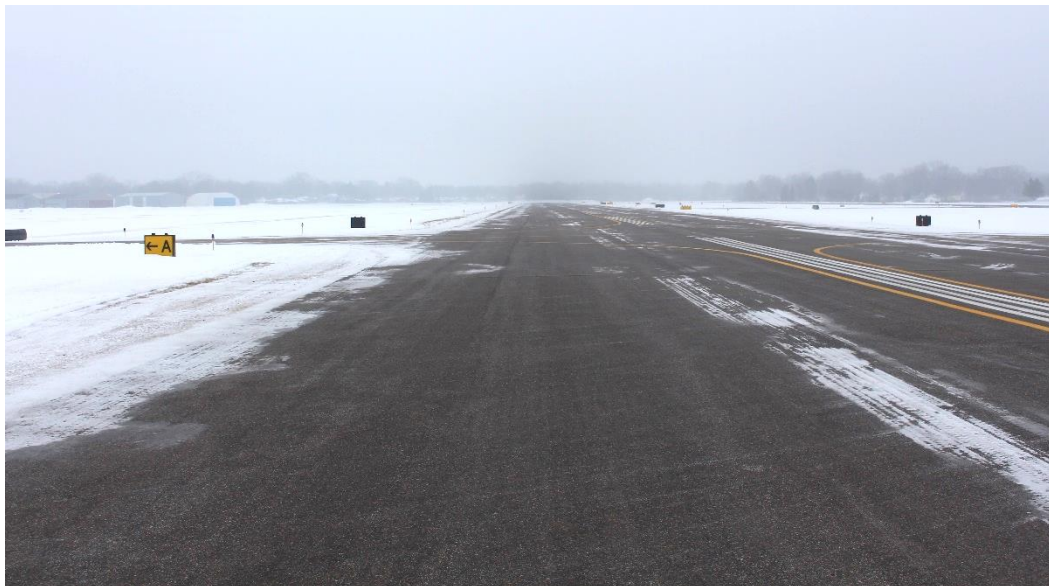
Figure 2. Paved Runway 14L/32R, view facing northwest.

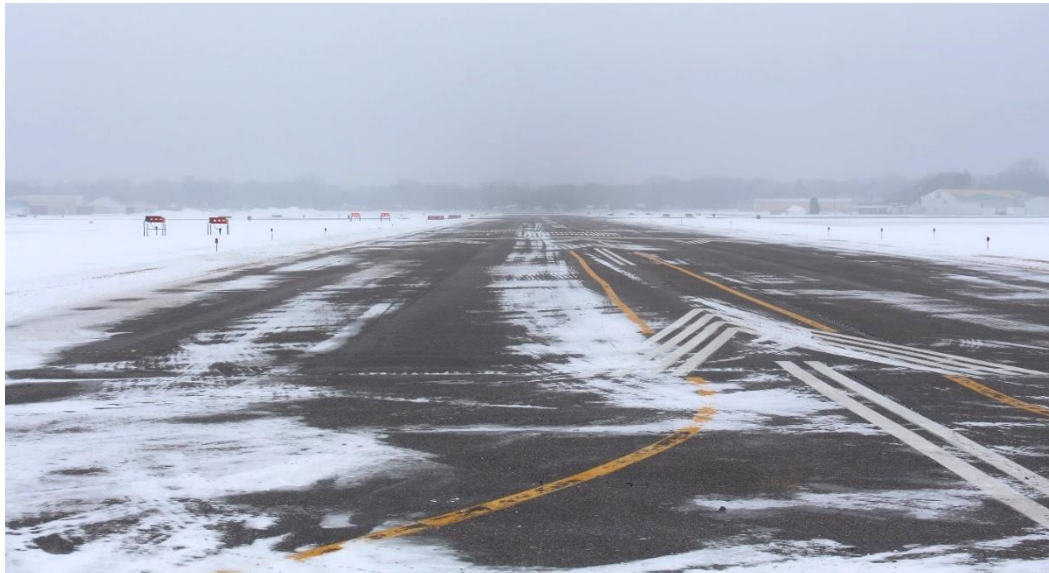
Figure 3. Paved Runway 6L-24R, view facing southwest.

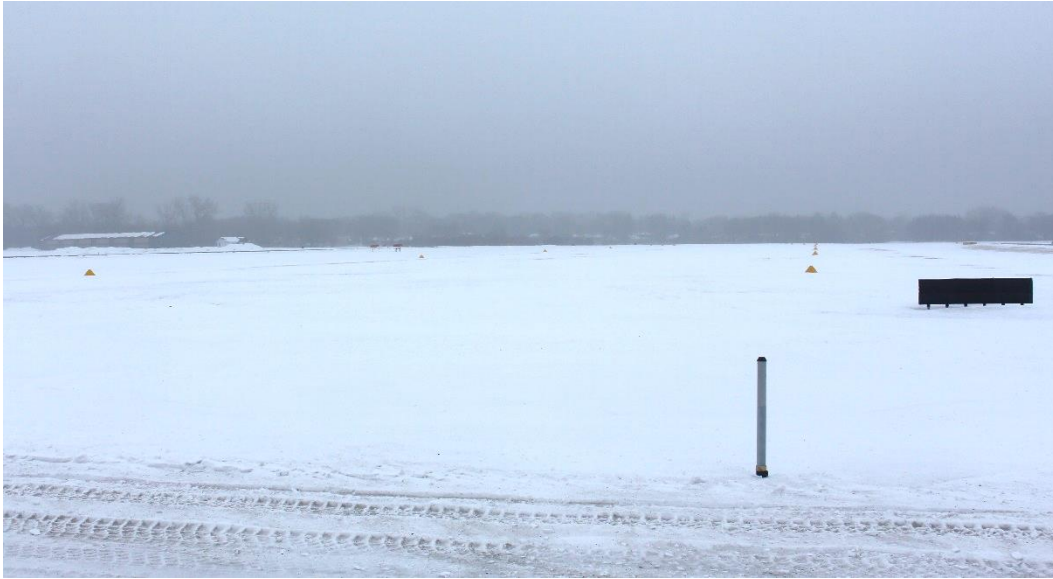
Figure 4. Turf Runway 6R/24L, view facing northeast.⁷

⁷ The site visit was conducted during winter and some site conditions were obscured by snow, including the turf runway, which is not plowed during winter months.

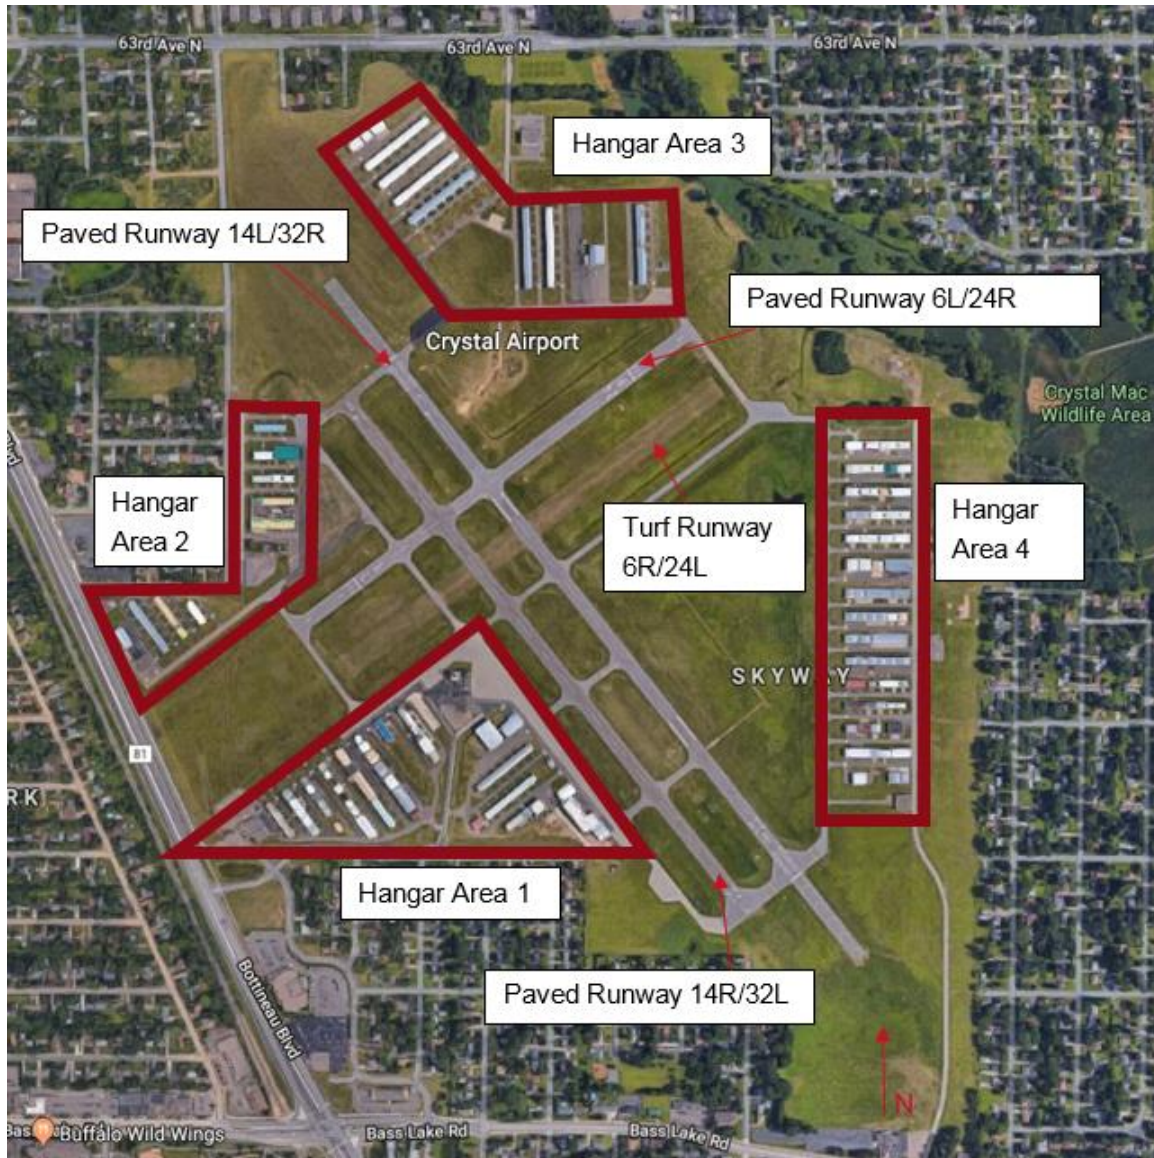
Figure 5. Crystal Airport hangar areas and runways.

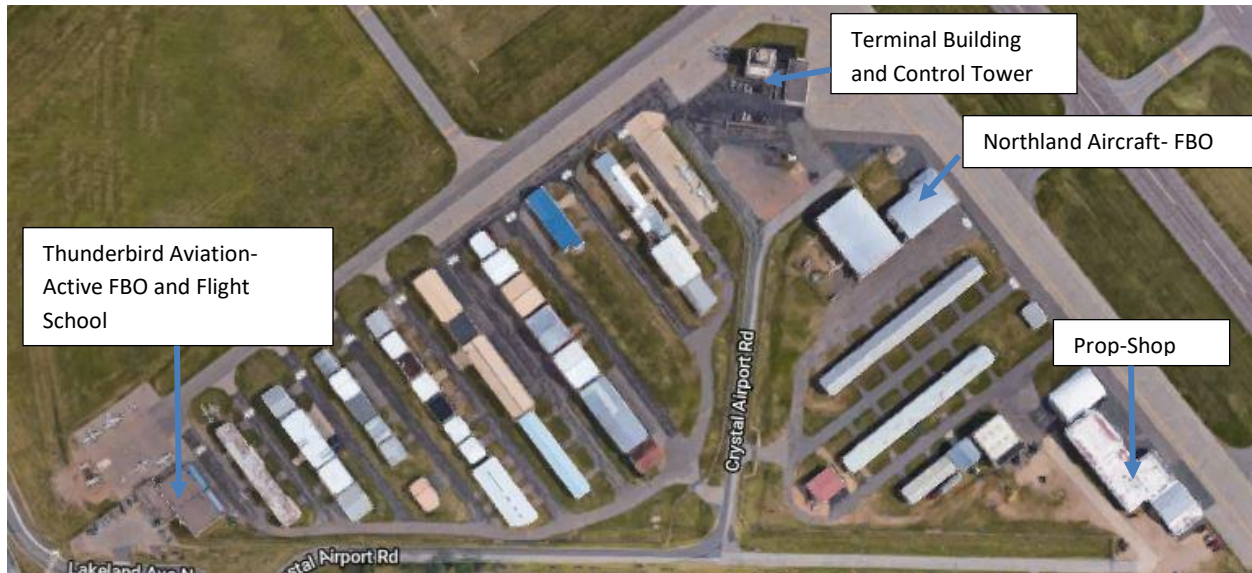
Figure 6. Current aerial of Hangar Area 1.

Located at the south end of the airport, Hangar Area 1 has 46 buildings, including ground service facilities and 42 hangars. The service buildings are the terminal building and control tower, two FBOs (Thunderbird Aviation and Northland Aircraft), and the Prop-Shop (see Figure 6).

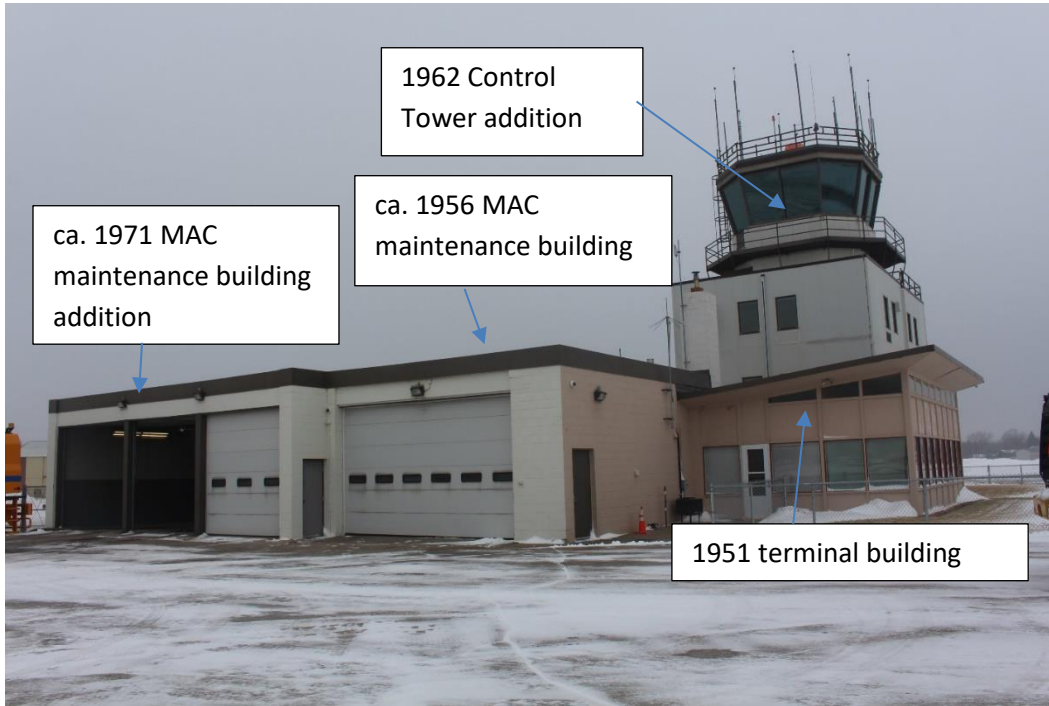
Figure 7. Crystal Airport terminal building and control tower, view facing southwest, showing the four components of the building: the 1951 terminal building, ca. 1956 MAC maintenance building, 1962 control tower, and ca. 1971 MAC maintenance building addition.

Located at the north end of Crystal Airport Road, the irregularly shaped terminal building and control tower consists of four distinct parts: a 1951 terminal and administration building (terminal building), ca. 1956 MAC maintenance building, 1962 control tower, and a ca. 1971 maintenance building addition. Due to the additions, the only visible portions of the original one-story, rectangular-shaped terminal building are the north elevation and a portion the east elevation. This earlier part of the overall building is clad in wood siding and has a shed roof. It has rows of fixed metal windows, one of which is now infilled with wood panels, and a single-leaf door on the east elevation. The ca. 1956 MAC building is attached to the south elevation of the terminal building. The concrete block, one-story, rectangular building rests on a poured-concrete foundation and has a flat roof. The 1962, five-story control tower is attached to the west elevation of the terminal building. A square, three-story block is capped with a set-back, two-story, polygonal tower with large canted windows on each elevation. The tower is clad in enameled metal panels and has one-over-one metal windows on the first three stories. A one-story wing spans the south elevation. A ca. 1971 maintenance building addition was added to the south and west elevations of the MAC building. It has multiple overhead doors on the east elevation and a main entrance on the west elevation (see Figures 7 and 8).

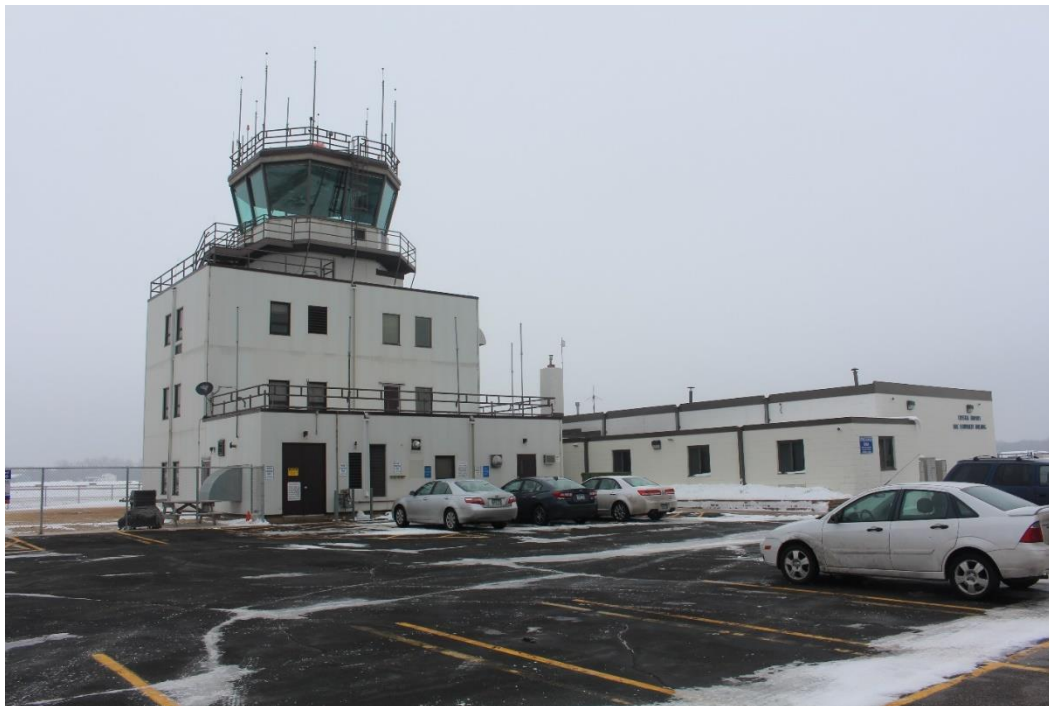
Figure 8. Crystal Airport terminal building and control tower, view facing northeast.

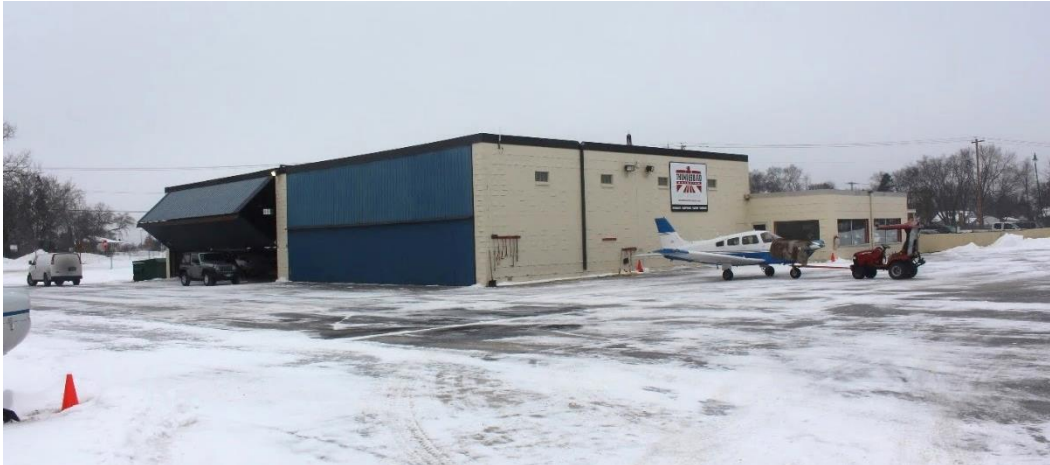
Figure 9. Thunderbird Aviation, active FBO, view facing southwest.

The active FBO and flight school, Thunderbird Aviation, is in a ca. 1967 building located at the far western edge of Hangar Area 1. The overall irregularly shaped, concrete block building with a flat roof has two rectangular one-story sections: an office and hangar. The office has brick around the entrance on the front (west) facade that is sheltered by a flat roof awning supported by round posts. Windows are fixed metal sash, and single-leaf doors are also present. The hangar has two vertical bifold doors on the east elevation. Windows are glass block (see Figures 9 and 10).

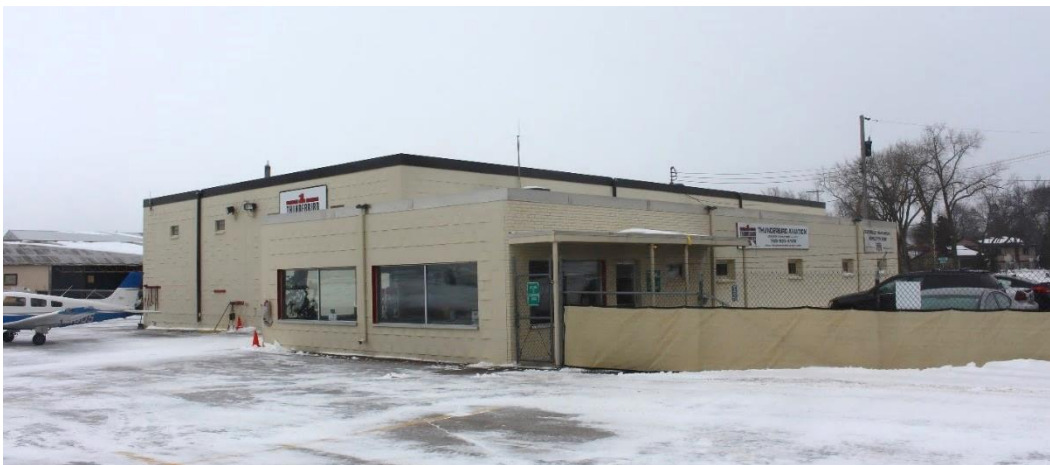
Figure 10. Thunderbird Aviation, view facing southeast.

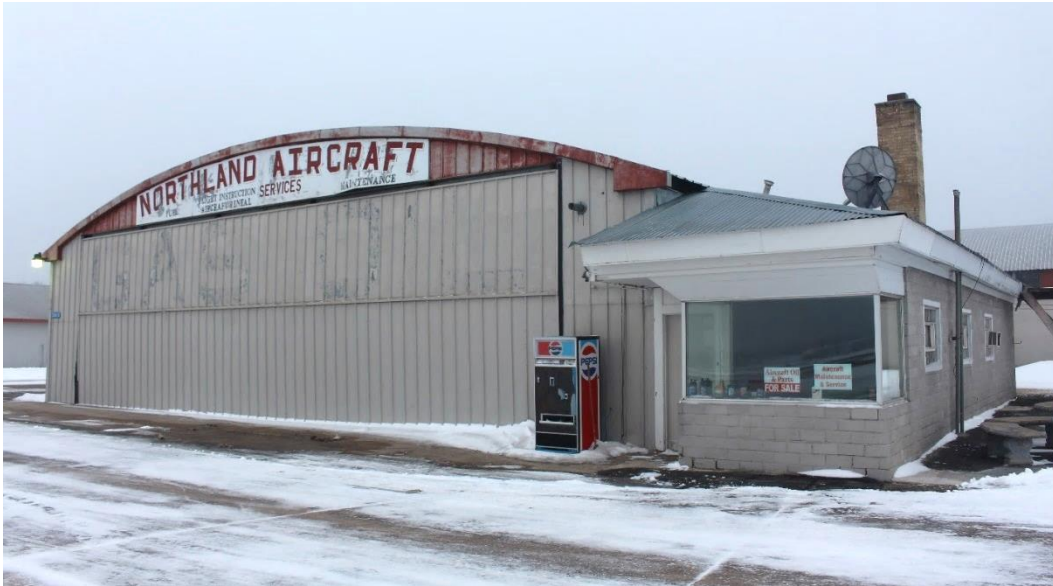
Figure 11. Ca. 1953 Northland Aircraft hangar and FBO building, view facing south/southwest.

Northland Aircraft, the second active FBO on site, is located east of the terminal building and control tower. The FBO is in a ca. 1953, one-story hangar is clad in standing seam metal siding and has an arched metal roof. A vertical bifold door is on the front (northeast) facade, and a one-story, concrete block office with a hip roof is on the side (northwest) elevation (see Figure 11). The hip roof is a ca. 2005 alteration. Located southwest of the main FBO building is a large associated hangar. Built in 1967, the one-story concrete block building has an arched roof (see Figure 12). Gas pumps associated with Northland Aircraft for refueling are northwest of the building.

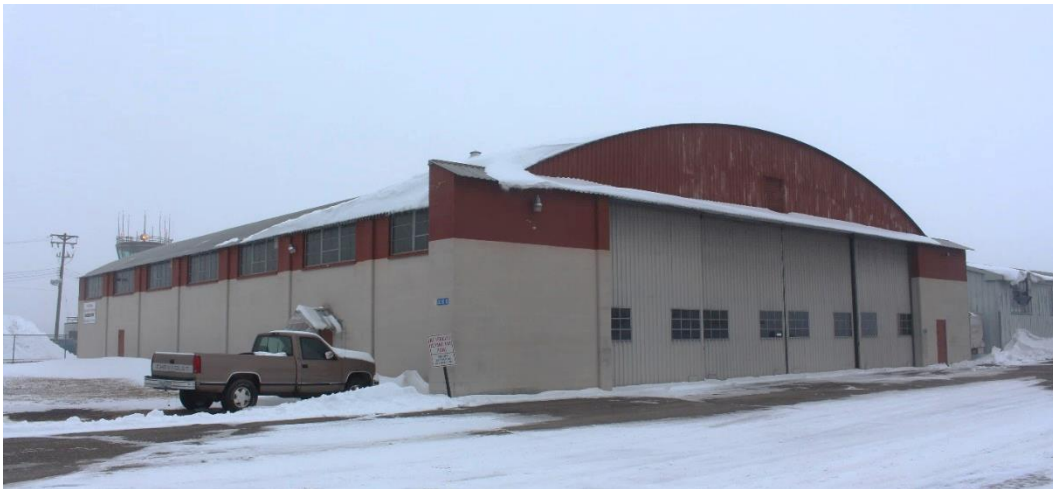
Figure 12. 1967 hangar associated with Northland Aircraft, view facing north.

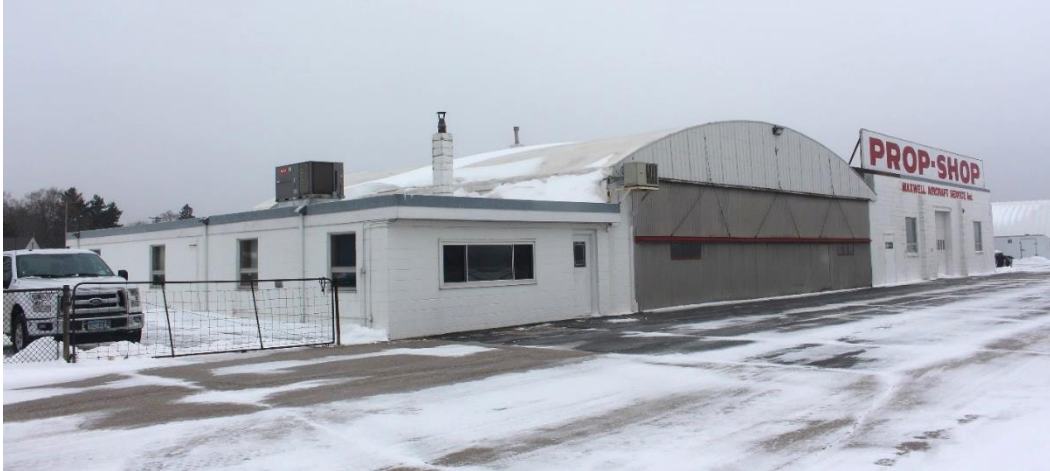
Figure 13. Prop-Shop, view facing southwest.

The Prop-Shop, located southeast of Northland Aircraft, is comprised of five interconnected buildings. It began as a ca. 1953 Quonset hangar and ca. 1953 arched-roof box hangar that are now connected by later additions: a ca. 1979 concrete block box hangar (set back from the apron), ca. 1960 concrete block service building with a single bay, and ca. 1960 concrete block addition with a flat roof. Each building is one story and has a flat or arched roof of varying height. Fenestration also varies on each building. The front (northeast) facade fenestration facing the apron on the Quonset-style hangar consists of three overhead doors. The ca. 1979 building has a vertical bifold door and a single-leaf door on the front (northeast) facade and one-over-one metal windows on the rear (southwest) elevation. The same one-over-one windows are on the ca. 1960 building, as are multi-light metal windows, an overhead door, and a single-leaf door. The ca. 1953 arched-roof box hangar

has a vertical bifold door and multi-light metal windows. Finally, the southernmost ca. 1960 building has one-over-one metal and sliding metal windows and a single-leaf door (see Figures 13 and 14).

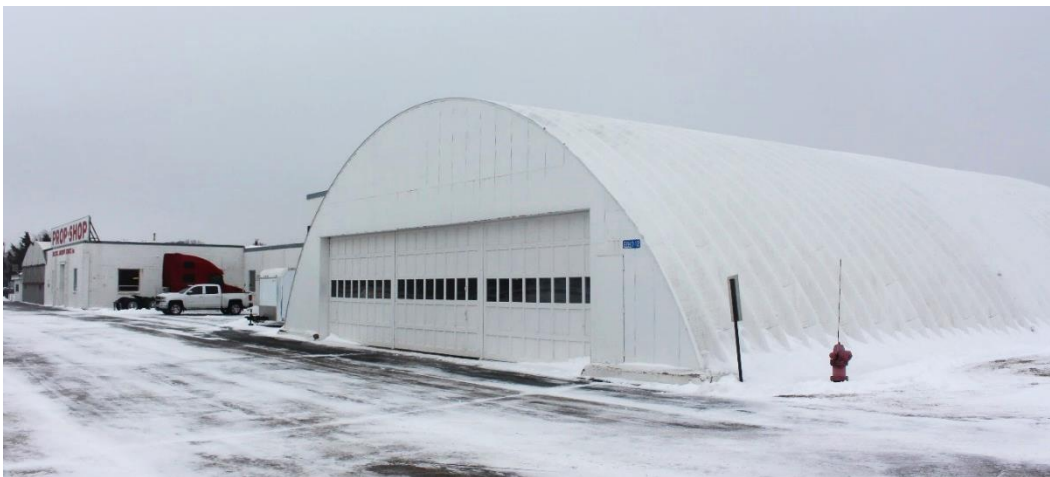
Figure 14. Prop-Shop, view facing southeast.

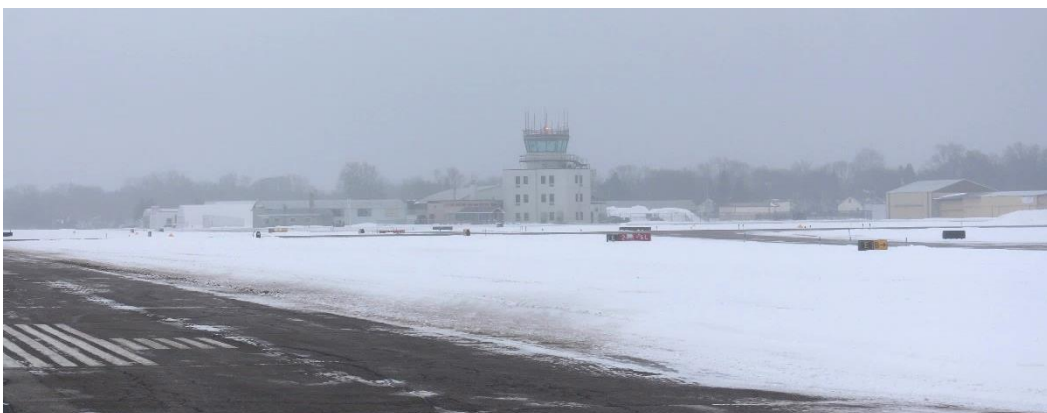
Figure 15. Overview of the east side of Hangar Area 1, view facing southeast.

Within Hangar Area 1, the hangars are arranged in 12 hangar rows and are a mixture of multi-unit T-hangars and box hangars (see Figures 15 and 16). Extending toward the control tower, Crystal Airport Road bisects the area, with eight hangar rows on the west side of the road and four on the east. The eight hangars on the east side of Hangar Area 1 date predominately to the 1950s and 1960s, with one dating to ca. 1971. The west side of Hangar Area 1 has 34 hangars from the 1950s to 1990s. Many of the 1990s hangars are largely concentrated in two rows and replaced the original individual-stall T-Hangars. The hangars commonly rest on poured-concrete foundations, are clad in metal, and have front- or side-gable roofs. Variations include concrete block and fiberboard cladding, and have shed, flat, or arched roofs. The one-story hangars vary in type and size and have sliding or vertical bifold doors (see Figures 17 through 20). Some also have sliding or fixed windows. Several of the hangars have alterations, specifically replacement siding and doors.

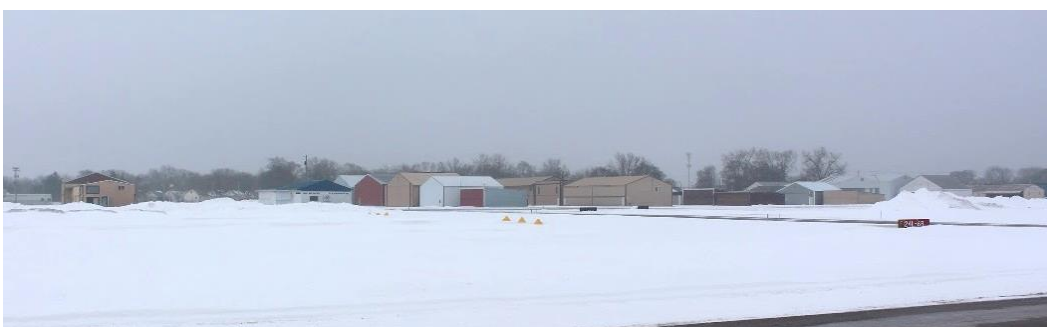
Figure 16. Overview of the west side of Hangar Area 1, view facing south.

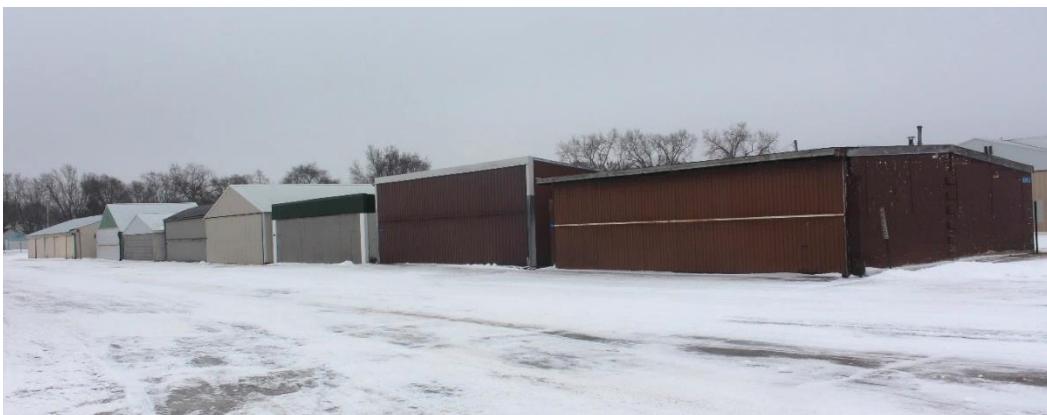
Figure 17. Row of 1950s and 1960s hangars on the west side of Hangar Area 1, view facing southwest.

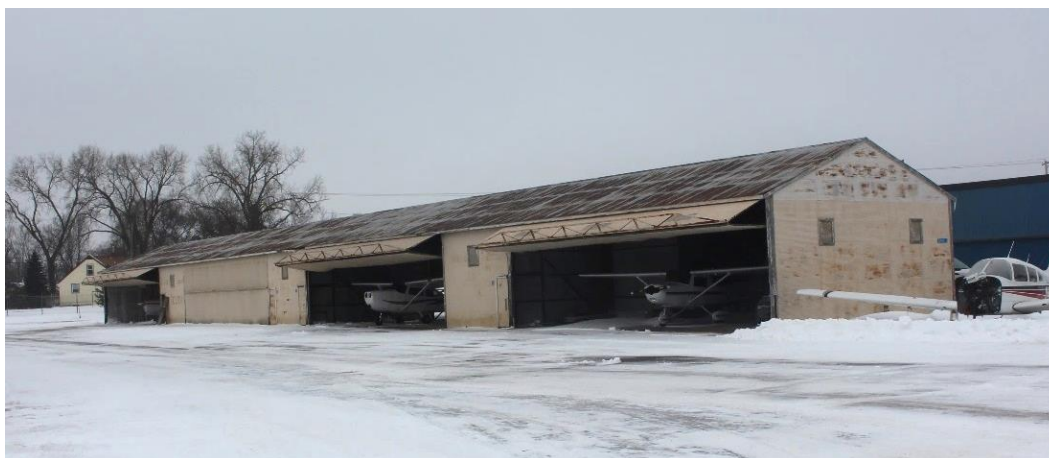
Figure 18. Ca. 1960 T-hangar on the west side of Hangar 1, view facing south southeast.

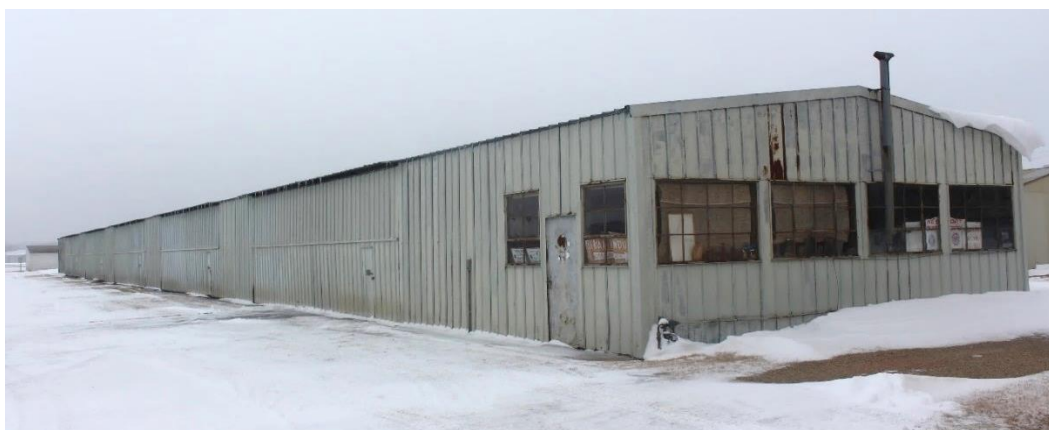
Figure 19. Ca. 1953 T-hangar, occupied by the American Legion, on the east side of Hangar Area 1, view facing northeast.

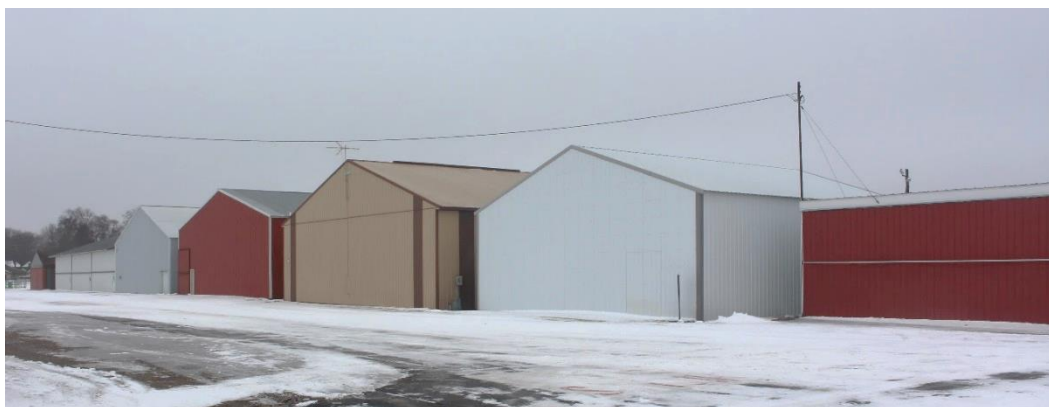
Figure 20. Ca. 1991 hangars on the west side of Hangar Area 1, view facing southwest.

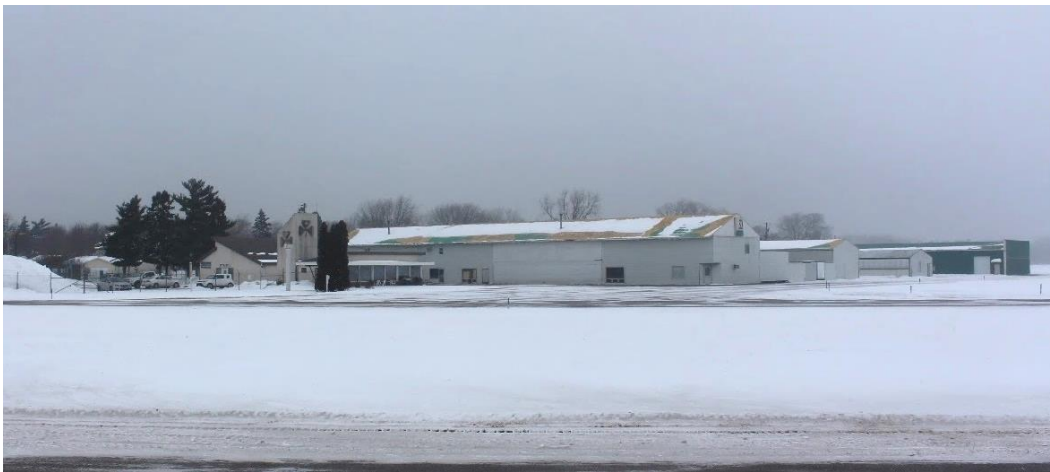
Figure 21. Overview of east side of Hangar Area 2, view facing north northeast.

Located at the west end of the property, Hangar Area 2 has 14 buildings and both T-hangars and box hangars that were largely developed in the 1960s. Three hangars built in the 1990s and 2000s are present as well as one ground service facility (see Figure 21). The area is roughly L-shaped and has approximately 10 hangar rows, with four along 60th Avenue North and six along Douglas Drive North. Two ca. 1966 buildings along 60th Avenue North were removed ca. 2015.⁸ The hangars typically have poured-concrete foundations, are clad in metal, and have front- or side-gable roofs. The one-story hangars are predominately multi-unit and have sliding or vertical bifold doors (see Figure 22). Some also have sliding or fixed windows. The hangars vary in type and size and some have alterations, including replacement siding and doors. The Crystal Shamrock building, a ca. 1966 Contemporary-style building, rests on a poured-concrete foundation, is clad in stucco, and has an irregular roof. It has a stucco pylon with a shamrock cutout on the south elevation, and a flat awning extends out over the main entrance. Windows are fixed metal. The east elevation has a ribbon of large fixed windows that fill up most of the wall space (see Figure 23). The former FBO building and two adjacent associated hangars now serve as an aircraft recovery firm.

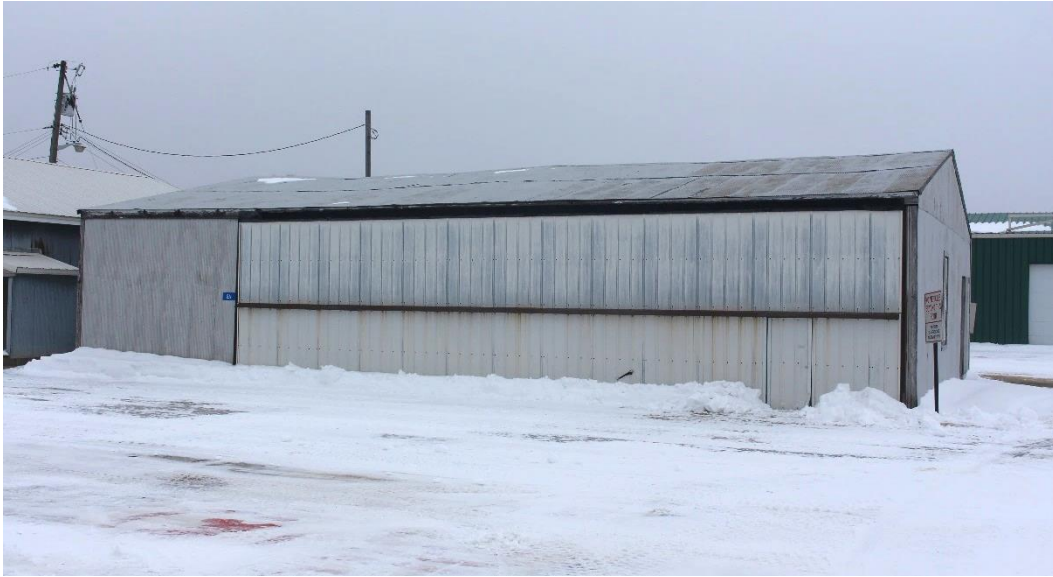
Figure 22. Ca. 1960 hangar in Hangar Area 2, view facing north.

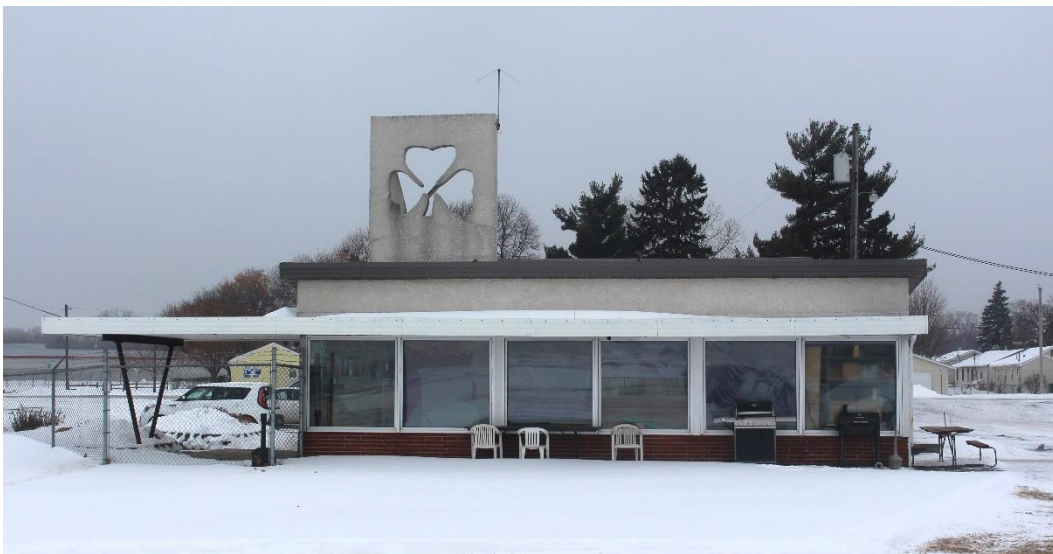
Figure 23. Ground service facility (former Crystal Shamrock FBO, ca. 1966), view facing west.

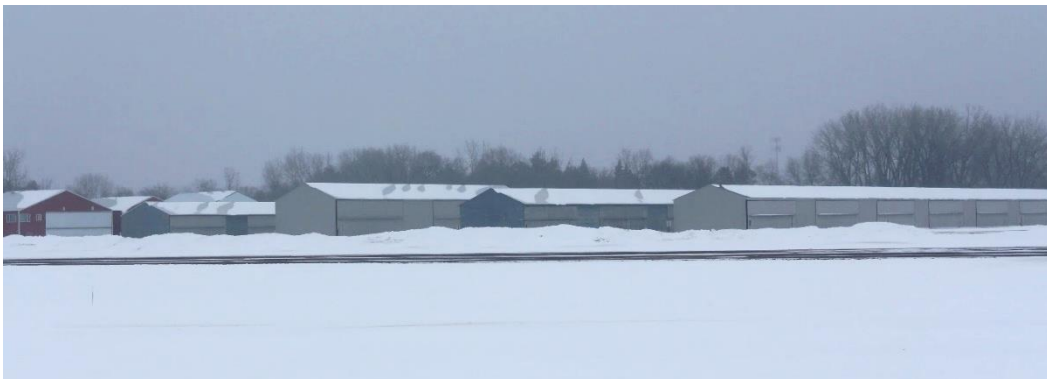
Figure 24. Overview of the west side of Hangar Area 3, view facing northwest.

Located at the north end of the property, Hangar Area 3 has 14 buildings with seven multi-unit T-hangars constructed in the 1970s, as well as three box and multi-unit T-hangars from the 1990s to 2000s (see Figure 24). The one-story T-hangars have poured-concrete foundations, are clad in metal, and have side-gable roofs. Each are approximately the same size and have vertical bifold doors (see Figure 25). Three hangars located on the westernmost row are two-story box hangars that have a poured-concrete foundation, are clad in metal, and have front-gable roofs (see Figure 26). Some of these hangars have sliding and fixed windows and single-leaf doors. Four ground service facilities are in the area, including a former 1990s FBO building and flight school; two

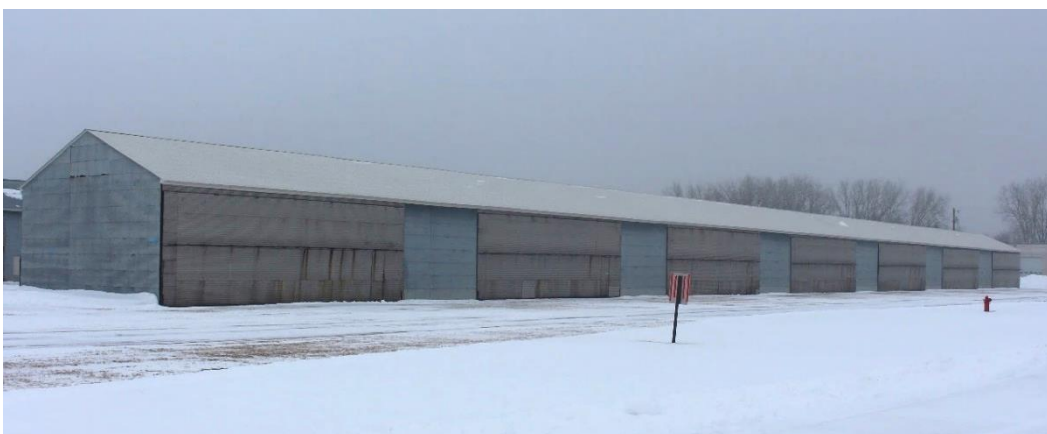
Figure 25. 1970s T-Hangar, view facing northwest.

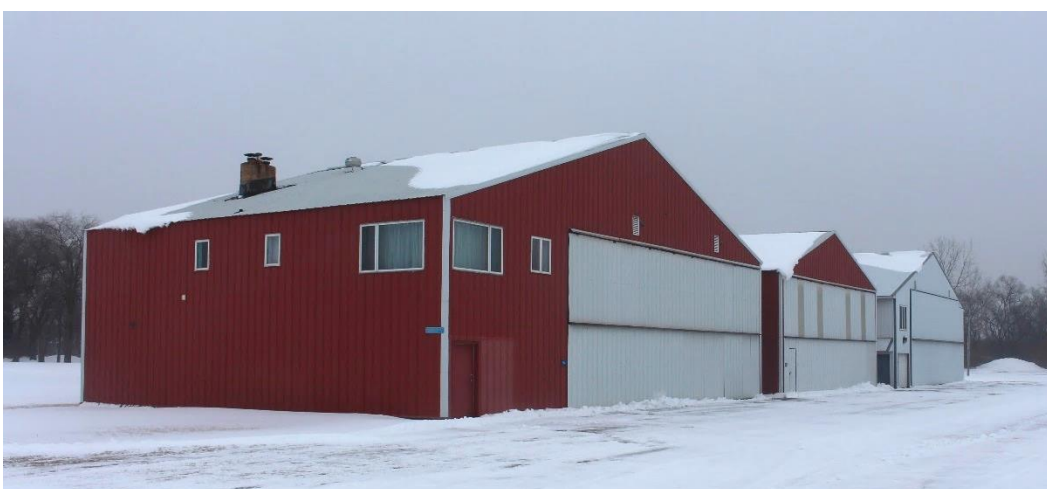
Figure 26. 1990s hangars in Hangar Area 3, view facing north.

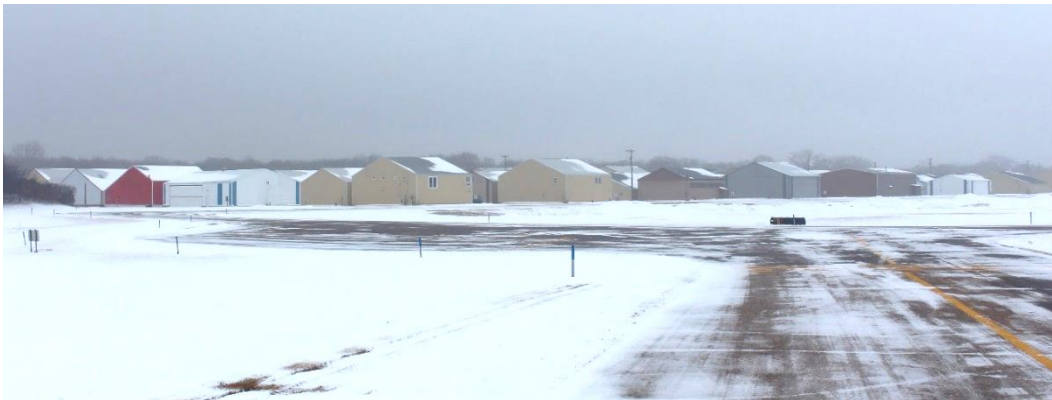
Figure 27. Overview of Hangar Area 4, view facing southeast.

Located at the east end of the property, Hangar Area 4 has 70 buildings that are mostly single-unit box hangars (see Figure 27). There are also several small, multi-unit T-hangars and a ca. 1971 Quonset-style hangar. The hangars are arranged in 16 rows and were largely constructed in the 1990s, although eight 1960s and ca. 1971 hangars are also present. The hangars have poured-concrete foundations, are clad in metal, and have front-gable roofs, though some have side-gable roofs. The hangars vary in size with vertical bifold doors. Several have single-leaf doors and sliding or fixed windows (see Figures 28 through 31). Support buildings include ca. 1979 and ca. 2003 MAC maintenance buildings and a c.2001 restroom facility. A ca. 1966 FAA radio equipment building is located east of the hangar rows. This simple, rectangular, concrete-block building has a flat roof with a wide eave overhang and a single-leaf door on the east elevation (see Figure 32).

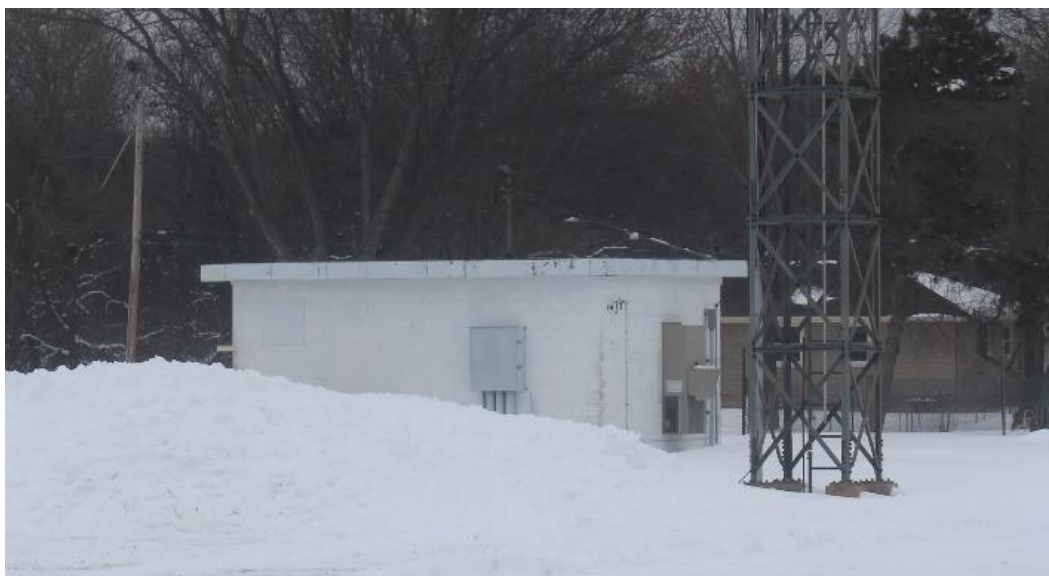
Figure 32. Ca. 1966 FAA radio equipment building, view facing east northeast.

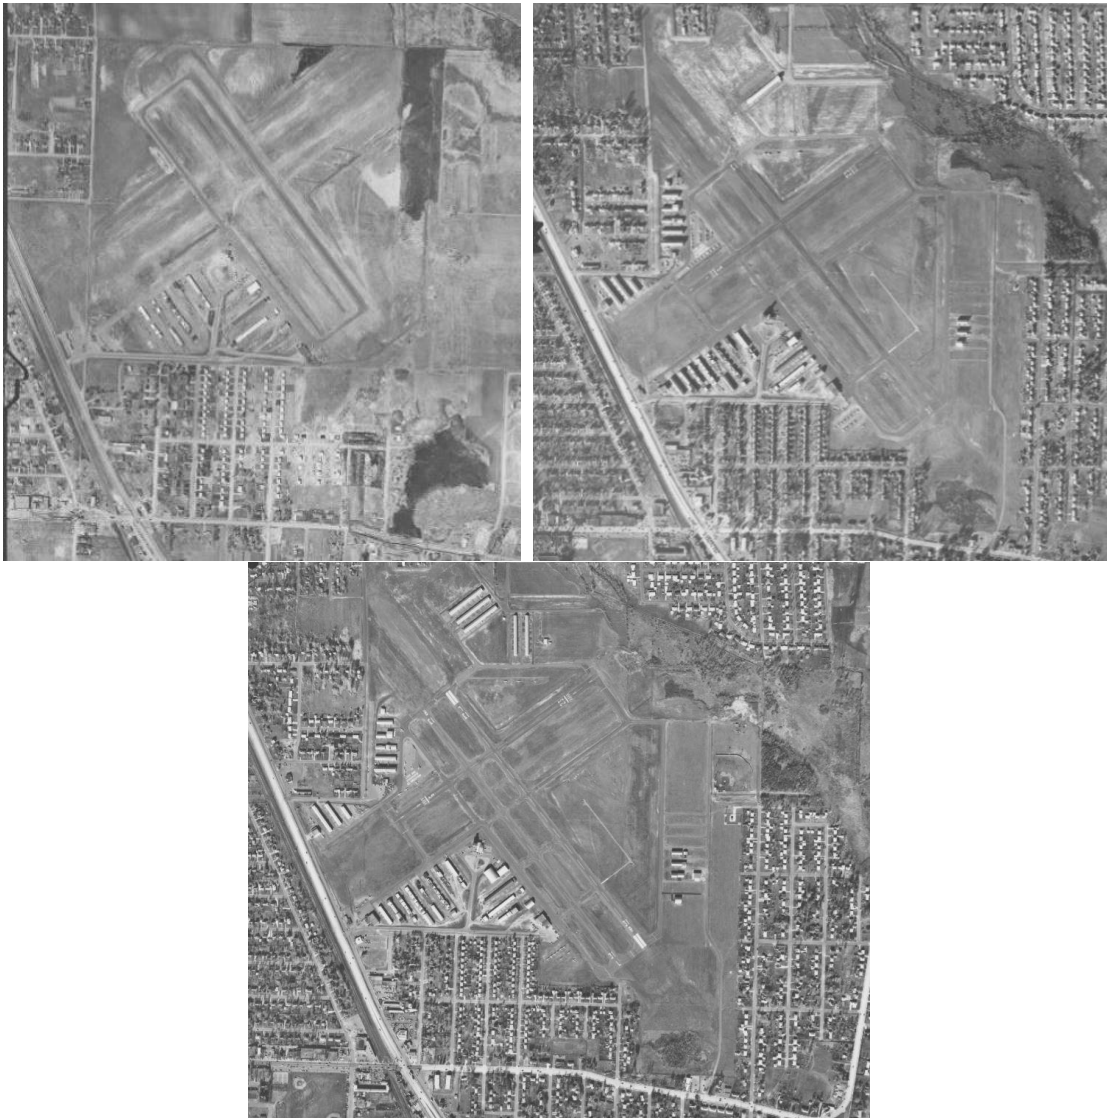
Figures 40 through 42. 1956 (top left), 1967 (top right), and 1971 (bottom) aerial photographs of Crystal Airport. Note the extension of runways (two of which are paved by 1967) and development of airport land. By 1967, Hangar Areas 1 and 2 were developed and the development of Hangar Areas 3 and 4 was just beginning. By 1971, the current runway configuration of three paved and one turf runway is in place.⁶⁸

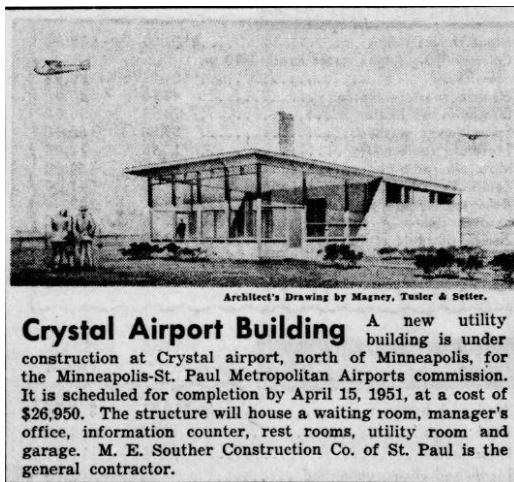
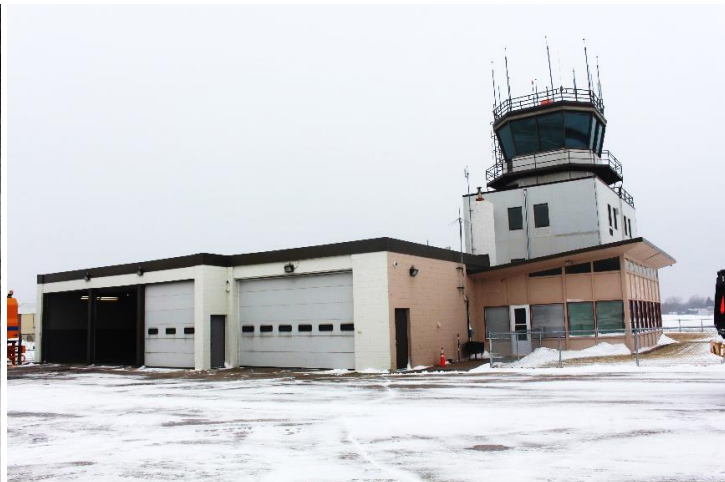
Figures 43 and 44. Left: Artist's rendering of the 1951 administration and terminal building at Crystal Airport. Right: the original administration and terminal building was expanded with additions of a maintenance facility ca. 1956 and ca. 1971, and the 1962 air traffic control tower.⁷³ This building is in Hangar Area 1.

Area 1 as defined for this project. Historic aerial photography reveals that this triangular area on the airport's south side included more than one dozen structures by 1953. These included the terminal building (built in 1951, see Figures 43 and 44), two large arched-roof hangar buildings (see Figures 45 and 46), three multi-unit T-hangars, a Quonset-style hangar, and about one-half dozen individual T-hangars (these individual T-hangars were replaced with small box hangars in the 1990s).⁷⁰ Three years later, in 1956, the number of structures in Hangar Area 1 had more than doubled to about 30. In addition to the types of structures listed above, by 1956, Hangar Area 1 also included 10 individual box hangars. Around then (ca. 1956) a maintenance bay was added to the terminal building (a second maintenance bay addition followed ca. 1971).⁷¹ A control tower was also added in 1962, greatly expanding the original administration and terminal building.⁷² It is unknown if the tower followed a standard plan.
