Appendices

FIGURE 3-5
Preferred Alternative
Crystal Airport
Environmental Assessment

FIGURE 1
 Proposed Action
 Crystal Airport
 Section 4(f) Evaluation

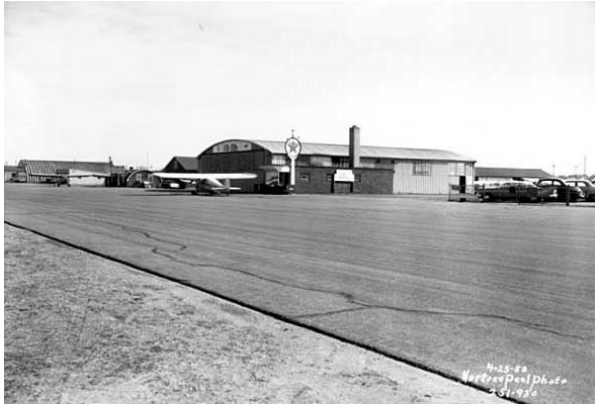
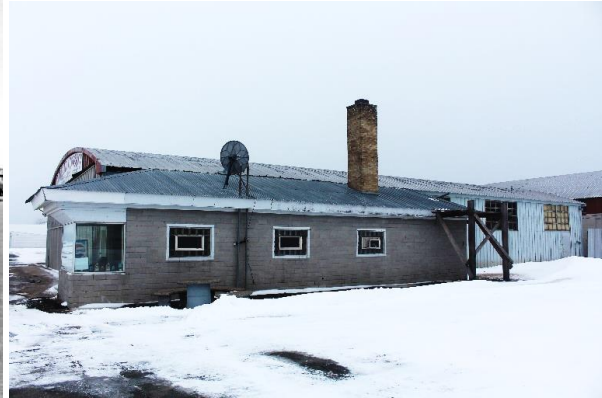
Figures 45 and 46. This ca. 1953, former FBO building and arched-roof hangar belonging to Northland Aircraft were part of the early development of Hangar Area 1, on the south edge of Crystal Airport. 1952 photo (left) courtesy of the Minnesota Historical Society.

Area 1 as defined for this project. Historic aerial photography reveals that this triangular area on the airport's south side included more than one dozen structures by 1953. These included the terminal building (built in 1951, see Figures 43 and 44), two large arched-roof hangar buildings (see Figures 45 and 46), three multi-unit T-hangars, a Quonset-style hangar, and about one-half dozen individual T-hangars (these individual T-hangars were replaced with small box hangars in the 1990s).⁷⁰ Three years later, in 1956, the number of structures in Hangar Area 1 had more than doubled to about 30. In addition to the types of structures listed above, by 1956, Hangar Area 1 also included 10 individual box hangars. Around then (ca. 1956) a maintenance bay was added to the terminal building (a second maintenance bay addition followed ca. 1971).⁷¹ A control tower was also added in 1962, greatly expanding the original administration and terminal building.⁷² It is unknown if the tower followed a standard plan.

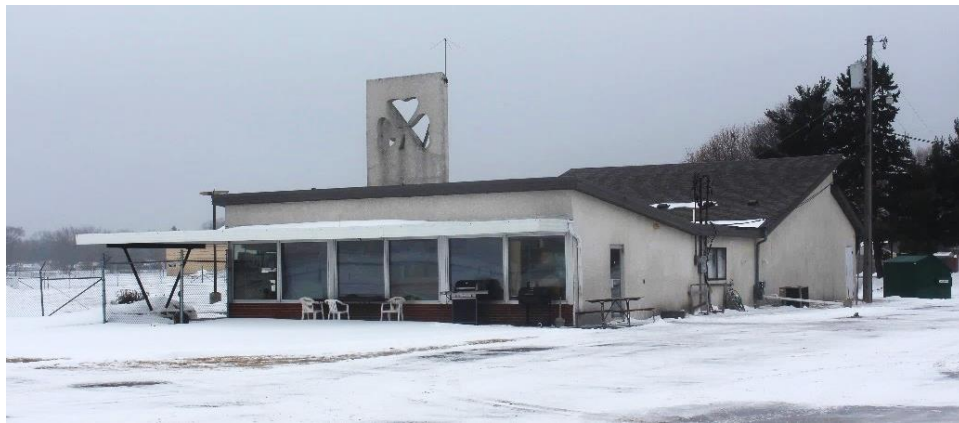
Figure 47. The ca. 1966 FBO Crystal Shamrock building located in Hangar Area 2. It is no longer in operation as an FBO.

By 1960, Hangar Area 1 was almost fully developed, and Crystal Airport moved to developing Hangar Area 2 (west hangar area), beginning in the northern section. By 1962, this area included one multi-unit T-hangar, three box hangars, and a new FBO building (ca. 1966) operated by Crystal Shamrock (see Figure 47).⁷⁴ Hangar Area 2 continued to develop into the 1960s, with the addition of more box and multi-unit T-hangars throughout the northern and southern sections. This period also saw an FAA radio tower and storage building (ca. 1966) built on the east side of the property, just east of hangar rows in Hangar Area 4.⁷⁵

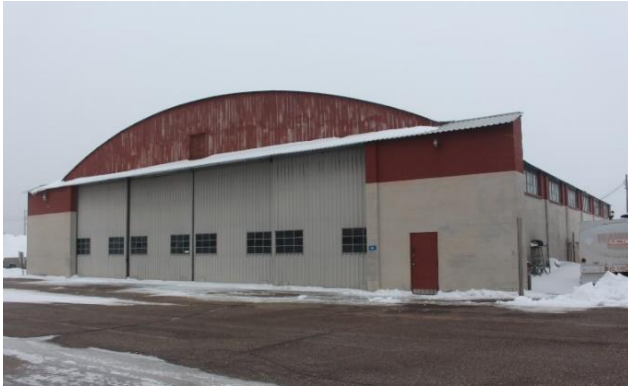
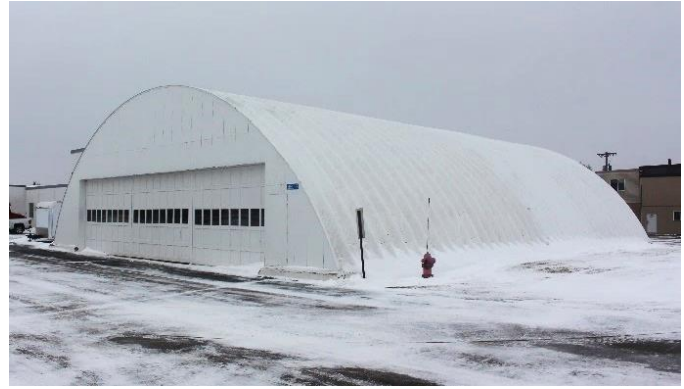
Figures 54 and 55. Two examples of large, arched-roof hangars found in Hangar Area 1. Left: A 1967 arched-roof hangar used by Northland Aircraft. Right: a ca. 1953 Quonset-style hangar used by the Prop-Shop.

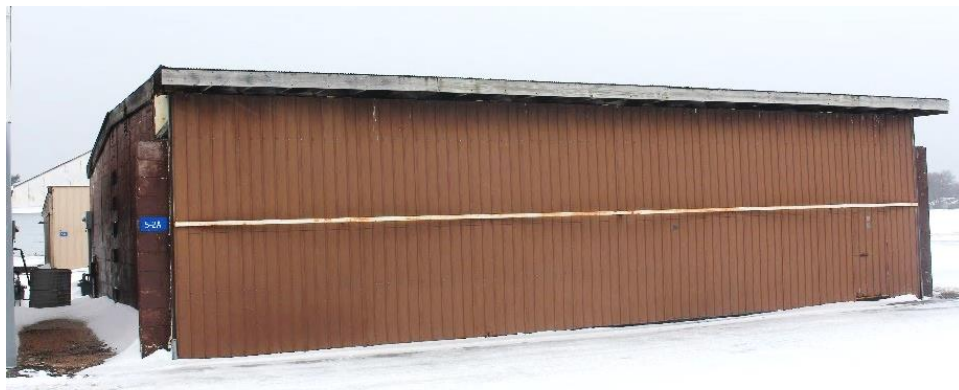
Figure 56. A ca. 1956 box hangar in Hangar Area 1. Note the concrete block wall and (likely replacement) bifold door.

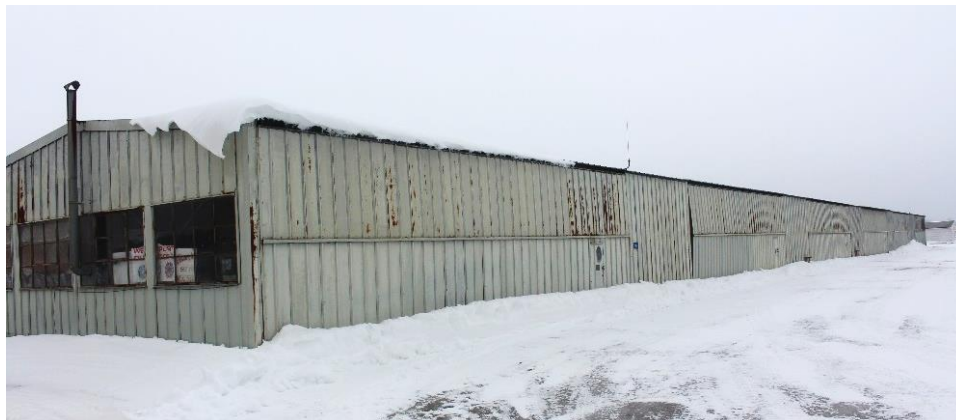
Figure 58. A ca. 1953, multi-unit T-hangar with five alternating stalls on each side in Hangar Area 1.

Multi-unit T-hangars have alternating T-stalls with doors on both sides of the hangar building. This pattern maximized the storage space of a hangar building while ensuring the safe storage of individual aircraft. T-hangars are framed in either wood or metal and usually clad in corrugated metal. Both individual and multi-unit T-stalls were inexpensive to build because they required no trusses to span large open spaces.¹⁴⁷ Individual T-stall hangars were present at Crystal Airport, in Hangar Area 1, from ca. 1950 to the 1980s, when they were replaced with box hangars. The airport retains most of its numerous multi-unit hangars (see Figure 58). These multi-unit hangars are present in all four hangar areas and vary in length, with the shortest being three stalls wide and the longest spanning the entire hangar row.

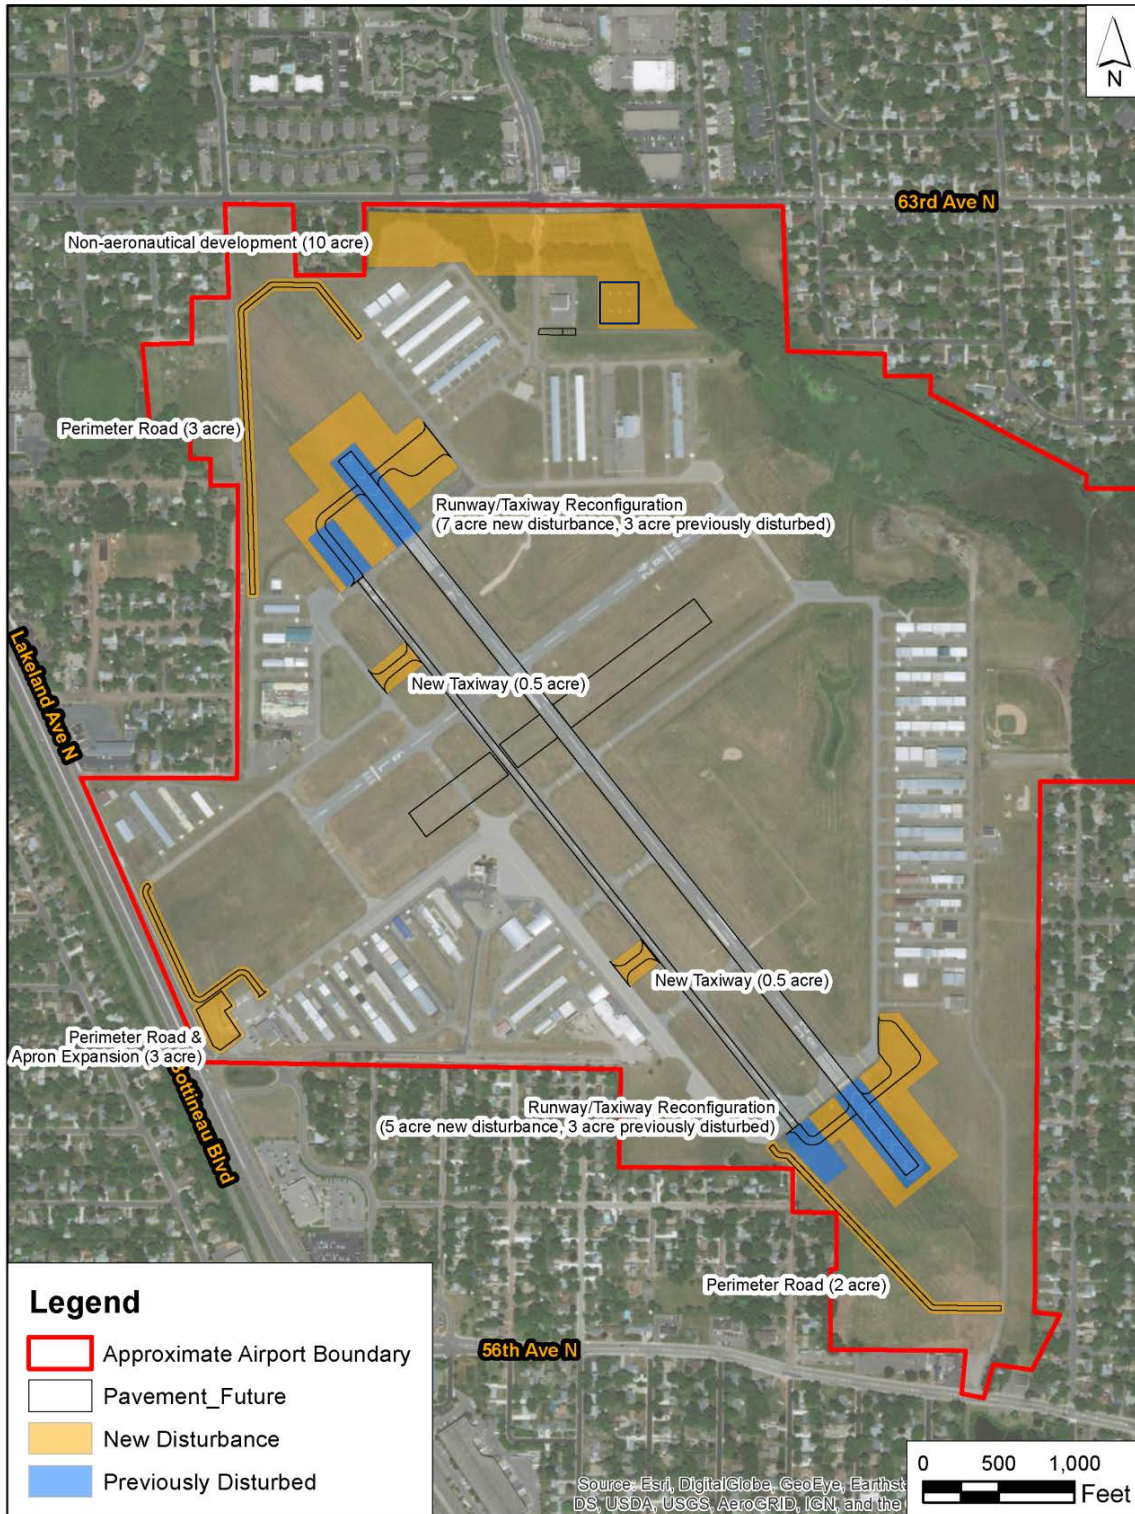
Figure 2. Aerial view of the areas of planned construction on the Crystal Airport property. A zone of specially manicured lawn with two lines of white cubes that was omitted from survey in the area of non-aeronautical development is outlined in dark blue. (Provided by Mead and Hunt.)

Project Description: The project area covers 31 acres of new disturbance across three proposed perimeter roads, an apron expansion, a segment of non-aeronautical development, two new taxiways, and reconfiguration at the ends of the northwest and southeast runway/taxiways at the Crystal Airport in Hennepin County, Minnesota (Figure 1). The project area is located in Section 4 and the NE and SE ¼ of Section 5, Township 118N, Range 21W; and the SE ¼ of Section 33, Township 119N, Range 21W. A small creek runs just 160 feet outside the project area at the northeast corner of the airport. The creek flows southeast to Upper Twin Lake, with Middle Twin Lake and Twin Lake immediately south, slightly over 0.5 miles to the east and southeast of the project location. Palmer Lake lies nearly 3 miles to the northeast. The Mississippi River flows south approximately 4.25 miles east of the project area. Figures 2 and 3 highlight the project plans on aerial and topographic maps.

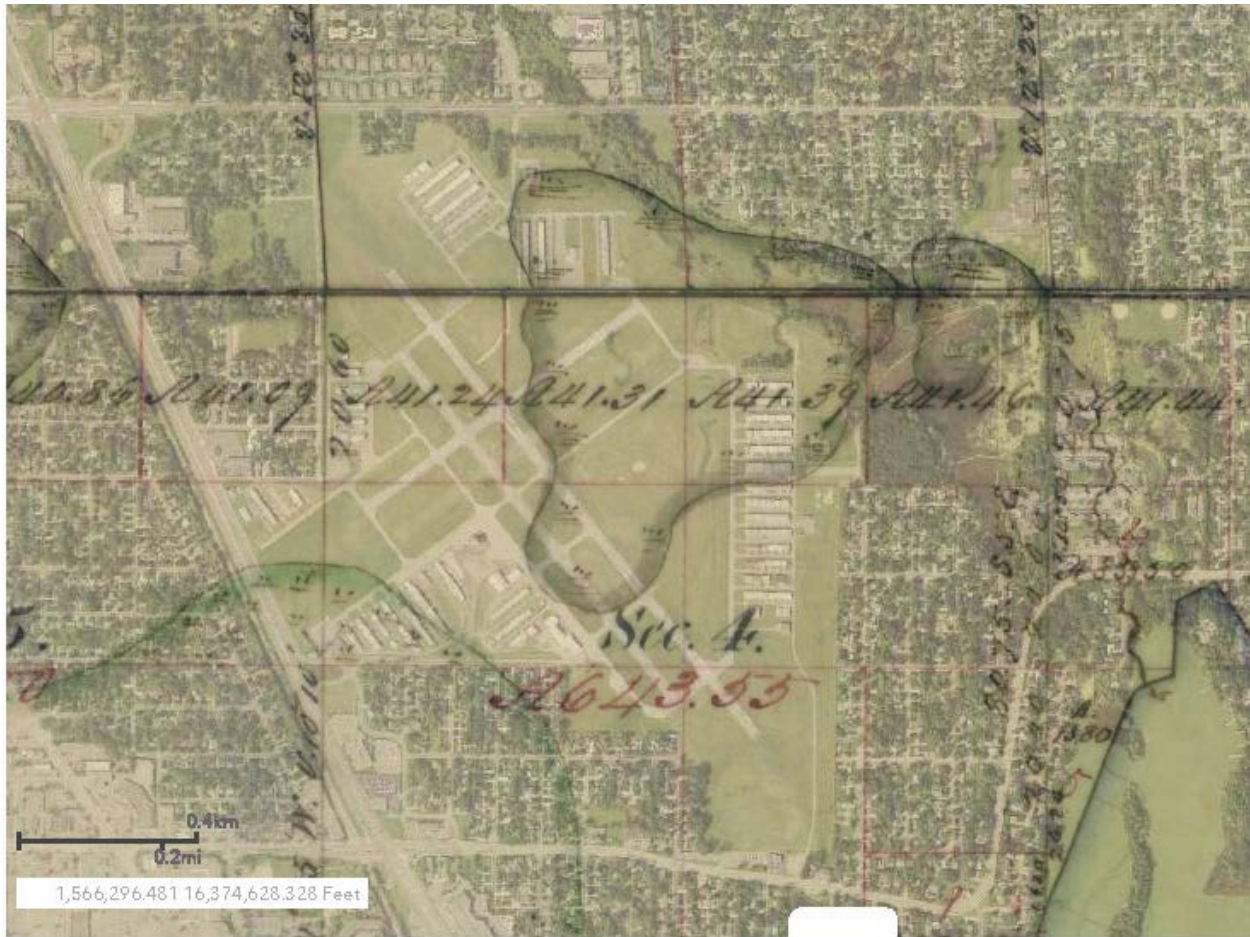
Figure 5. GLO plat maps showing prairie, within a green border, and marsh, bounded by a border with black interior shading, overlaying a modern aerial image of the Crystal Airport. (Generated through the Minnesota Office of the State Archaeologist web portal.)

The original vegetation cover of the project area would have consisted of brushland (oak openings and barrens with scattered trees and groves of oaks of scrubby form, with some brush and thickets and occasionally with pines) (Marschner 1930). The relatively wet, poorly drained soils that compose much of the project area, such as Forada sandy loam, would have supported marsh vegetation and trees (USDA-NRCS 2018a). Native tall prairie grasses and deciduous trees could have grown in the deep and better drained soils, such as Duelm loamy sand (USDA-NRCS 2018a). In accordance with the abovementioned soil types, General Land Office (GLO) plat maps of the project area from ca. 1856 document a marsh overlapping what are now the southeastern portion of the non-aeronautical development area and the southeast new taxiway and a prairie in the planned apron expansion and perimeter road in the southwest corner of the airport (Minnesota IT Services Geospatial Information Office [MnGeo] 2018; Figure 5).

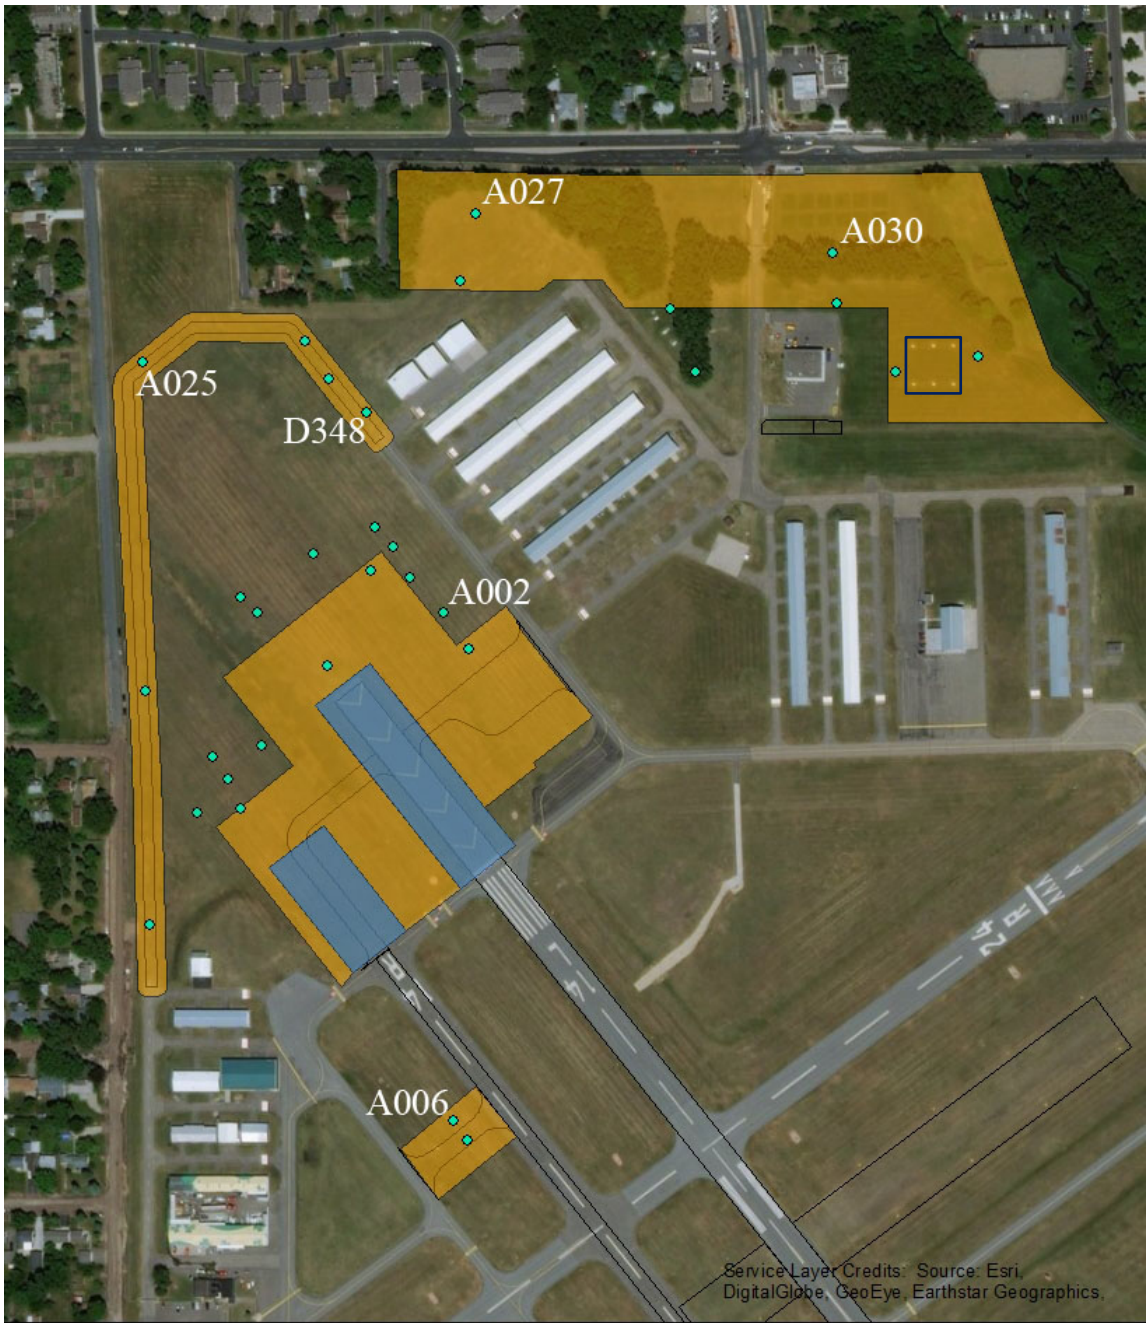
Figure 11. GPS waypoints for select shovel tests in the northern half of the airport. Labelled shovel tests are discussed specifically in the text. (Generated in ArcGIS.)

Each of the northwest and southeast new taxiways between the two runway/taxiway reconfigurations were investigated with five shovel tests in two rows spaced at 30 meters (Figures 11 and 12). The topsoil was dark brown and 15 to 20 cm in depth, overlying grey, wet (hydic) soil, in the northwest taxiway (Figures 16 and 17). Hydic soils are present in wetlands (anticipated in the project area based on the USDA-NRCS Web Soil Survey, GLO maps, and aerial photos [MnGeo 2018; University of Minnesota 2015; USDA-NRCS 2018b]) and have a low probability of containing archaeological sites. Shovel tests in the southeast taxiway encountered 20 to 30 cm of dark brown topsoil with light brown subsoil (Figures 18 and 19). This area was once marsh and should yield Hubbard loamy sand (Figure 5; MnGeo 2018; USDA-NRCS 2018b), but construction of the runway and apron to the immediate northeast and southwest, respectively, likely already impacted much of this area, as well as the other new taxiway.

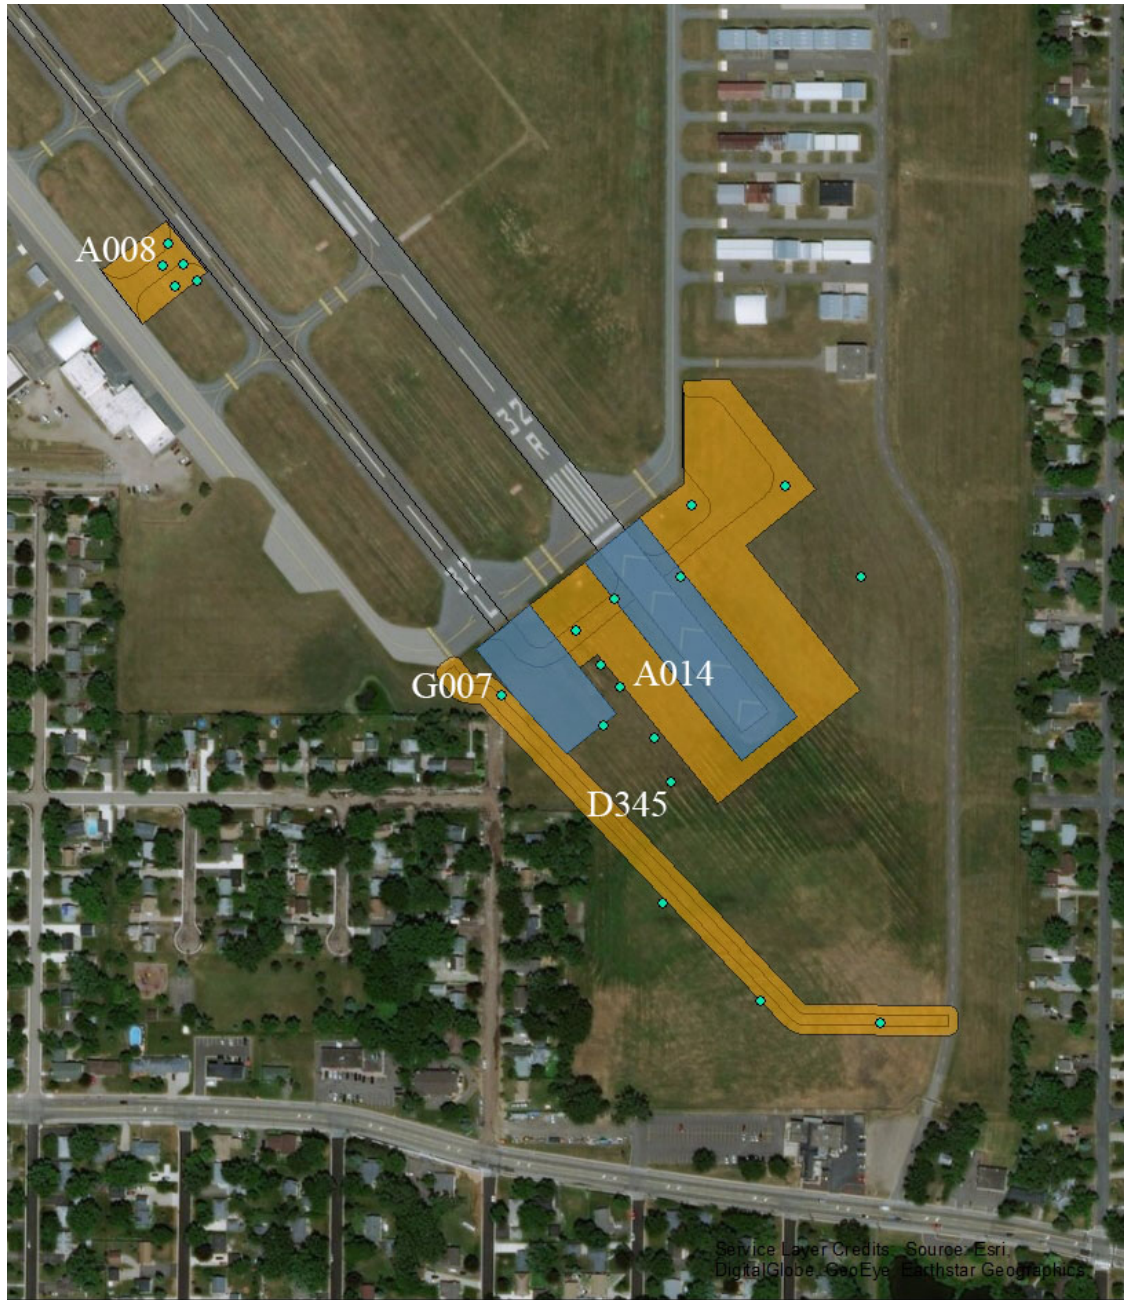
Figure 12. GPS waypoints for shovel tests in the southeast new taxiway, runway/taxiway reconfiguration, and perimeter road. (Generated in ArcGIS).

In the apron expansion, shovel tests were placed 30 meters apart outside a maximum 50-meter buffer between the westernmost row of shovel tests and the edge of the pavement for the fueling station to avoid striking any buried pipes, tanks, or equipment (Figures 12 and 24). These tests produced fill, consistent with the urban land-Udipsamments cut and fill recorded for this portion of the project area (USDA-NRCS 2018b). Shovel tests on the perimeter road just north of the apron expansion encountered fill and hydic subsoil similar to that in other sections of the project area, which varied from the better drained Hubbard loamy sand and Duelm loamy sand expected (Figure 25). The topsoil tended to be dark brown and approximately 30 cm deep (Figure 26).

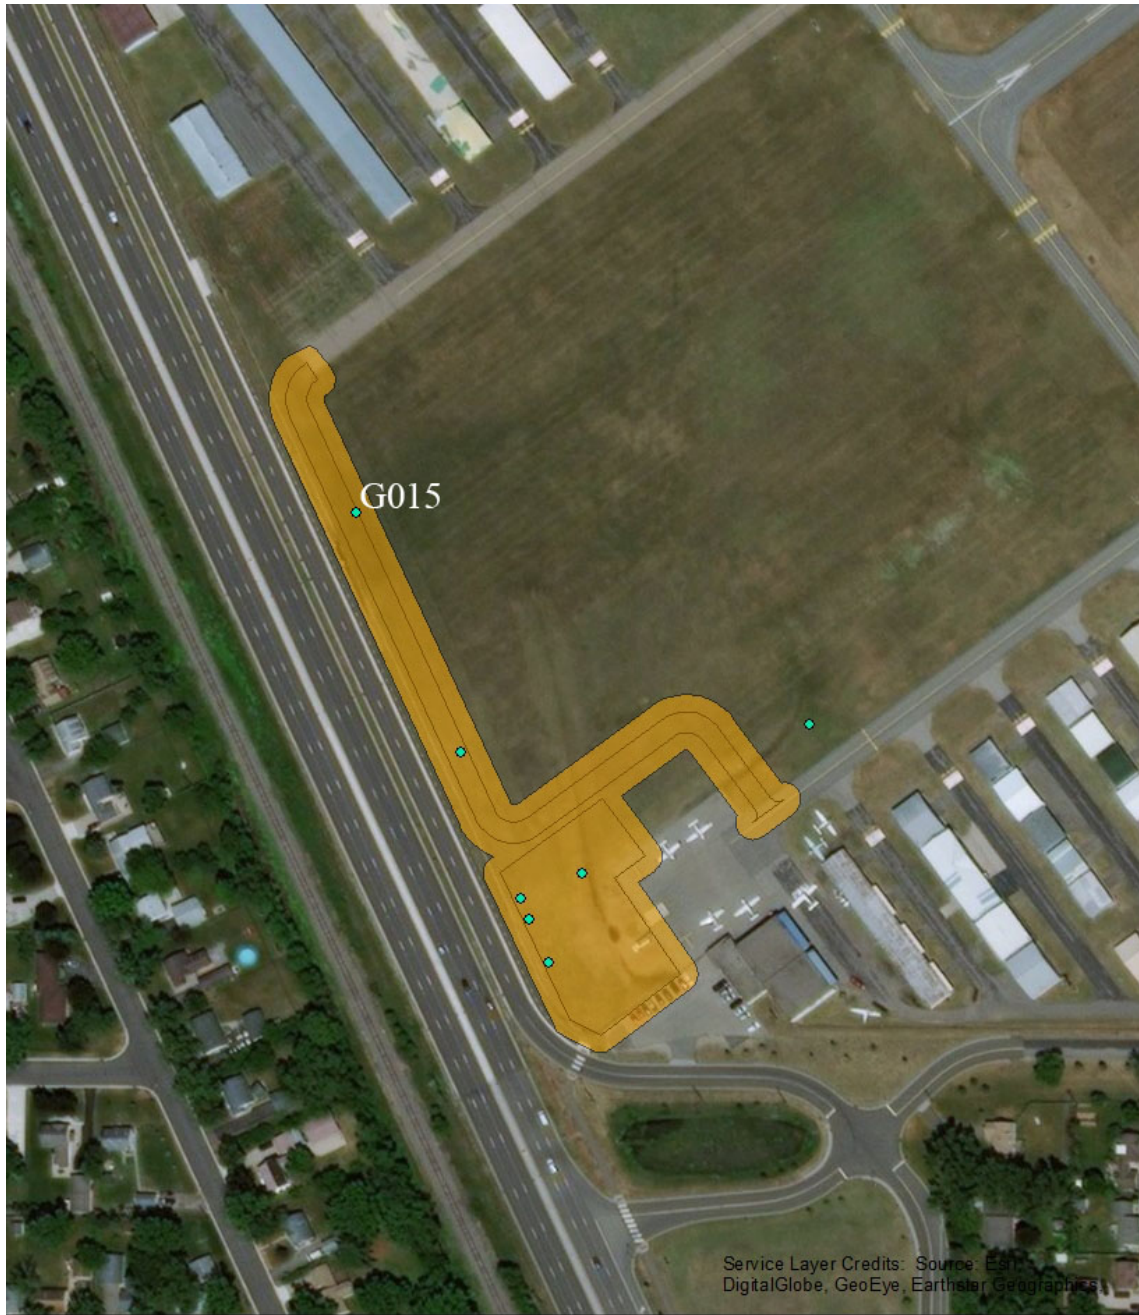
Figure 13. GPS waypoints for shovel tests in the planned apron expansion and west perimeter road. (Generated in ArcGIS).

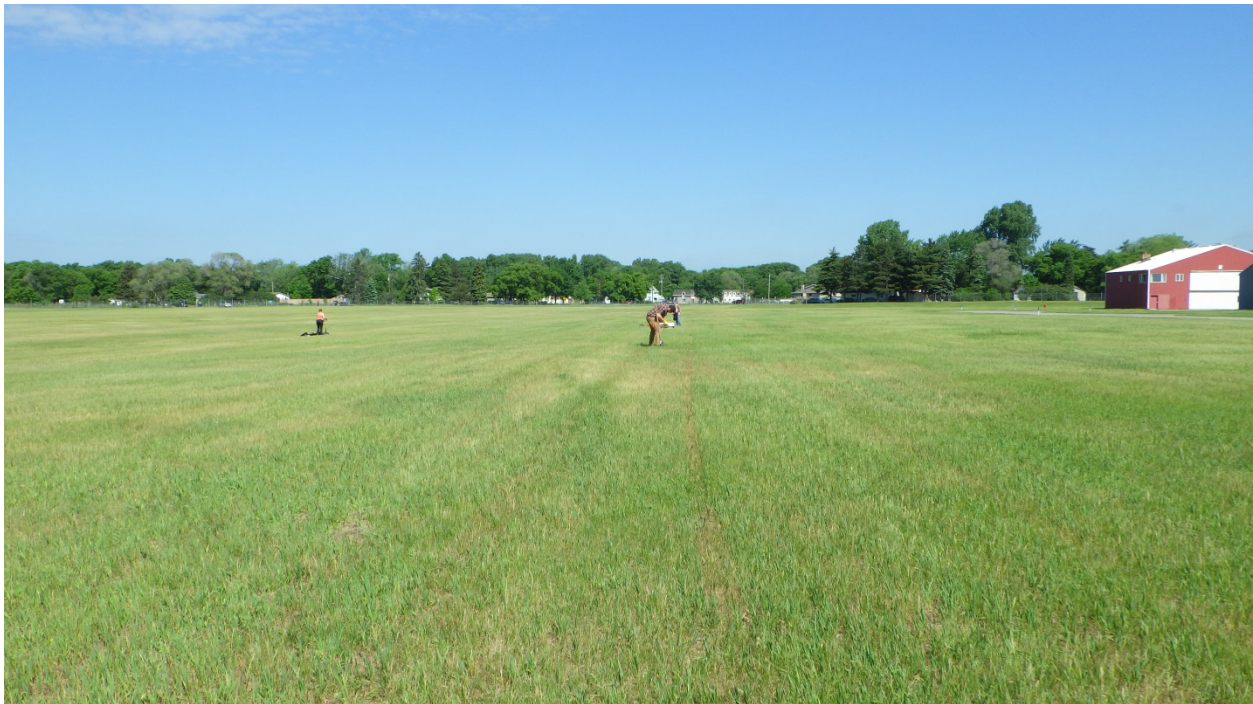
Figure 14. View to the northwest of shovel testing in the area northeast of the northwest end of the existing runway in the northwest runway/taxiway reconfiguration.

Shovel testing at 30-meter intervals in the northwest runway/taxiway reconfiguration encountered cut and fill land with topsoil generally of dark brown loamy sand running from approximately 8 to 45 cm deep, usually around 20 cm (Figure 14). A sharp boundary delineated the topsoil from the loose sand below (Figure 15). Shovel tests in the western portion of this

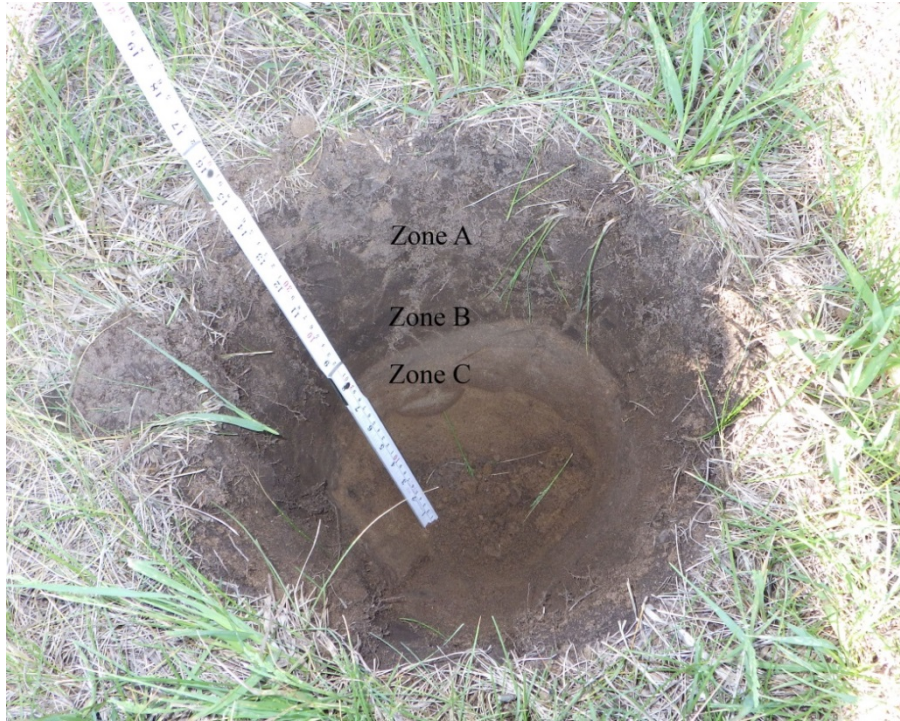
Figure 15. Shovel test at GPS waypoint A002 (Figure 11) in the northwest runway/taxiway reconfiguration, typical for this area of the project. Note the sharp boundary between upper Zones A (10YR 3/2) and B (10YR 2/2), disturbed, and Zone C (10YR 3/6). This particular hole contains a band of black fill (Zone B) under the dark greyish brown topsoil (Zone A).

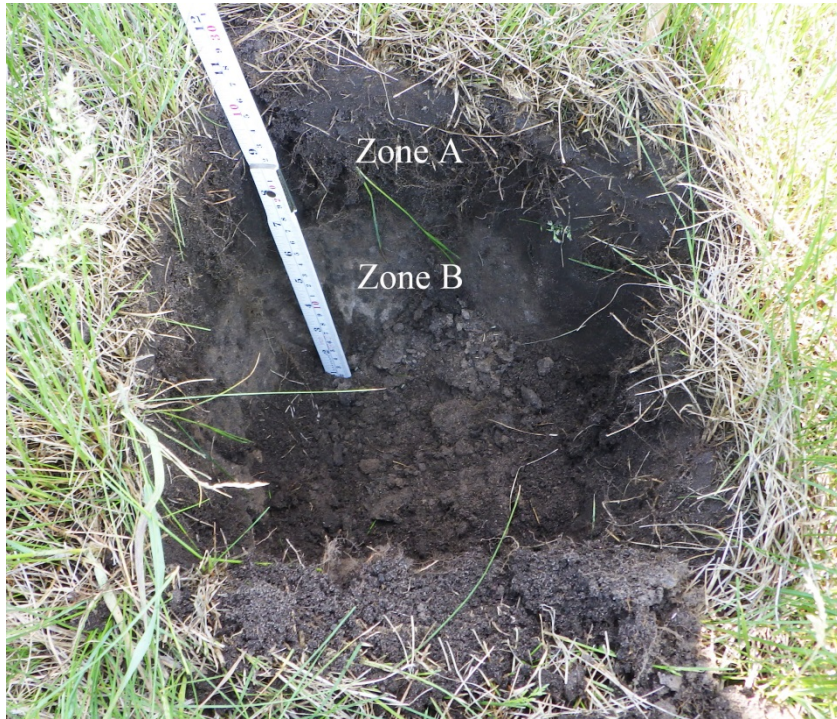
Figure 17. Shovel test A006 (Figure 11), in the footprint for the northwest new taxiway, exhibiting hydric soil in Zone B below the topsoil (Zone A).

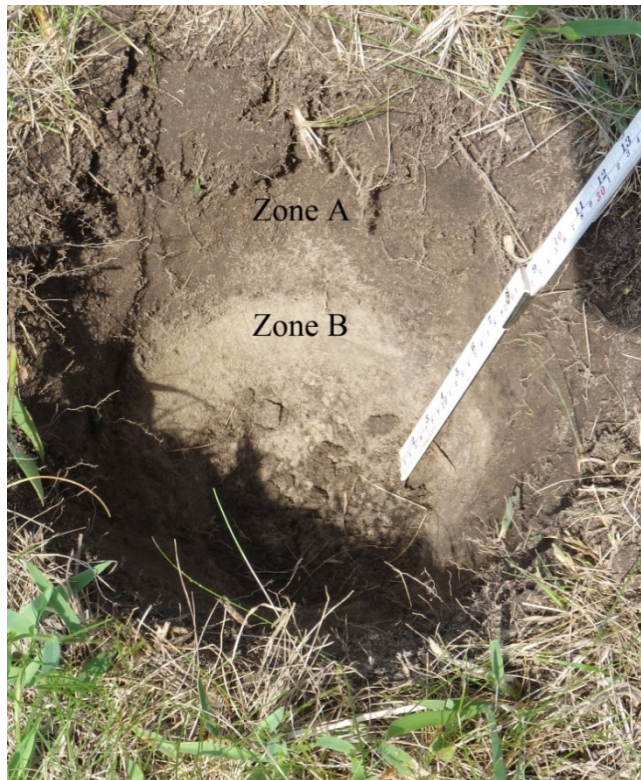
Figure 21. Shovel test at waypoint A014 (Figure 12), illustrative of the hydric soils, seen here in the grey Zone B (10YR 5/1), in the southeast runway/taxiway reconfiguration.

Shovel testing in the southeast runway/taxiway reconfiguration revealed hydic soils, in some instances with orange streaks from the oxidation of iron in the wet soil, underneath dark brown to nearly black topsoil 15 to 30 cm deep (Figures 20 and 21). Bottle glass, a nail, and pieces of fabric attributable to modern disturbance and filling activity were discovered in shovel test D345. Likewise, the perimeter road running southwest to south of the existing runway was disturbed, as evinced by fill including pieces of asphalt and nails (Figures 22 and 23).

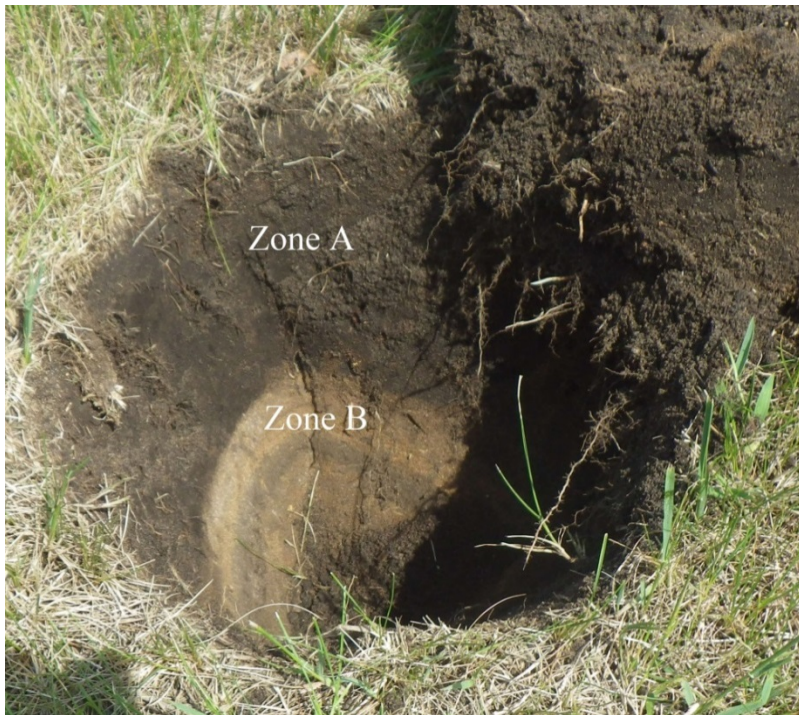
Figure 23. Disturbed soil, as indicated by a sharp boundary between Zones A (20 cm deep) and B and the mottling of the soil, in shovel test G007 (Figure 12) along the southeast perimeter road. A similar soil profile dominated throughout the footprint for the perimeter road.

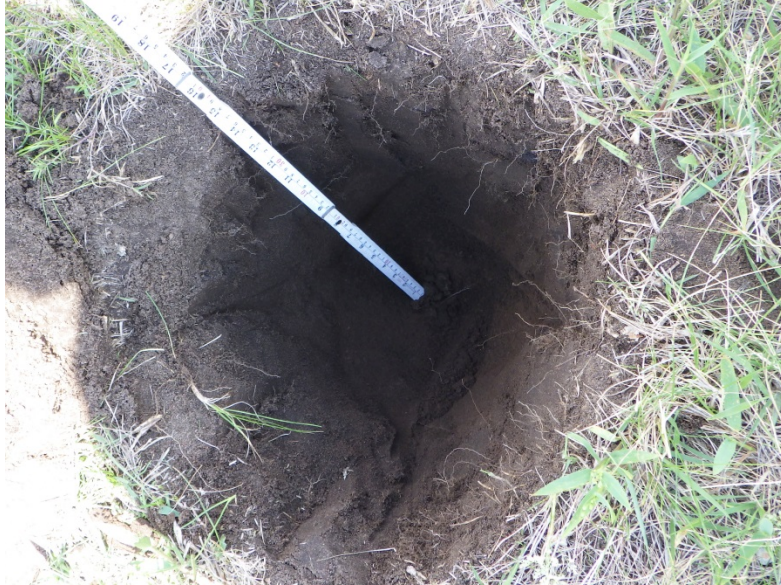
Figure 29. Shovel test at waypoint A025 (Figure 11) in the footprint for the northwest perimeter road. The dark, deep soil, characteristic of the Forada sandy loam anticipated in this segment of the northwest perimeter road, suggested an expanse of intact soil.

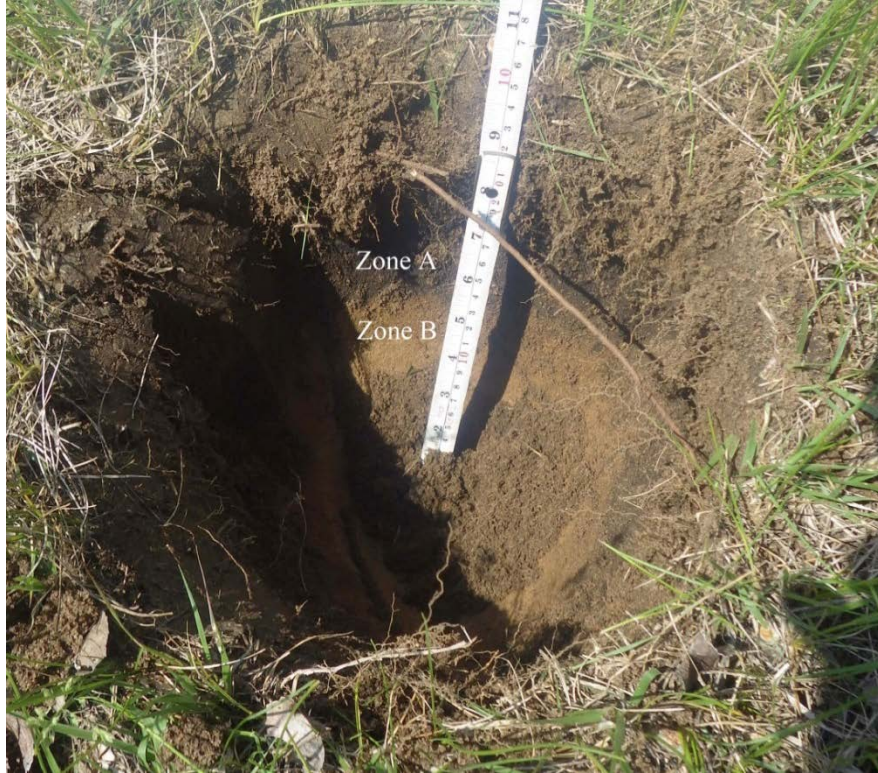
Figure 31. At the north edge of Udorthents cut and fill land where it borders Forada sandy loam, as classified by the USDA-NRCS Web Soil Survey (USDA-NRCS 2018b), shovel test A027 (Figure 11) exemplifies the graded soil in the southwest corner of the non-aeronautical development area. Shovel tests farther east more consistently revealed hydric subsoil.

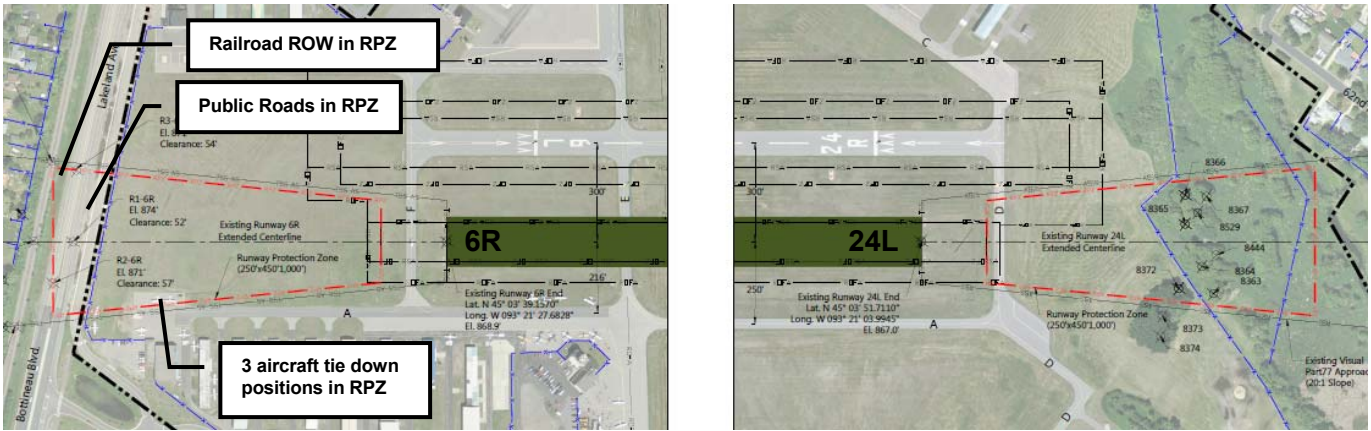
The proposed shortened turf runway concept improves RPZ land use compatibility in the following ways:

- Shifts the Runway 6R RPZ fully onto airport property.
- Removes Bottineau Boulevard, Lakeland Avenue, and the railroad right of way from the Runway 6R RPZ.
