## **Appendix J – Wetland Delineation, Functional Assessment, and Associated Correspondence**

## Notice of Decision

Applicant Name <b>Bridget Rief – Metropolitan          Airports Commission</b>	Project Name <b>Crystal Airport</b>	Date of Application <b>November 2018 –          submitted outside          growing season</b>	Application Number
<input checked="" type="checkbox"/> Attach site locator map.

CRYSTAL AIRPORT  
Proposed Airfield Improvements

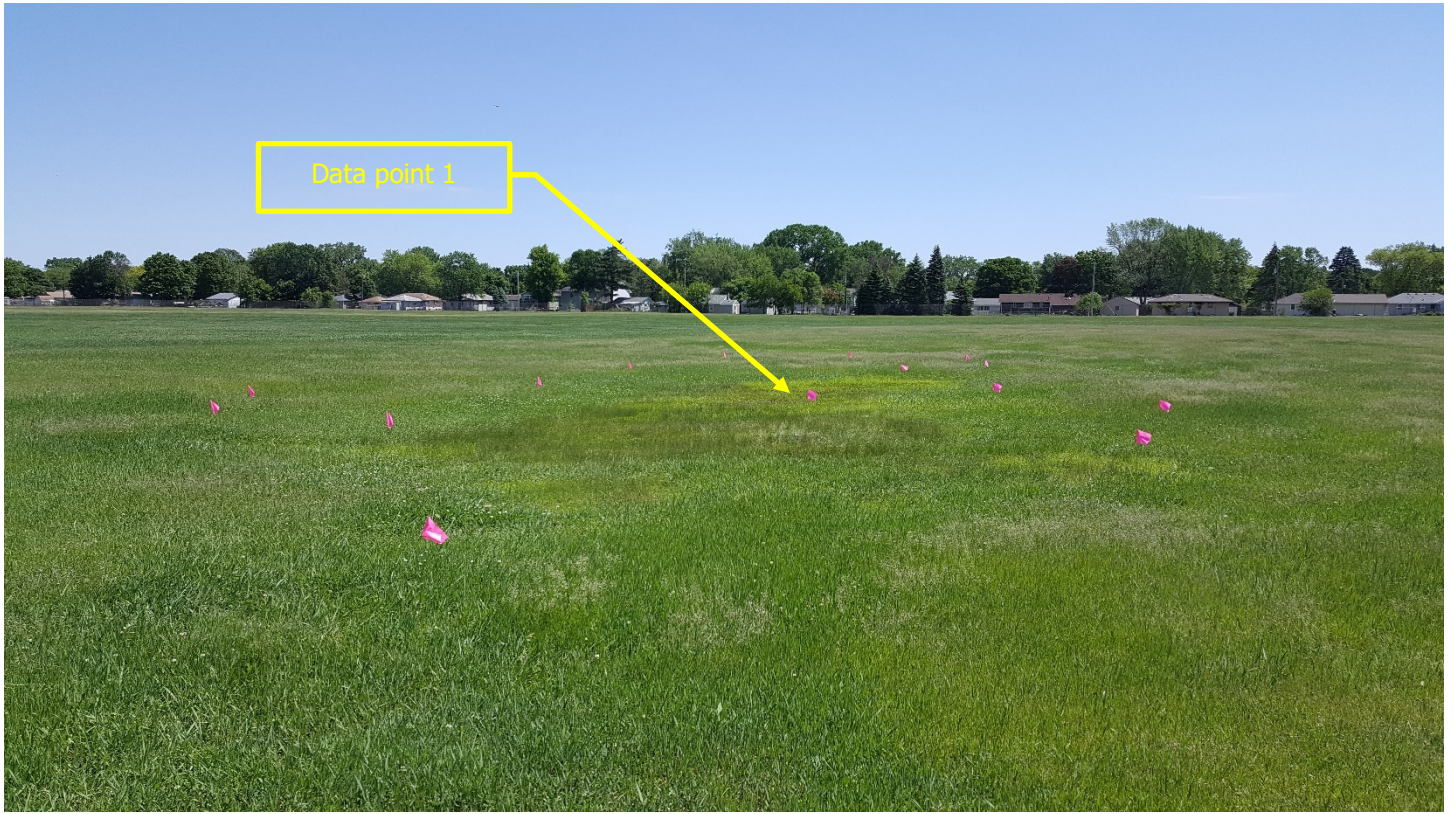
**Photo 3.** Wetland 1. Data point 1, view to the northeast.

While evidence of surface water, a high water table, or saturation was not observed at either DP1 or DP3 under drier than normal climatic conditions, wetland hydrology was indicated by field observation of secondary indicators Geomorphic Position (D2) and a positive FAC-Neutral Test (D5) at both these sampling points. Examination of several recent aerial photographs (Google Earth 2018, 2017, 2016 in Appendix C), show saturated signatures corresponding to these areas and thus fulfill the secondary indicator Saturation Visible on Aerial Imagery (C9) at both sampling points. Wet signatures (darker areas) can be seen in other photographs taken in previous years later in the growing season.

Remarks: Wetland hydrology is indicated.

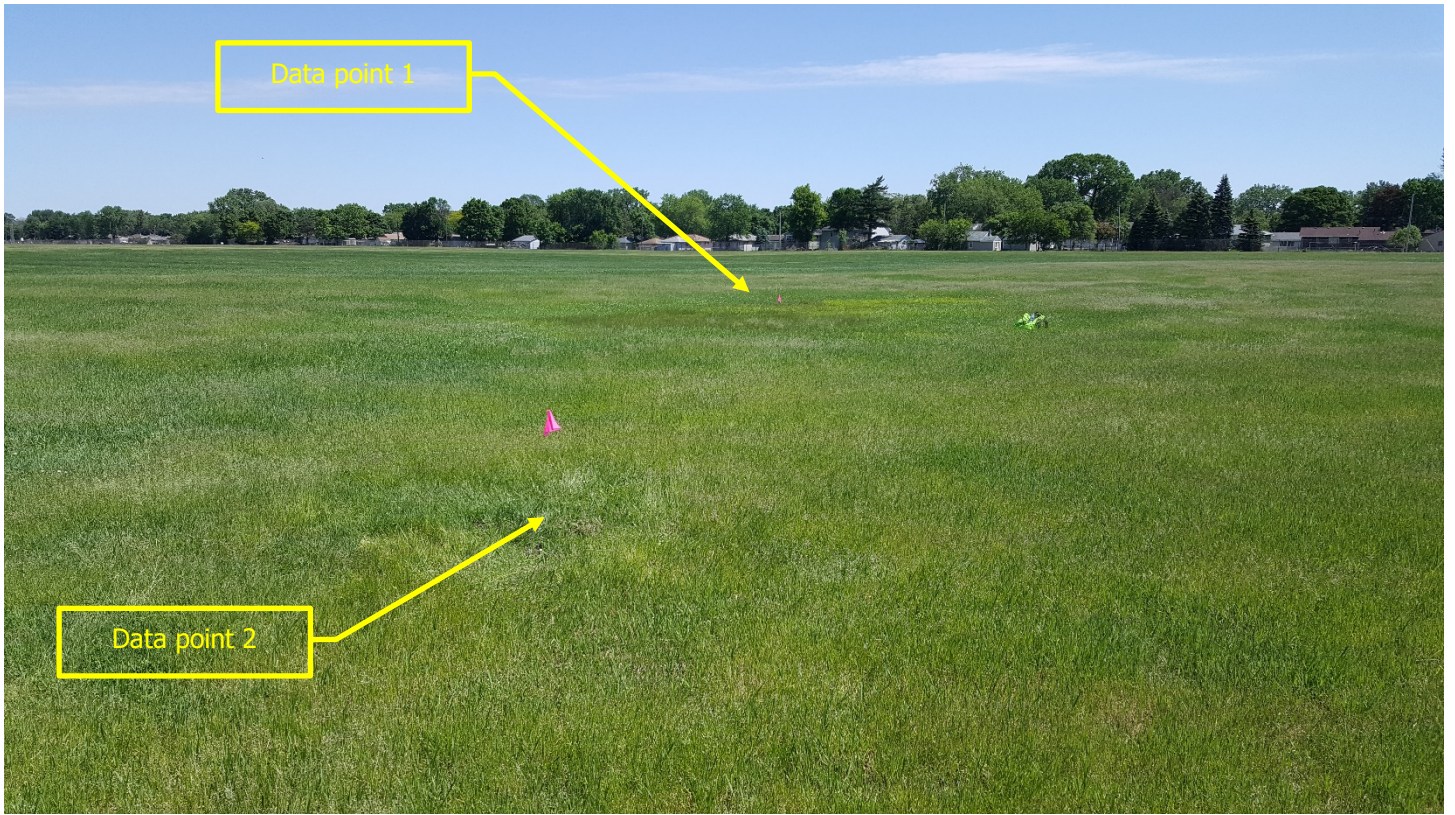
Data Points 1 and 2, view to the east.

The upland data point (DP2) did not satisfy any hydric soils indicator with a very dark brown (10YR 2/2) sand over a mixed very dark gray (10YR 3/1) and black (10YR 2/1) sand layer. Redox features were not found in the very dark gray (10YR 3/1) component, the largest percentage component (90%) of the mixture. Redox features were found in the black (10YR 2/1) sand matrix component, the much smaller component by percentage basis (8%) of the overall layer. This profile did not meet any hydric soils indicators. The soil pit was dug to refusal at 16 inches where a very hard compacted layer was encountered.

Remarks: Wetland hydrology is neither present nor indicated.

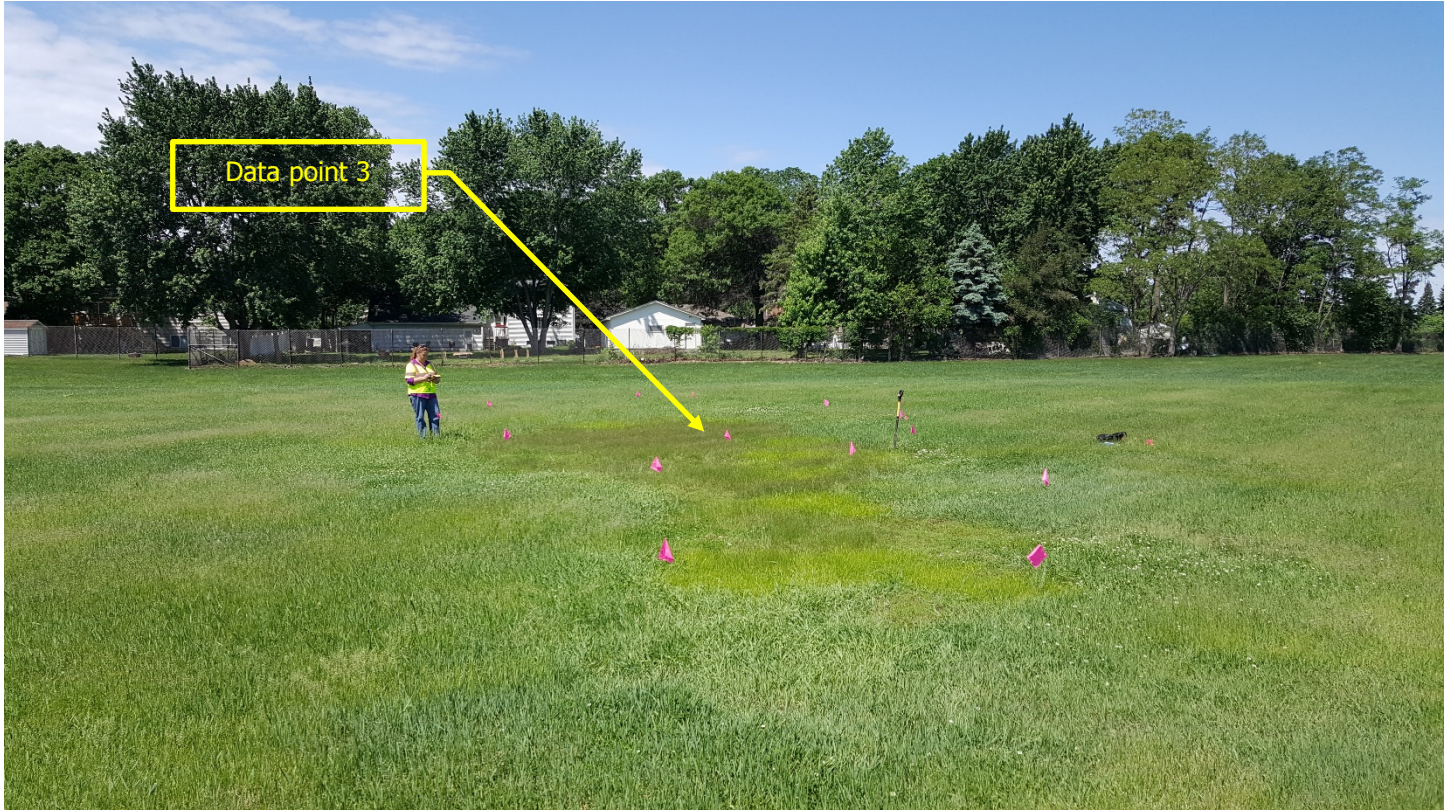
**Photo 4.** Wetland 2. Data point 3, view to the west.

1.						
2.						
				= Total Cover		
Remarks: (Include photo numbers here or on a separate sheet.) Hydrophytic vegetation is present; data point within small shallow basin, slightly lower than upland point (DP3) on transect.

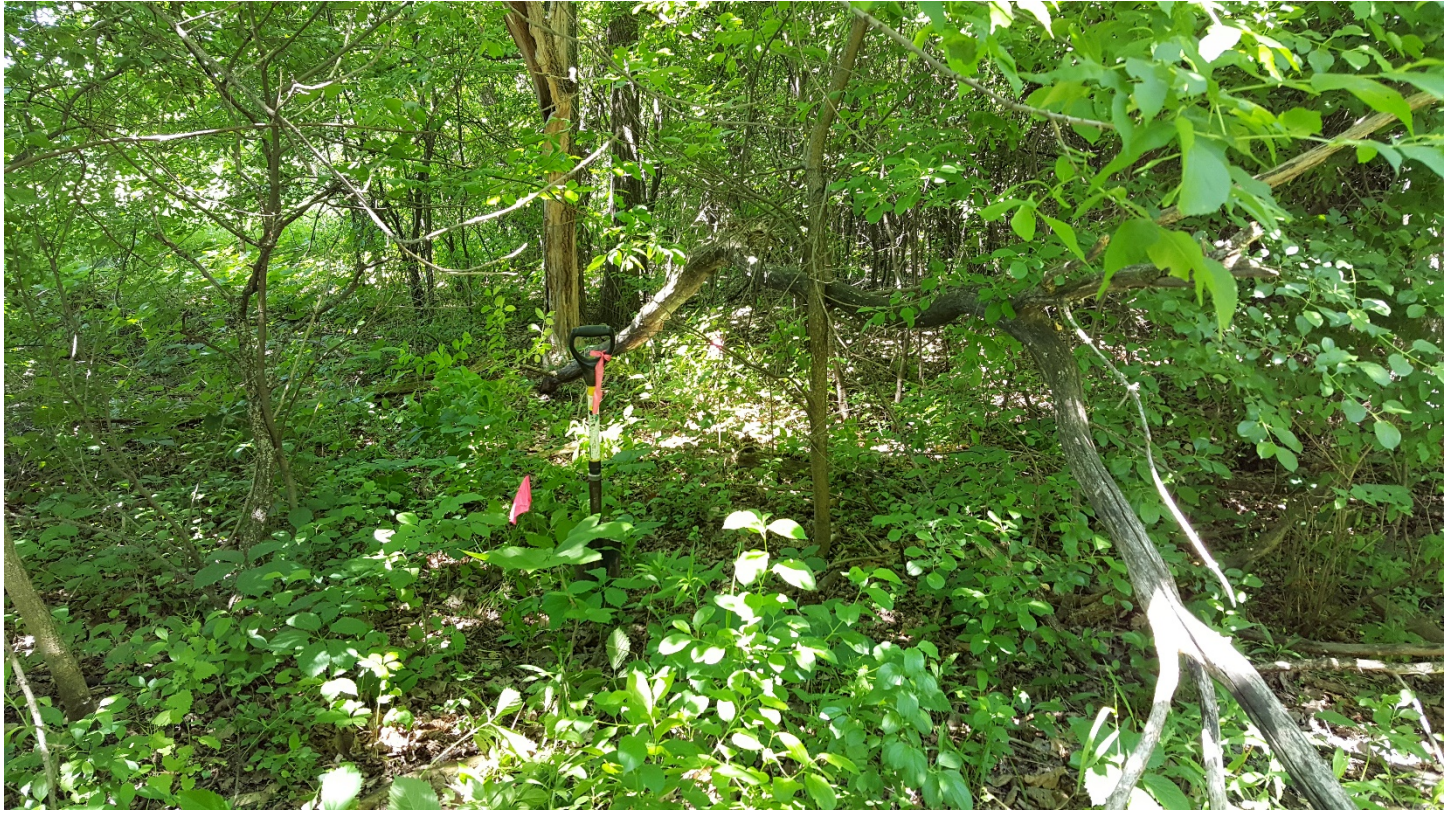
**Photo 11.** Wetland 3. Data point 4, view to the north.

Hydric soils and wetland hydrology indicators were absent at DP4. The soil profile noted here was marked by a thick layer of very dark grayish brown (10YR 3/2) sandy loam over a pale brown (10YR 6/3) sand layer, both of which lacked redoximorphic features. Wetland hydrology was neither present nor indicated at this upland sampling point.

Remarks: Wetland hydrology is neither present or indicated.

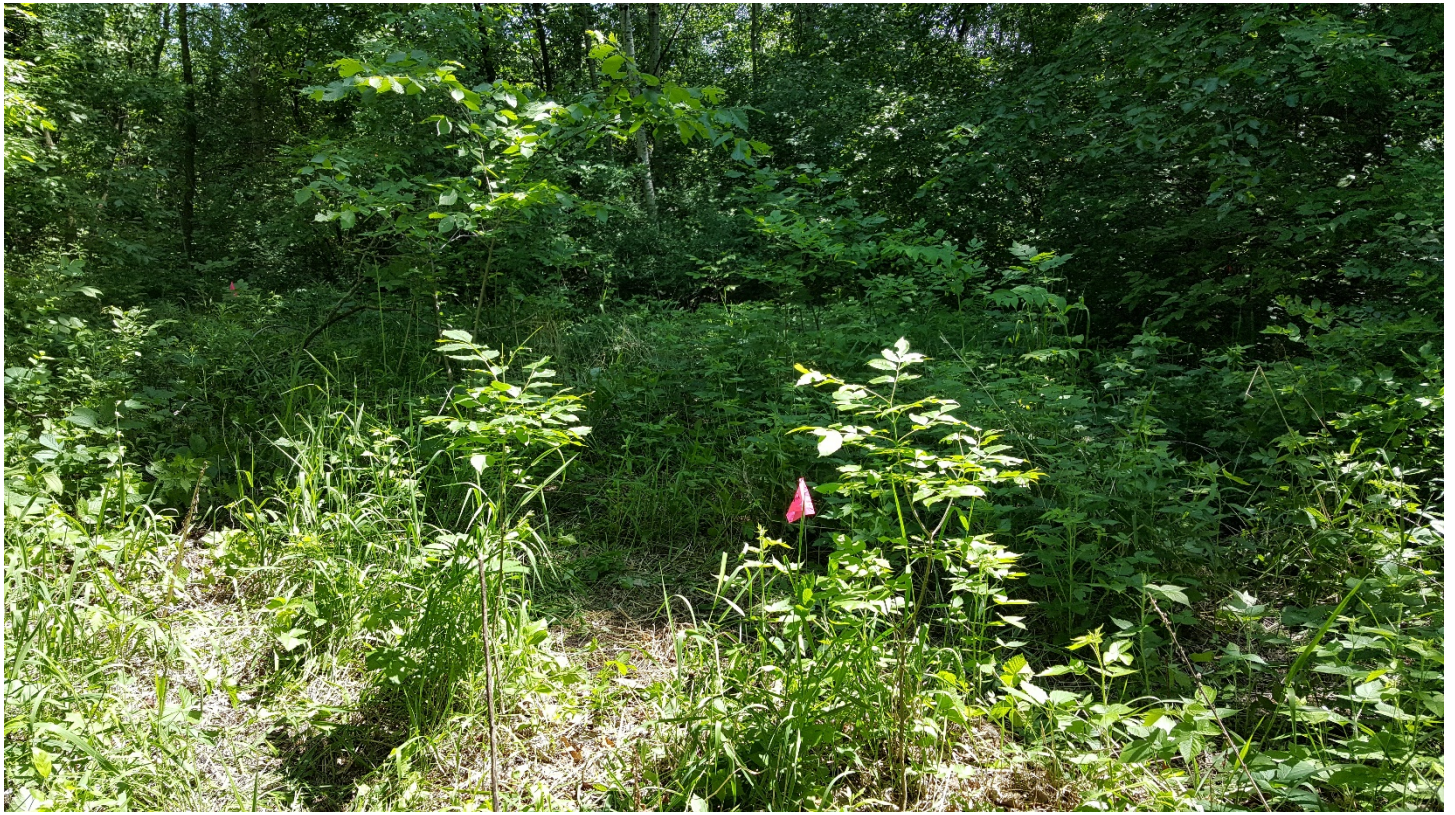
**Photo 12.** Wetland 3. Data point 5, view to the east.

Wetland hydrology was indicated. At data point DP5 (wetland), secondary indicators Geomorphic Position (D2) and a positive FAC-Neutral Test (D5) were met. Runoff from the south appears to drain into this wooded area and collect in this shallow basin with no apparent outlet before infiltrating into the subsoil.

Remarks: Wetland hydrology is indicated.

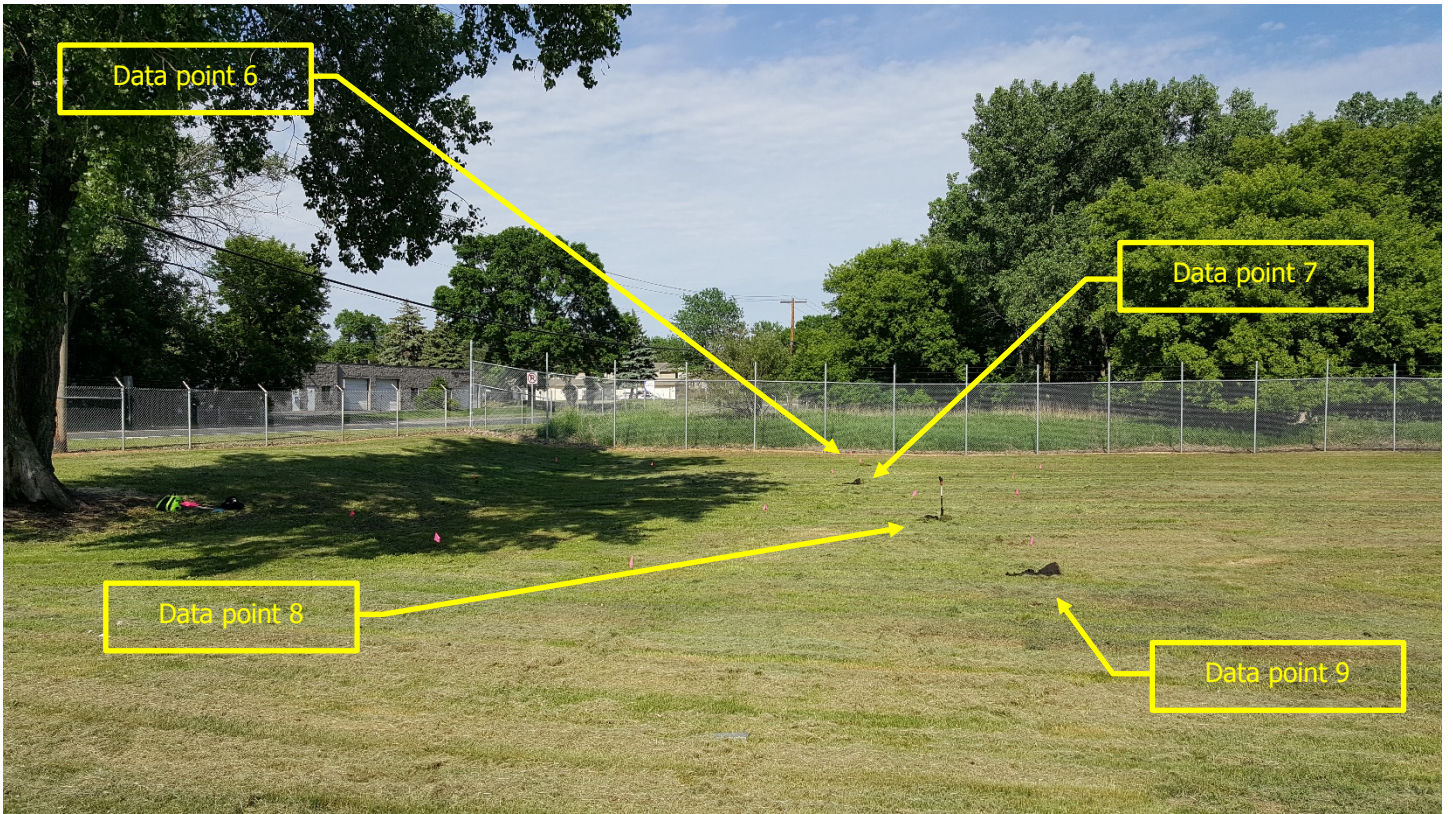
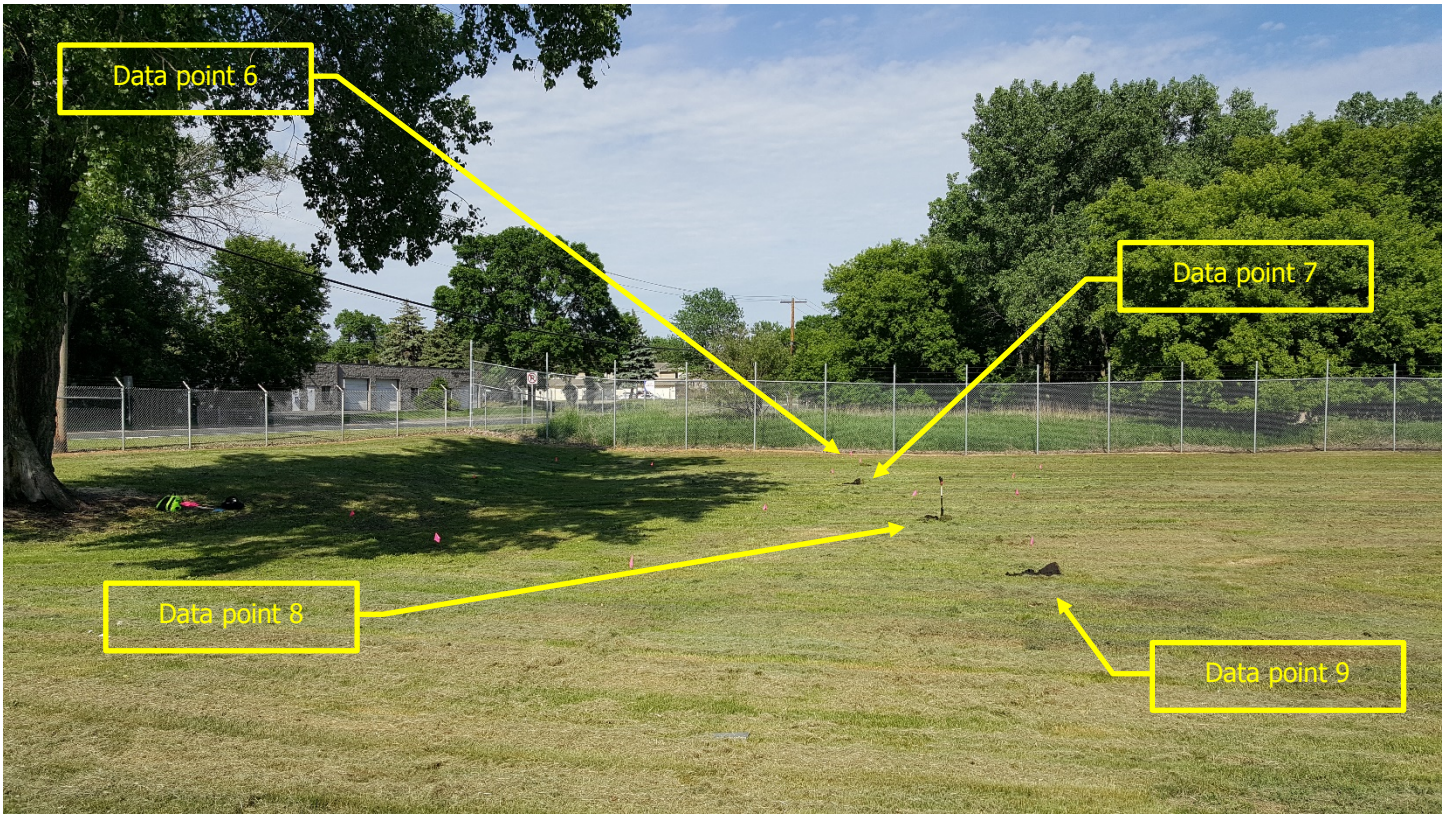
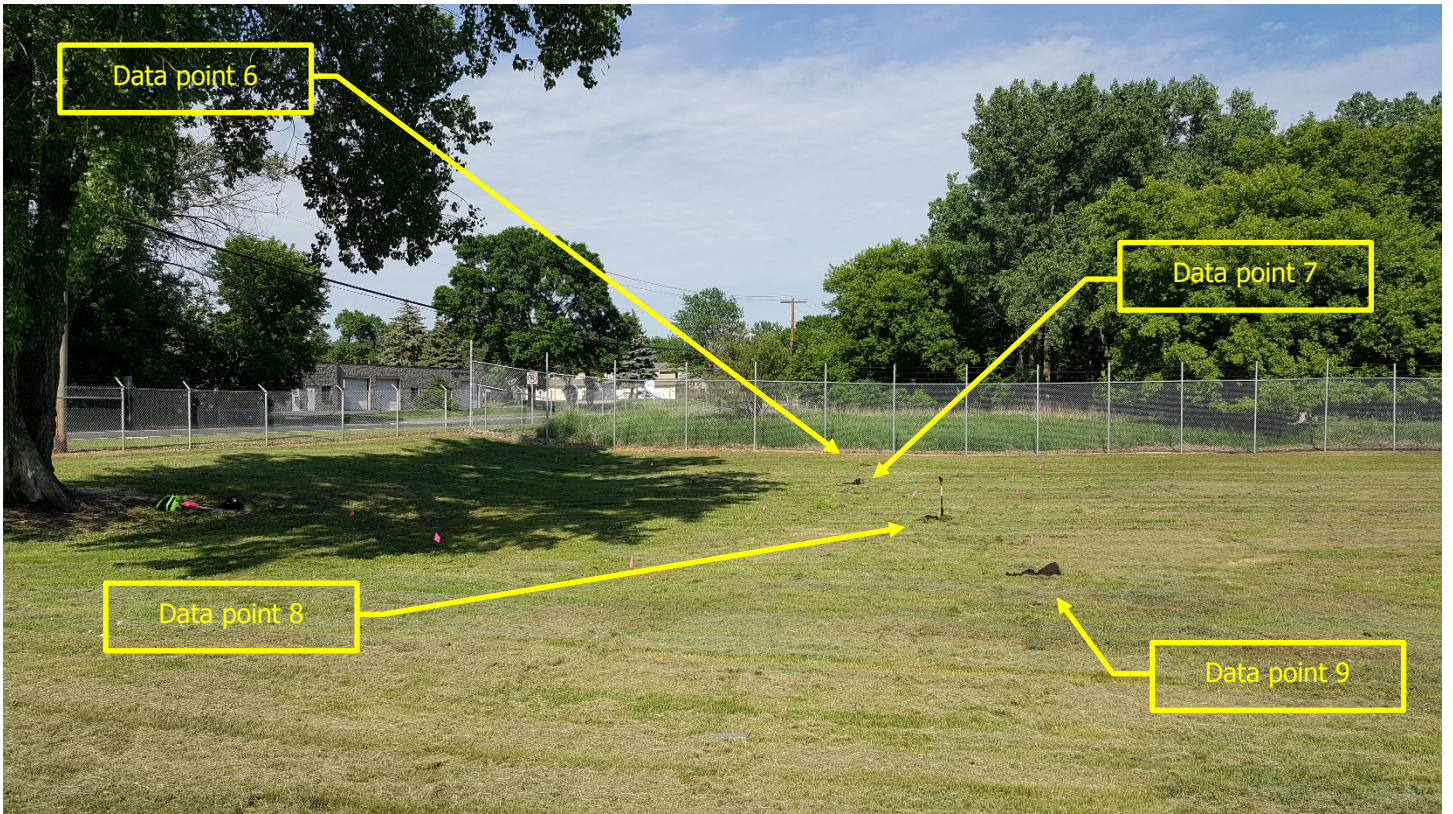
**Photo 17.** Wetland 4. Data points 6 through 9. View to the east.

Topographic rises along both sides of this part of the floodplain form a shallow basin within which both wetlands sit. Wetland hydrology is indicated at DP7 (wetland) within W4. Secondary indicators Geomorphic Position (D2) and a positive FAC-Neutral Test (D5) were observed and satisfied the hydrology criterion. The same secondary indicators were met at DP10 within W5.

Remarks: Wetland hydrology is indicated. Hydrology has been altered due to road construction and fence construction.

Remarks: Wetland hydrology is neither present nor indicated. Alteration to hydrology due to road construction and fence construction.

Remarks: Hydrology is neither present nor indicated. Hydrology has been altered due to road construction and fence construction.

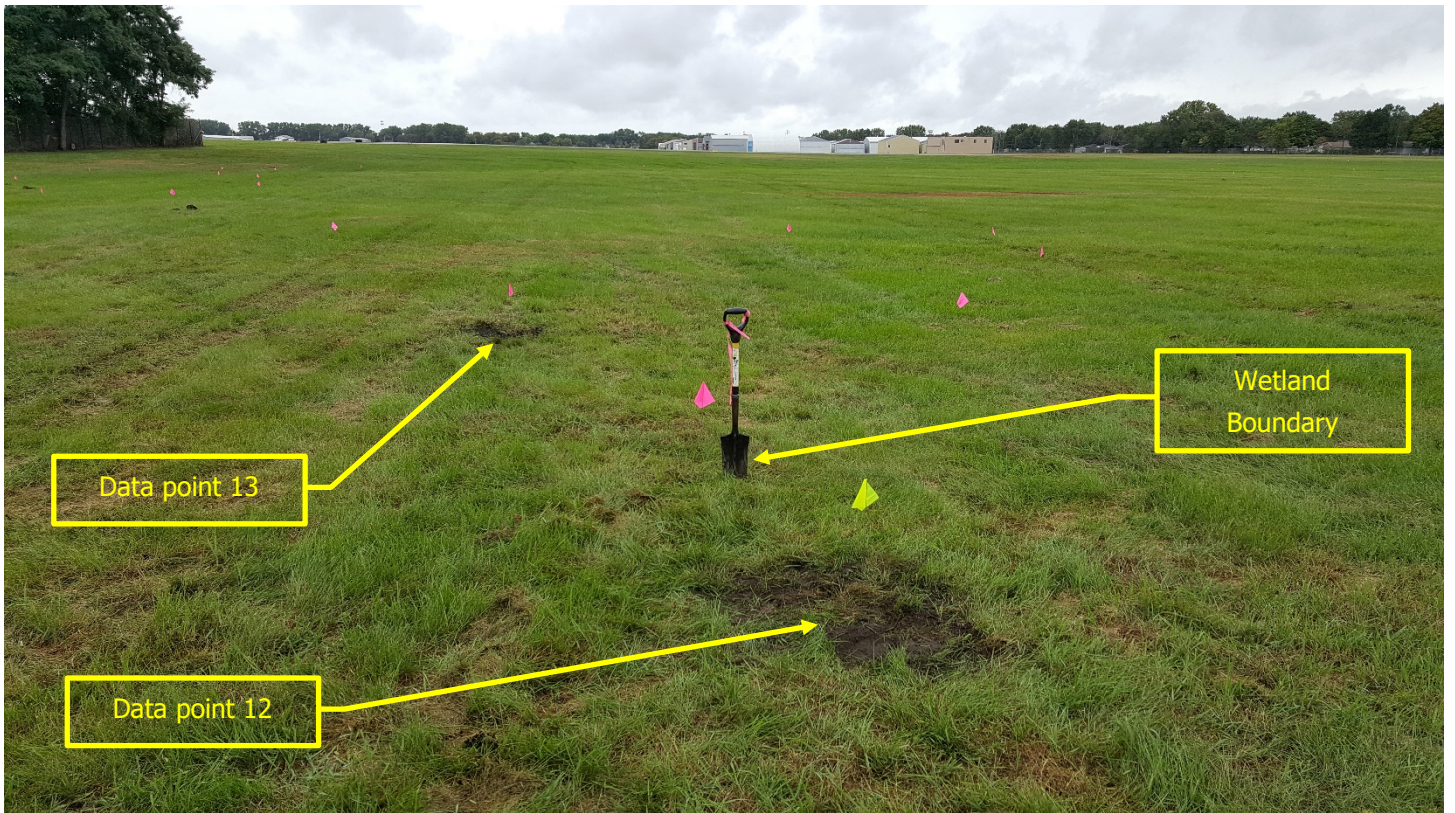
**Photo 21.** Wetland 6. Data points 12 and 13. View to the north.

Soils in uplands showed evidence of mixing, deposition of debris, trash, and other sandy fill materials over the native Seelyville and Markey soils. This can be seen at upland sampling points DP12 and DP14, associated with Wetland 6, where the native soil is found at 20 and 22 inches in depth, respectively. At DP16, also associated with W6, the original muck layer was found at 11 inches in depth.

Remarks: Wetland hydrology is neither present nor indicated. Heavy rainfall (4.5 inches) 4 days prior and 0.3 inches previous night.

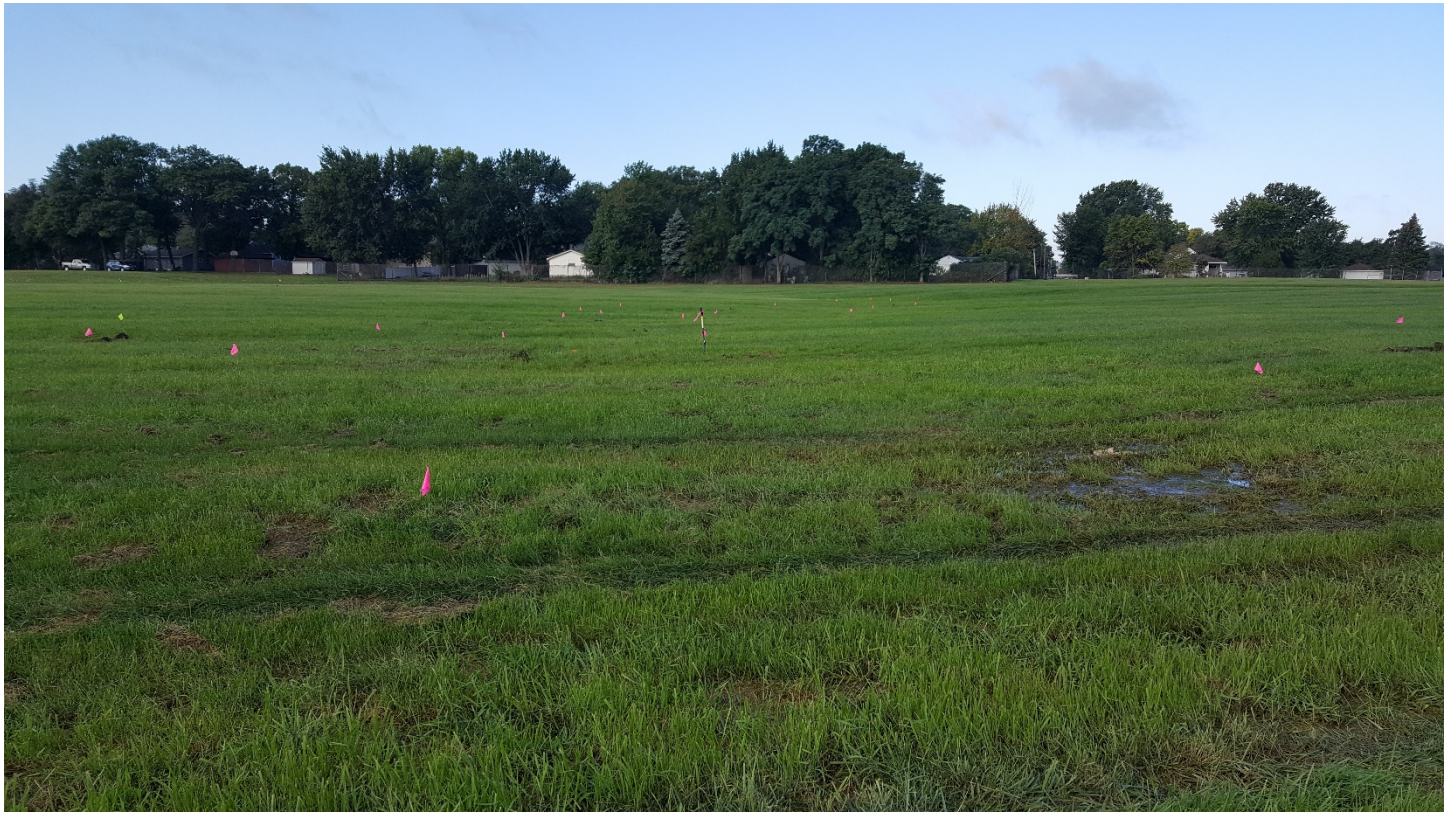
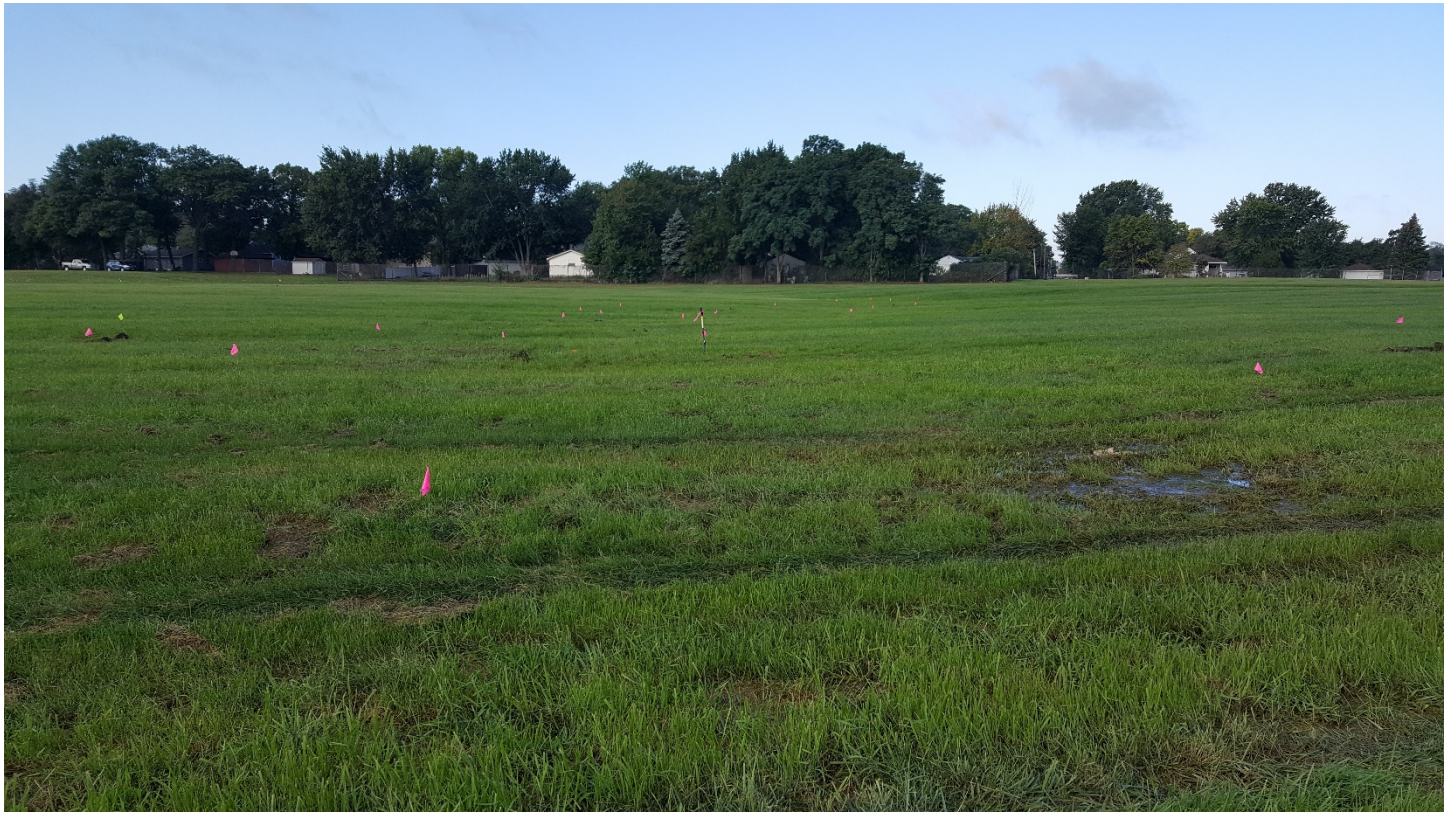
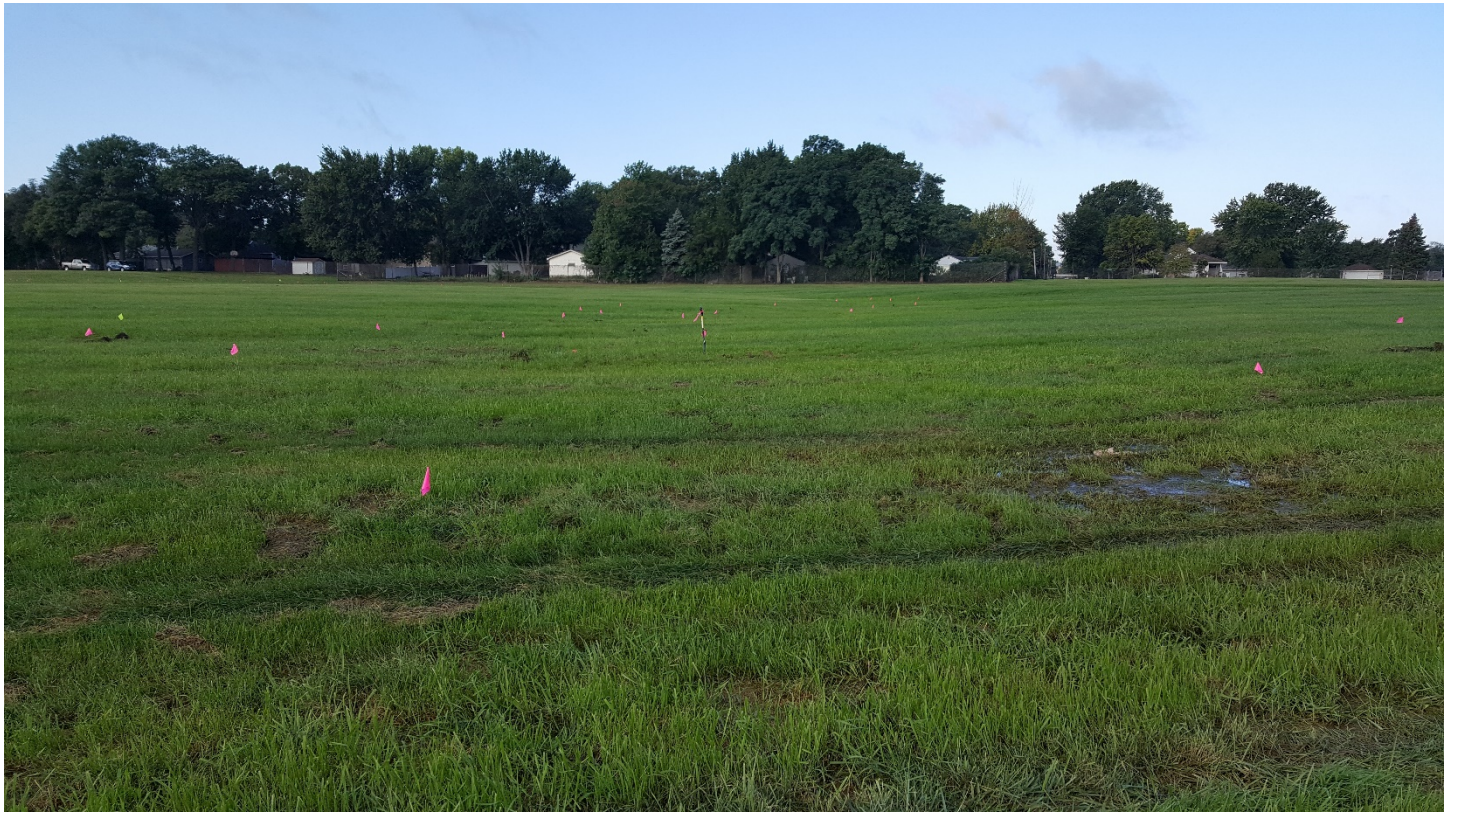
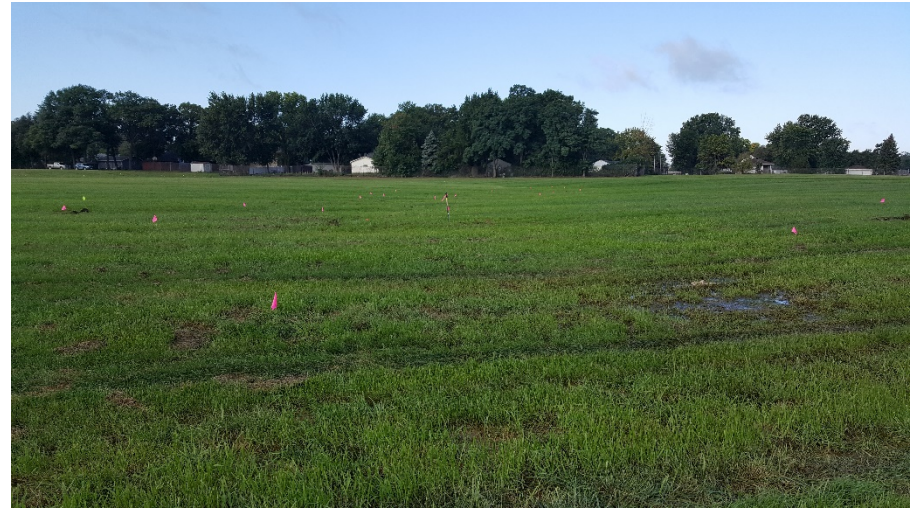
**Photo 28.** Wetland 7. General, saturated conditions. View to the west.

A heavy rainfall event occurred four days prior to the start of the September field work when approximately 4.5 inches of rain fell. At the time of the site visit, standing water and saturation at the surface was observed in both Wetlands 6 and 7. Generally, the larger area south of the Runway 32L and 32R ends is a closed flat area with no external outlets; thus, this area serves a groundwater infiltration function.

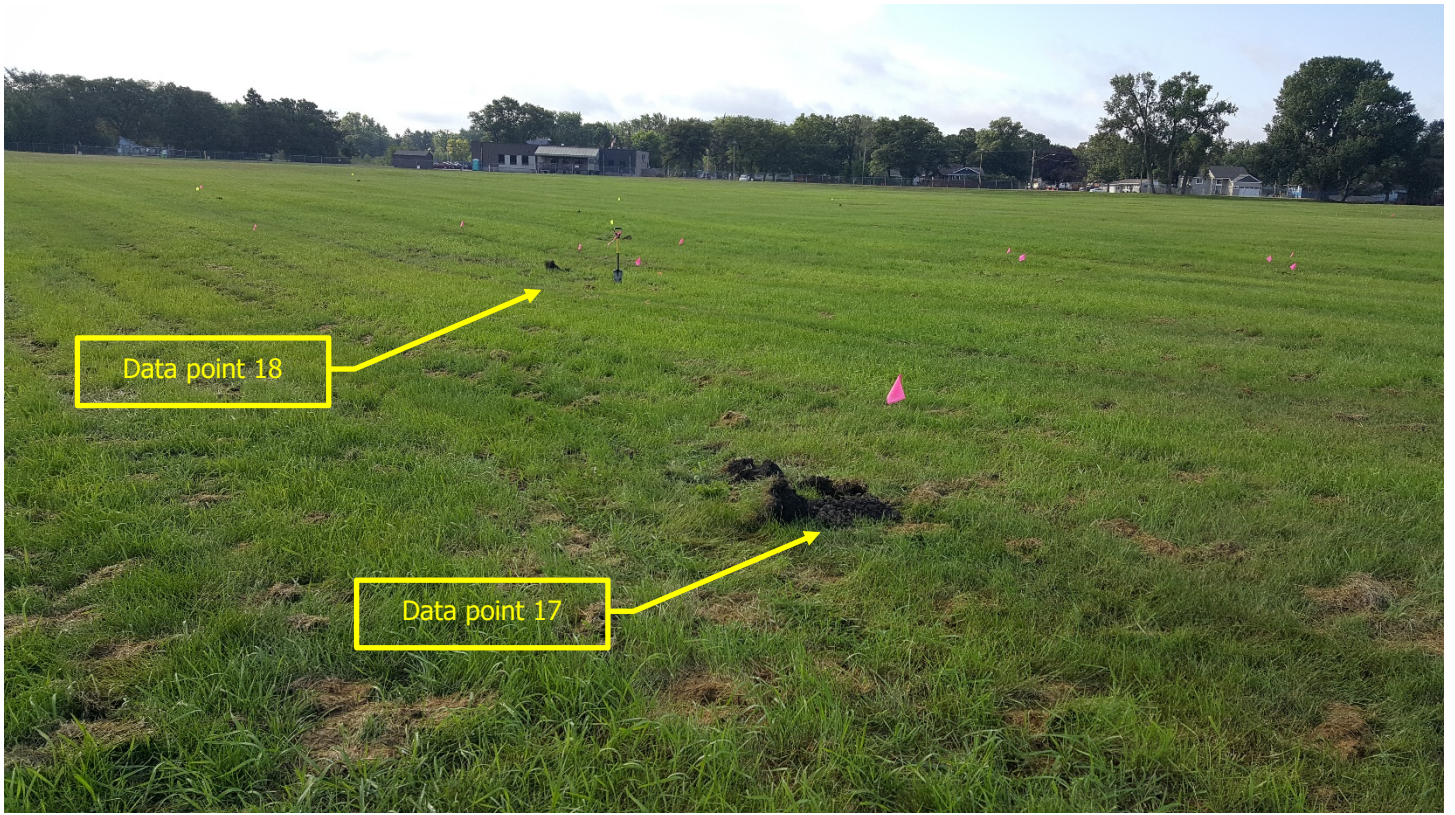
**Photo 26.** Wetland 7. Data points 17, 18, and 19. View to the south.

Similarly, at wetland sampling point DP18 within Wetland 7, the deep 22-inch thick black (10YR 2/1) muck layer, found at the surface, satisfied the Thick Dark Surface (A12) indicator.

Remarks: Wetland hydrology is present. Heavy rainfall (4.5 inches) 4 days prior and 0.3 inches previous night. Sampling point within swale at base of grade slope at end of runway blastpad.

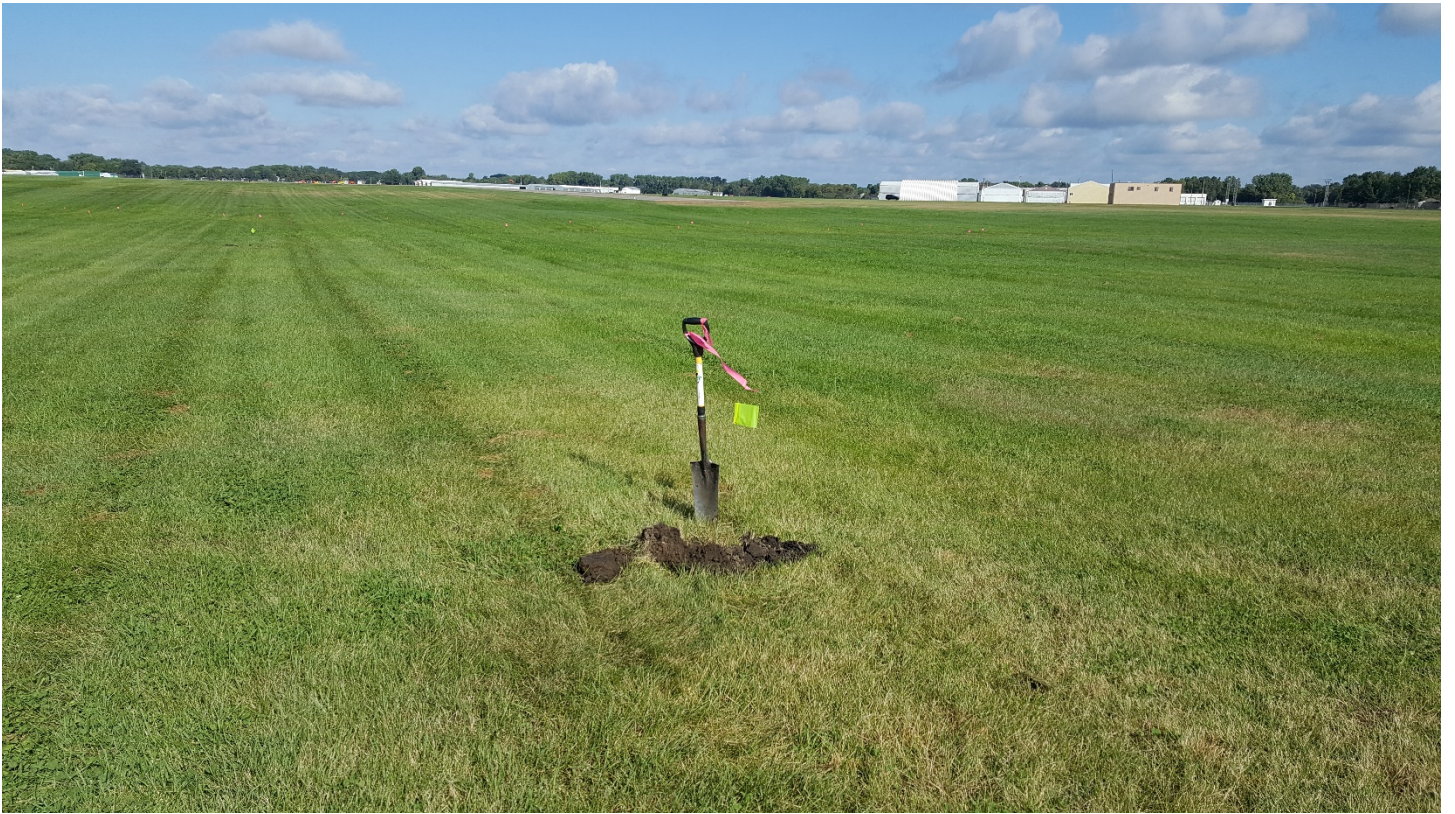
**Photo 31.** Data point 23, view to the northwest.

During the September field visit, the large previously mapped area of PEM1A/Type 1 wetland was examined. Four sampling points (DP22 – 25), taken on an east-to-west transect, documented conditions within the area.

Remarks: Water table > 12 inches in depth; wetland hydrology is neither present nor indicated. Heavy rainfall (4.5 inches) 5 days prior and 0.3 inches 2 days prior.

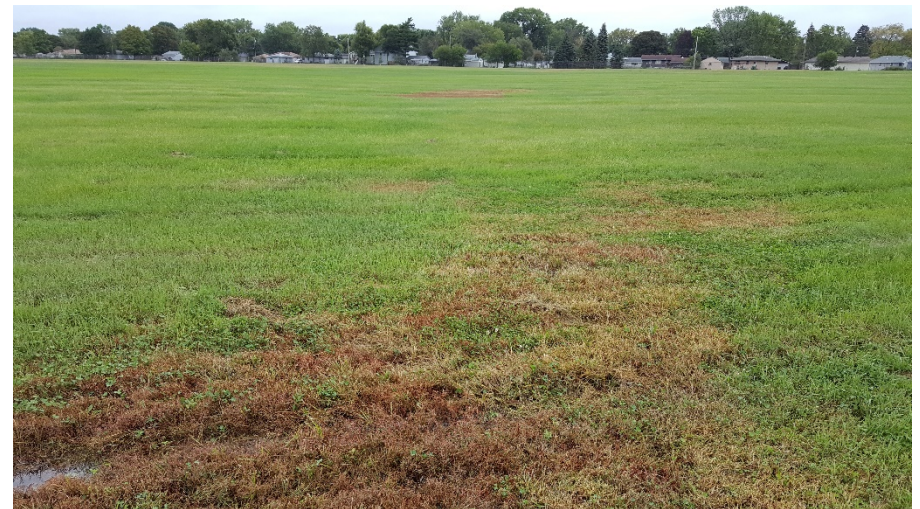
**Photo 34.** Wetlands 1 and 2. Late season conditions, view to the east.

Delineation of Wetlands 6 and 7 occurred during the September field visit while examining lands within Area H. To assess the status of the previously mapped Type 1 wetland, an east-to-west sampling transect consisting of four data points was taken through the area. This second site visit also enabled the examination of Wetlands 1 and 2 under late season conditions.
