## Appendix E – U.S. Fish & Wildlife Section 7 Consultation Correspondence

Content	Page
U.S. Fish & Wildlife Services Section 7 Concurrence Email and Attachment December 7, 2017	E-1 thru E-14

**From:** Joshua.Fitzpatrick@faa.gov  
**Sent:** Thursday, December 7, 2017 2:00 PM  
**To:** Evan Barrett  
**Subject:** FW: Lake Elmo Airport ESA Effect Determination  
**Attachments:** OPHI - Presentation for ODOT FAA Workshop.pdf

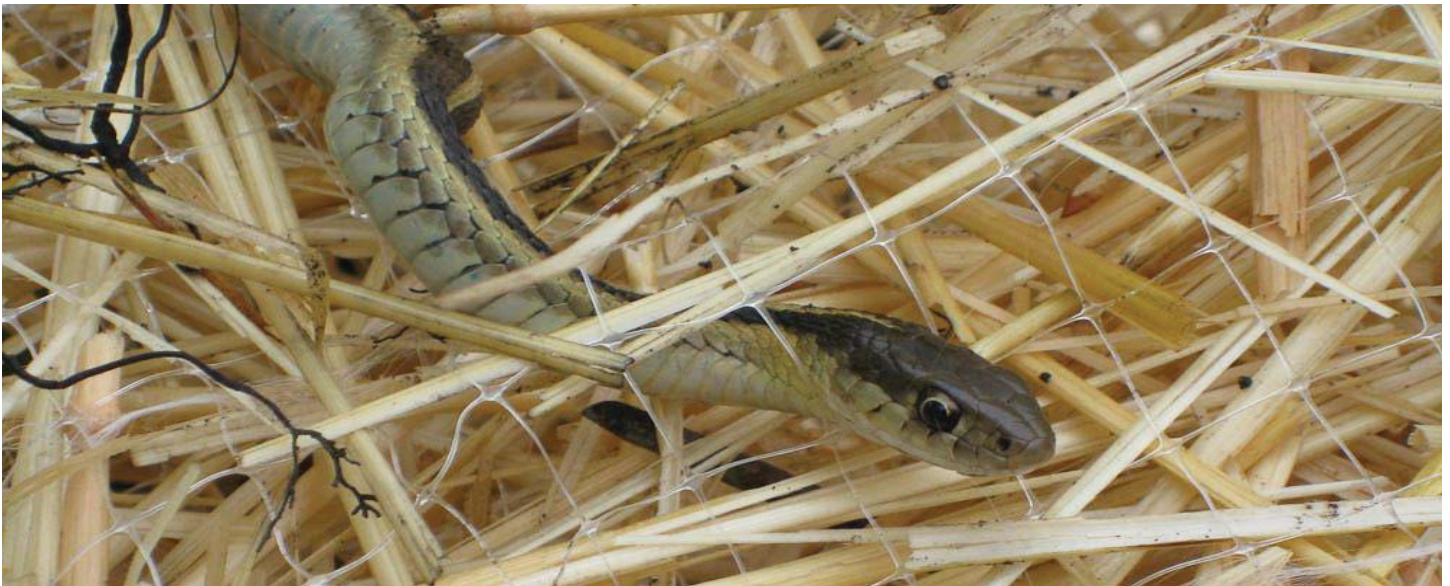
The plastic mesh component of erosion control blanket becomes a net for entrapment.

Plastic mesh netting is a common component in erosion control blanket. It is utilized to hold loose fibrous materials in place (EG straw) until vegetation is established. Erosion control blanket is being utilized extensively and is effective for reducing soil erosion, benefitting both soil health and water quality. Unfortunately there is a negative aspect of the plastic mesh component: It is increasingly being documented that its interaction with reptiles and amphibians can be fatal (Barton and Kinkead, 2005; Kapfer and Paloski, 2011). Mowing machinery is also susceptible to damage due to the long lasting plastic mesh.

- Plastic netting remains a hazard long after other components have decomposed.
- Plastic mesh netting can result in entanglement and death of a variety of small animals. The most vulnerable group of animals are the reptiles and amphibians (snakes, frogs, toads, salamanders, turtles). Ducklings, small mammals, and fish have also been observed entangled in the netting.
- Road maintenance machinery can snag the plastic mesh and pull up long lengths into machinery, thus binding up machinery and causing damage and/or loss of time cleaning it out.

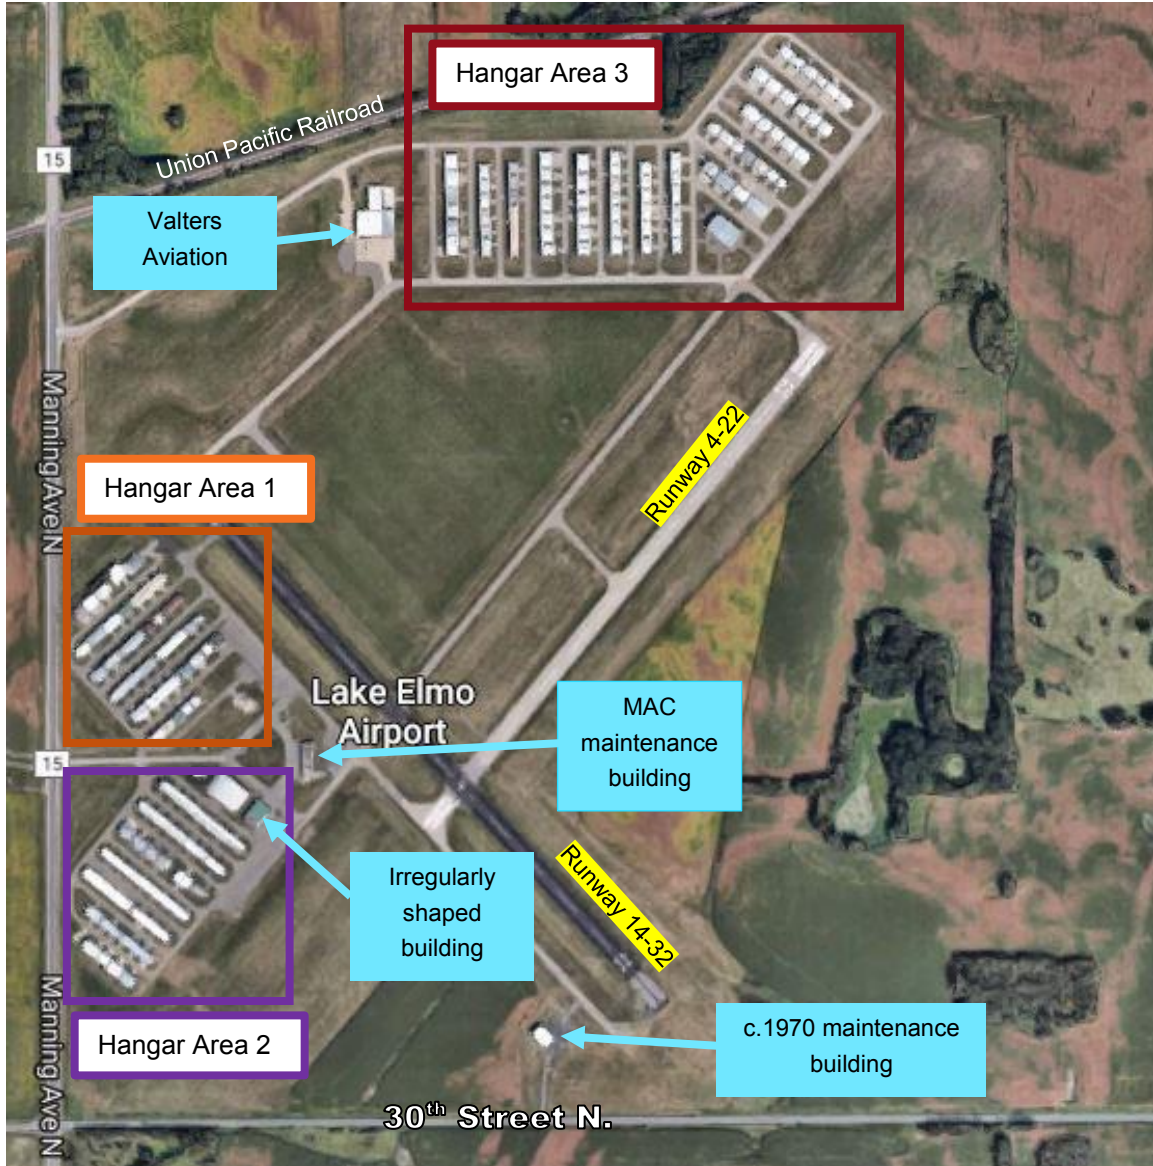
Figure 1. Current aerial of Lake Elmo Airport.

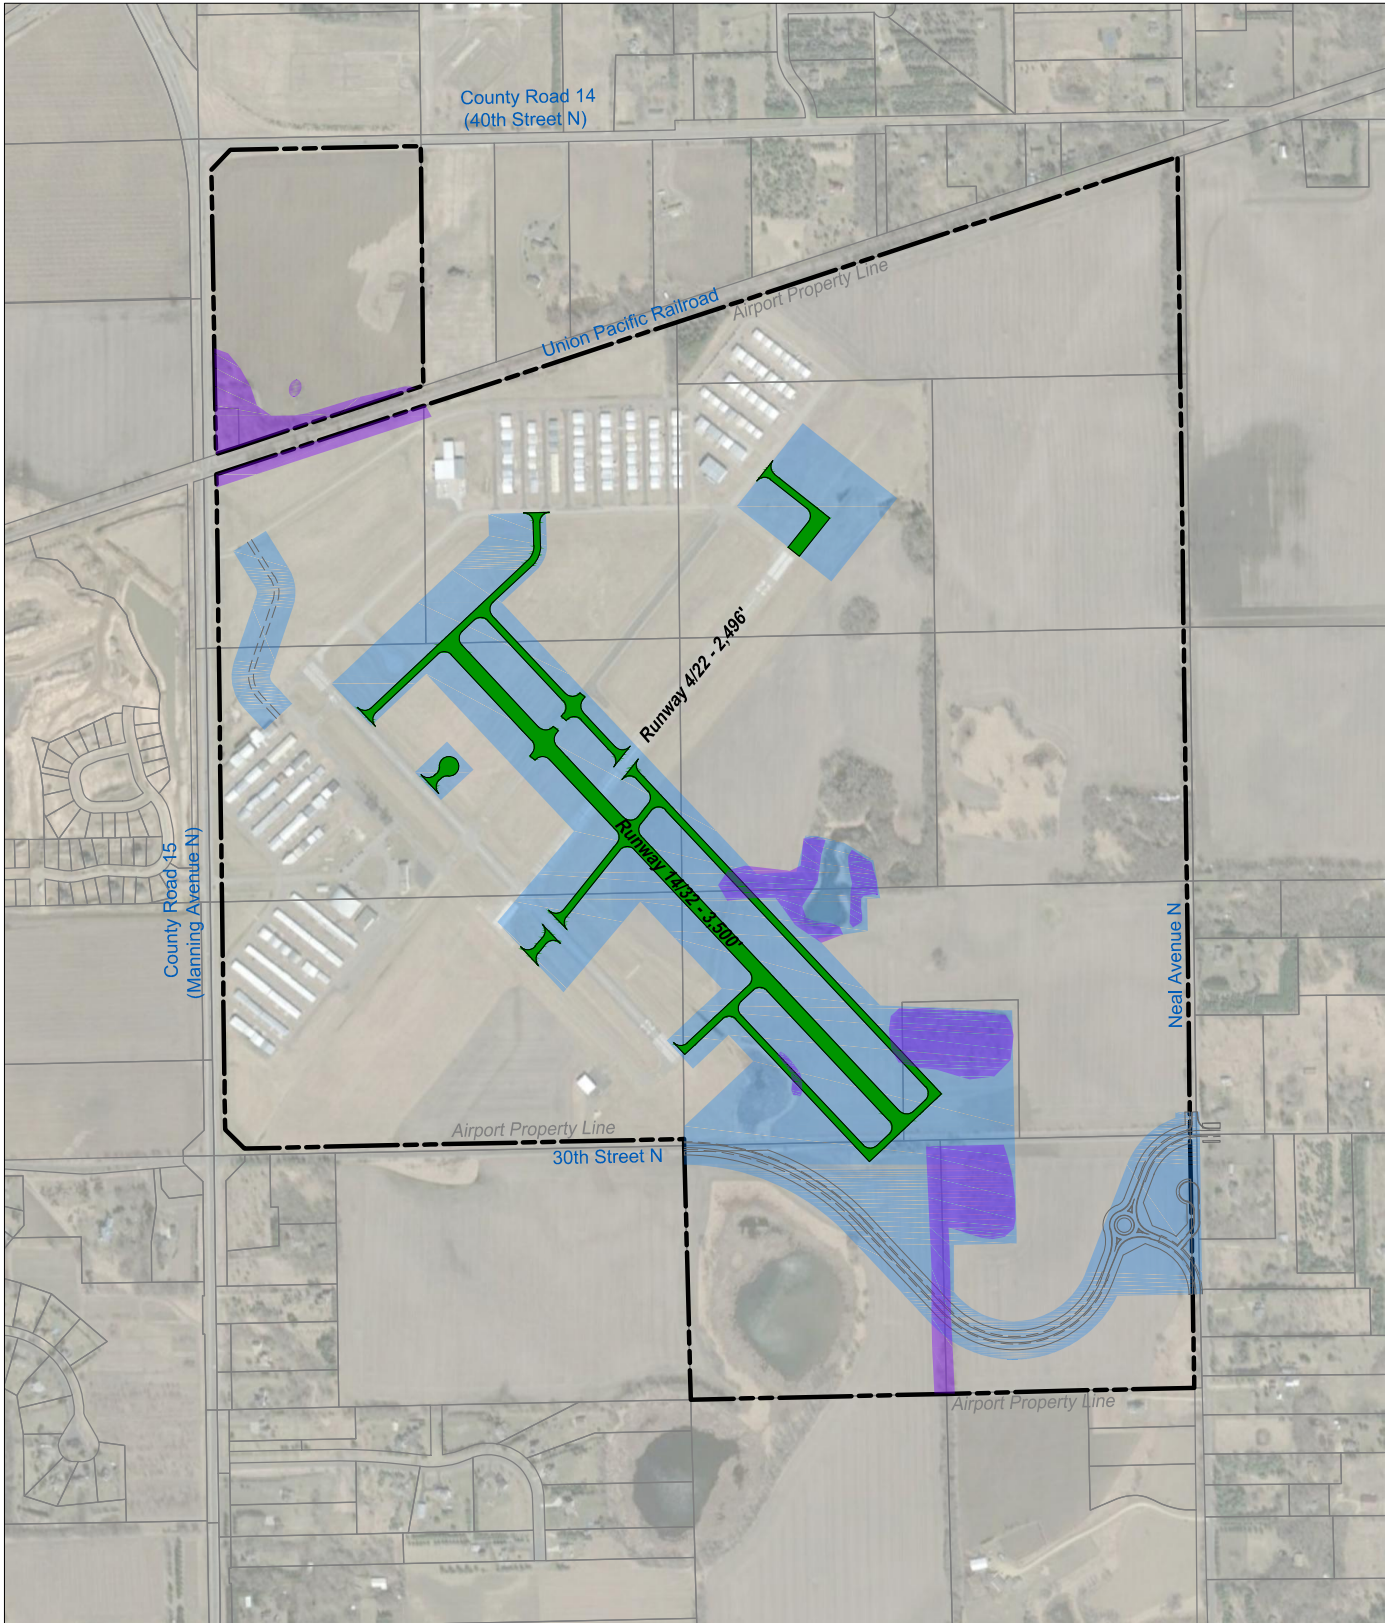
**Appendix B. Proposed Project Activities Exhibit**

- Grading Areas
- Pavement Additions
- Approximate Tree Removal Areas

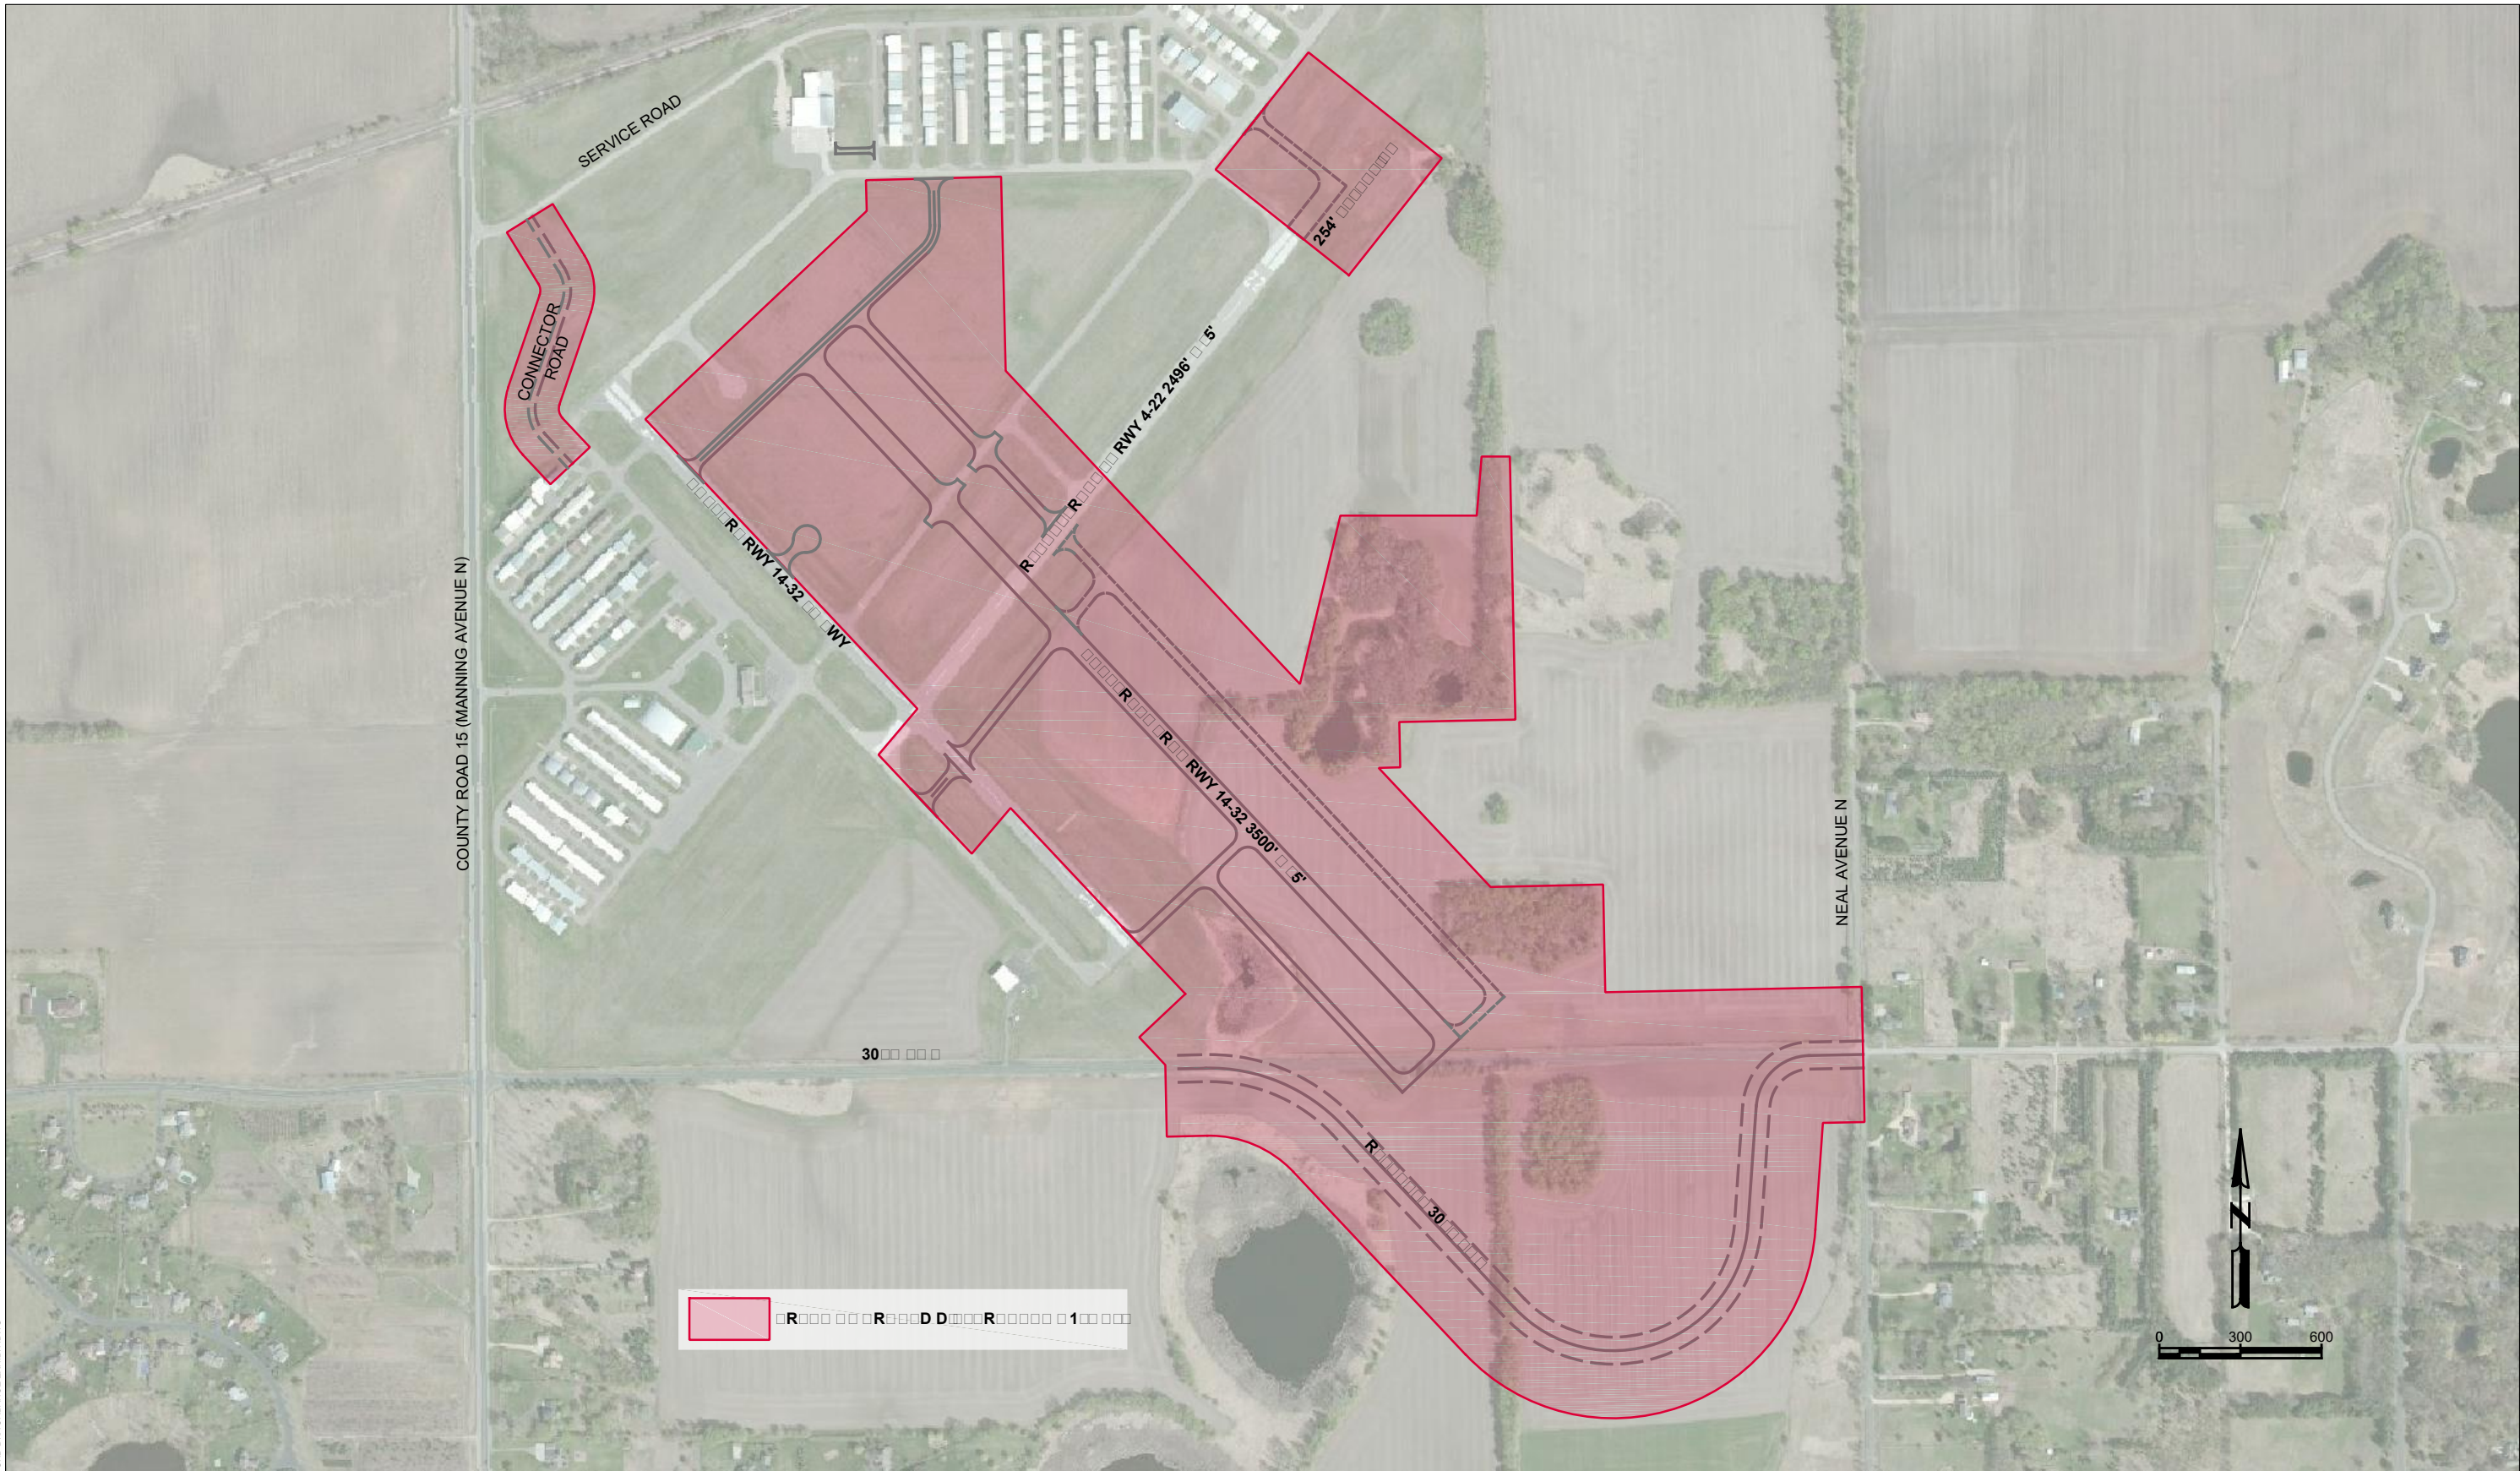
**Appendix C. Area of Ground Disturbance Exhibit**

AREAS OF GROUND DISTURBANCE

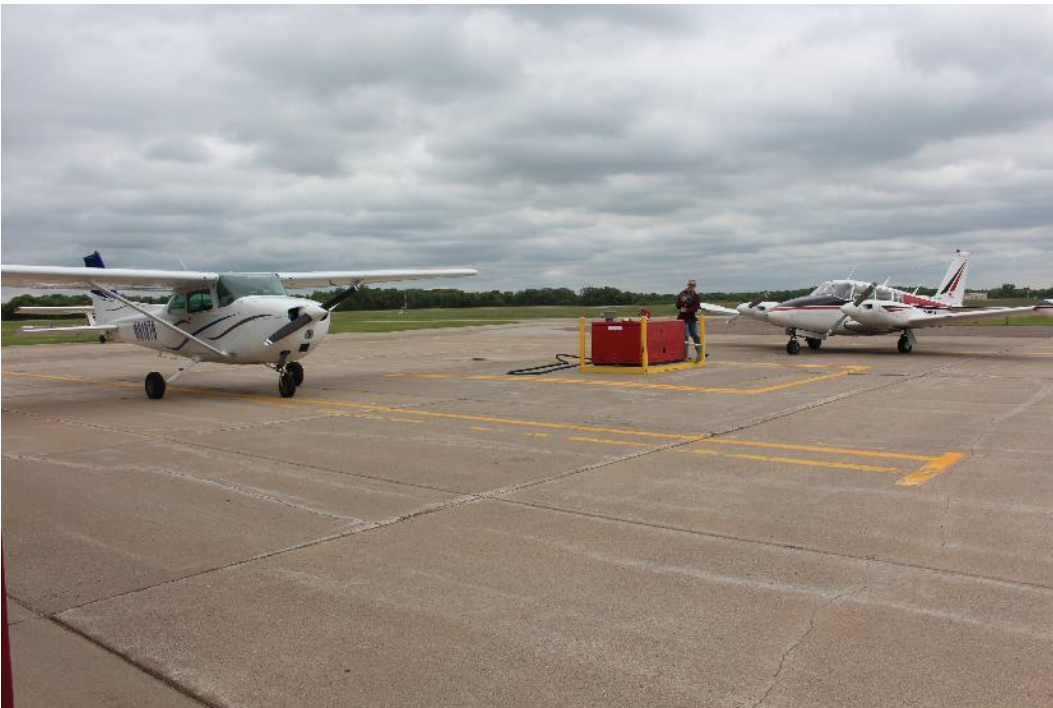
*UST and fuel pump at Valters Aviation Building.*

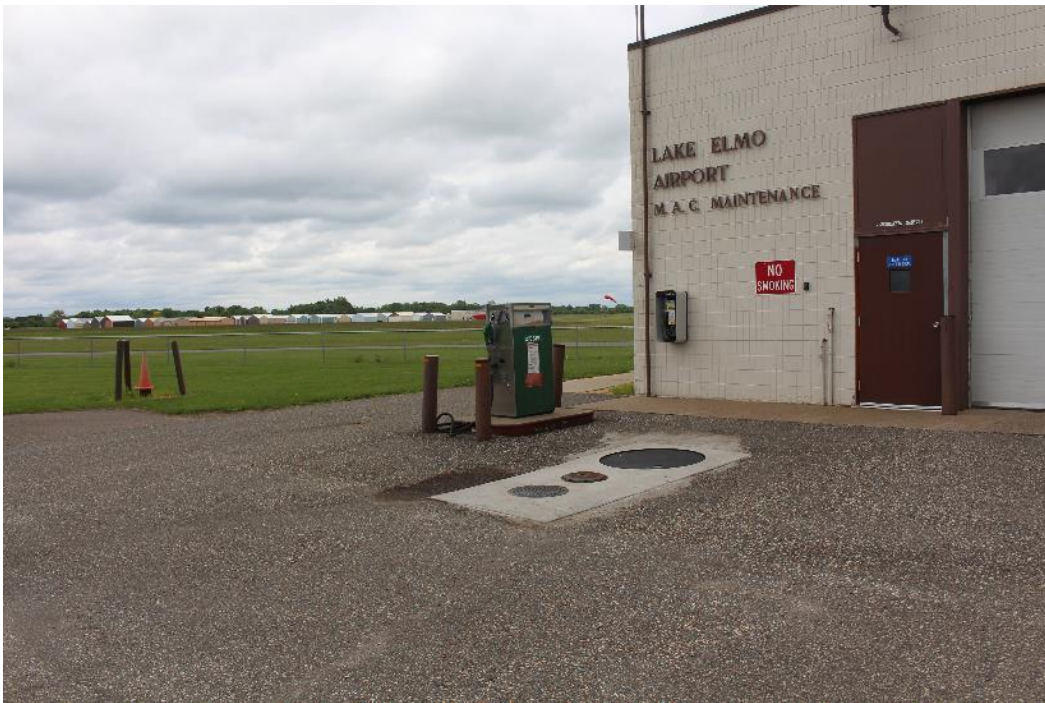
*Diesel fuel pump and UST at MAC Maintenance Building.*

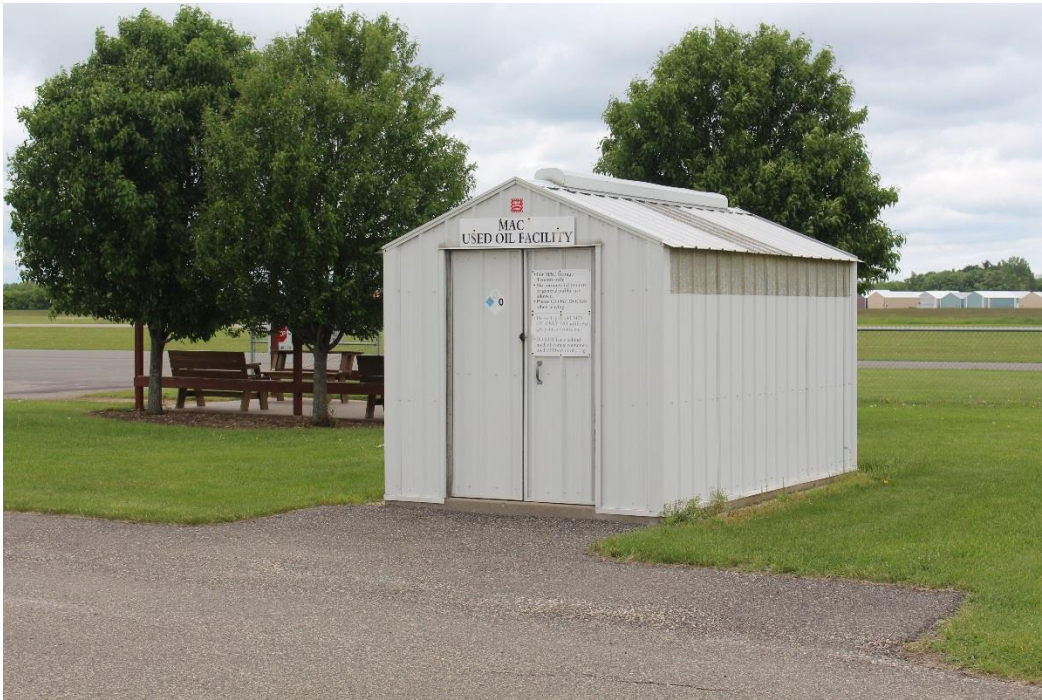
*Used Oil Facility adjacent to MAC Maintenance Building.*

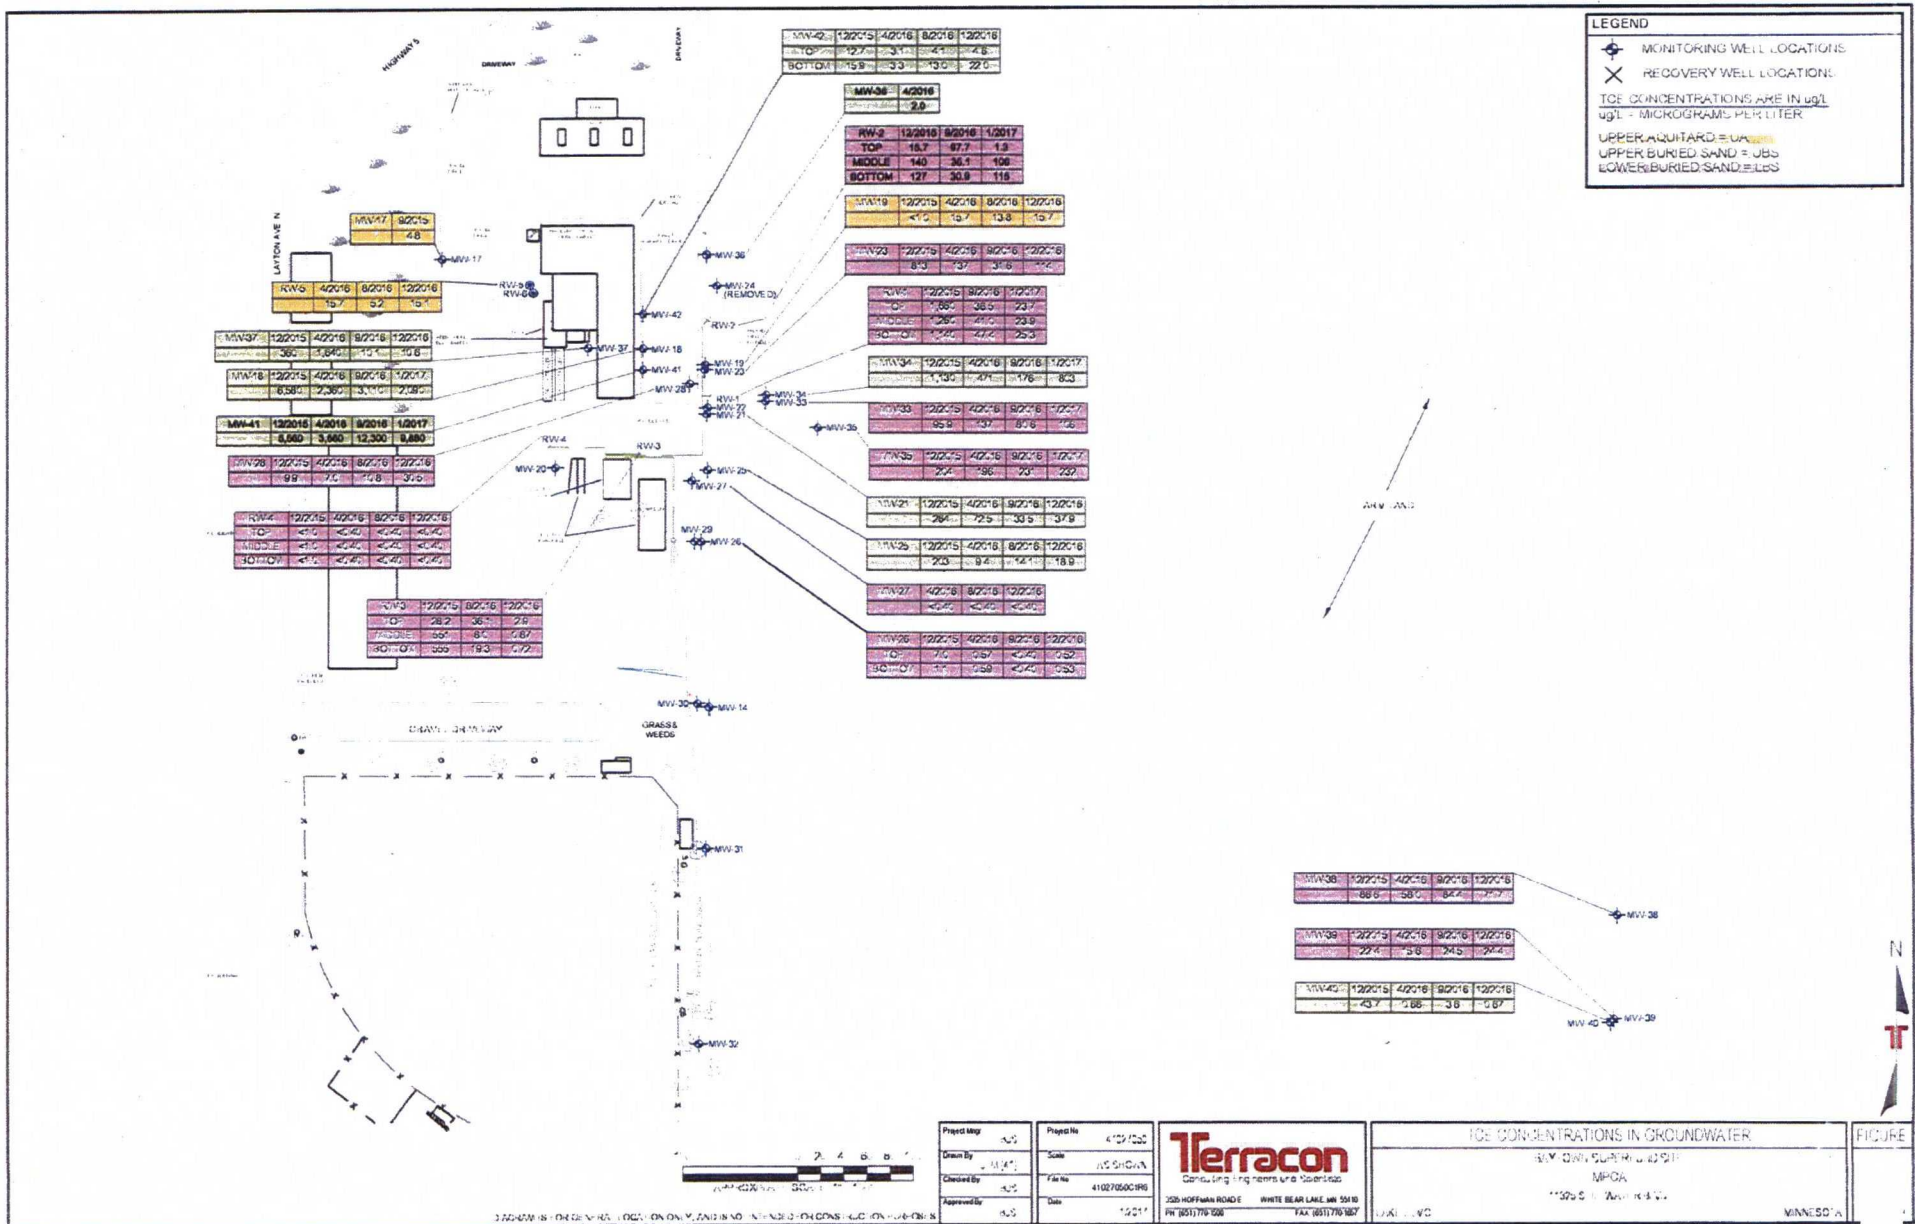
Figure 7. TCE Concentrations in Source Area Groundwater (2017)  
 (see Annual Report for additional information)

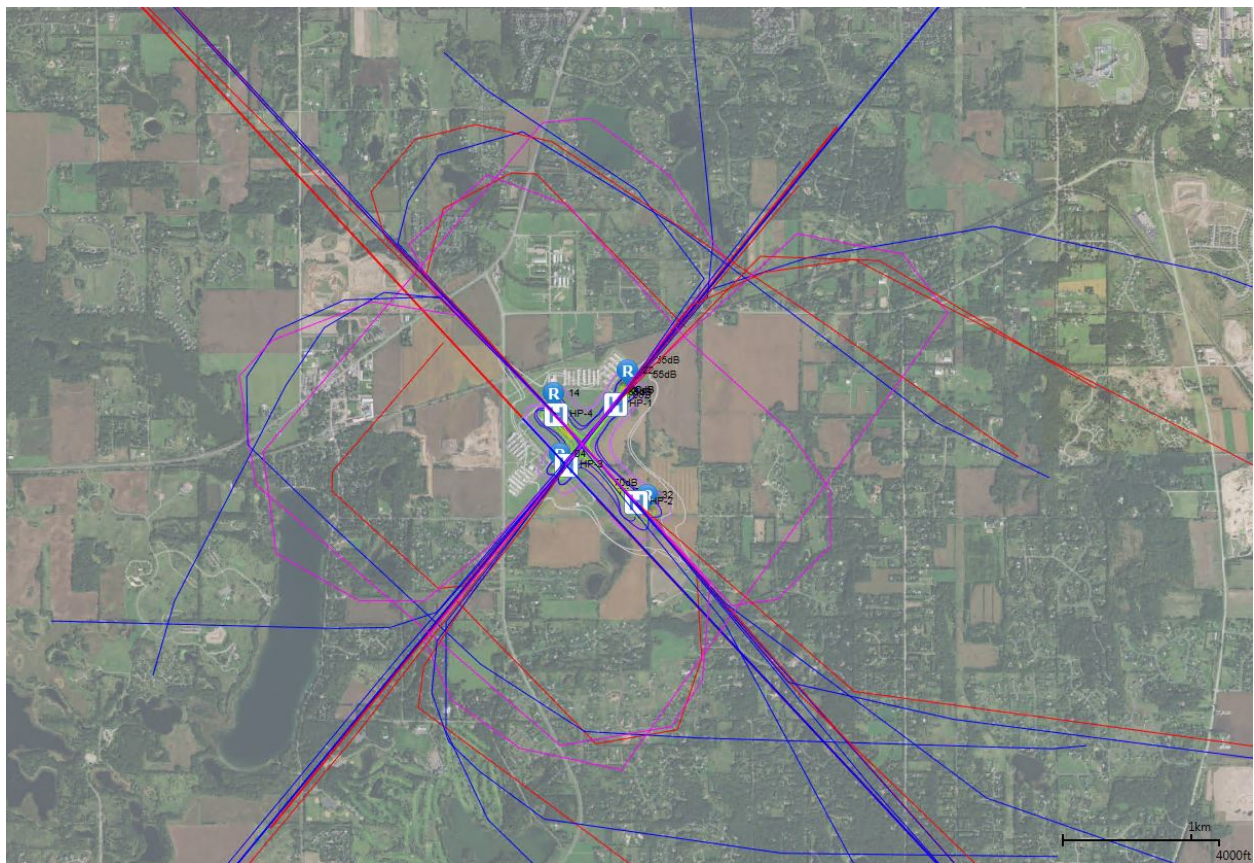
- Red are arrival tracks
- Blue are departure tracks
- Magenta are touch-and-go tracks

Track utilization percentages used in the AEDT study are shown in **Table 6** attached to this memorandum. It is worth noting that due to the low number of total operations, the locations of arrival and departure tracks, and track utilization percentages are not expected to impact the contour size and shape. The contours do not extend out to the point where tracks begin to make turns, therefore would not change with different percentage utilization. The primary drivers of where noise is located and distributed at this airport, is the runway end utilization percentages and aircraft types modeled.

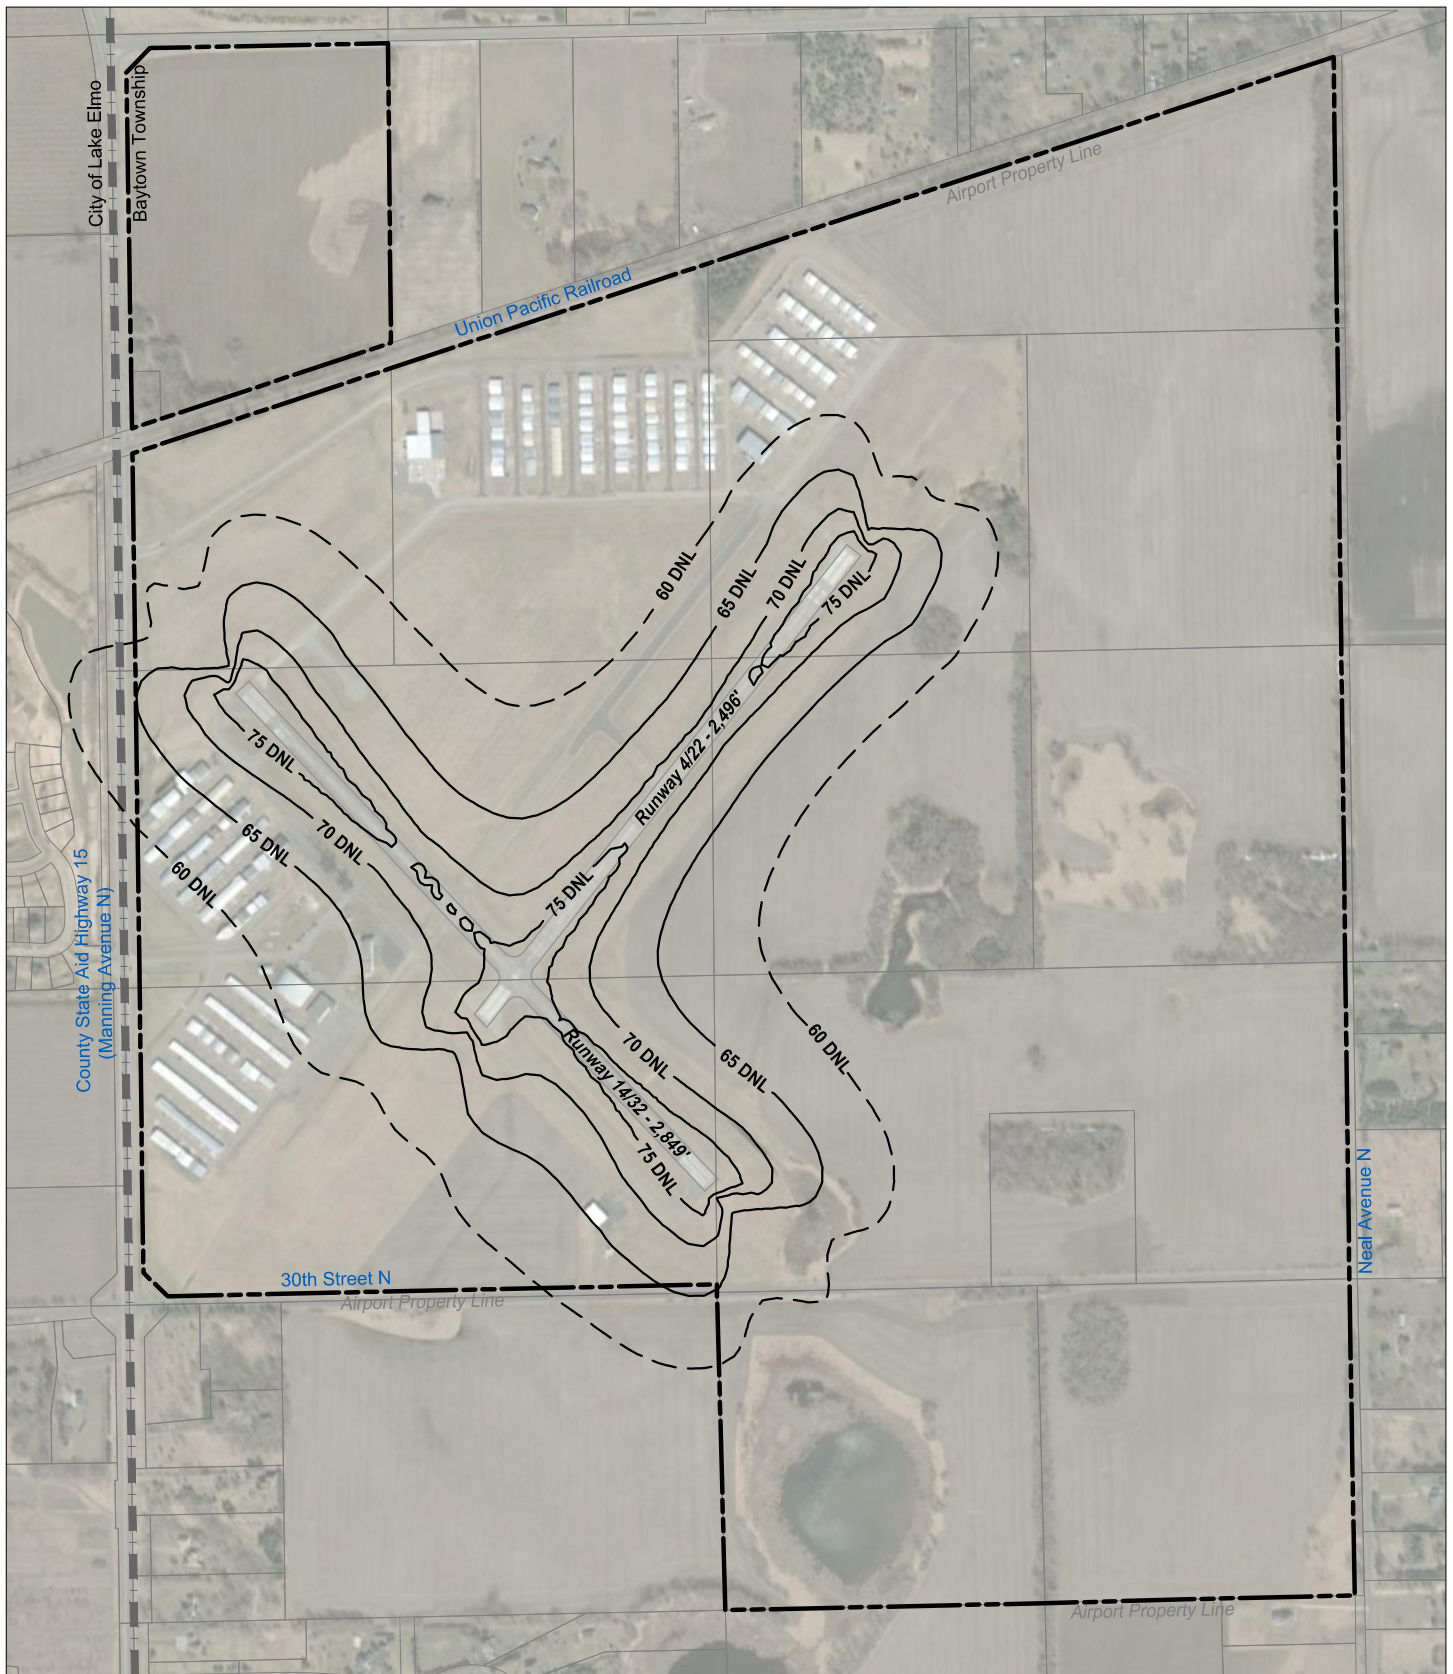
**2025 No Action Alternative Aircraft Noise Contours** **FIGURE 5-2**

Note: Aircraft noise contour 60 DNL is shown for informational purposes only.
